Independence National Historical Park

Cultural Landscape Inventory, Phase 1

Final Draft June 1, 1994

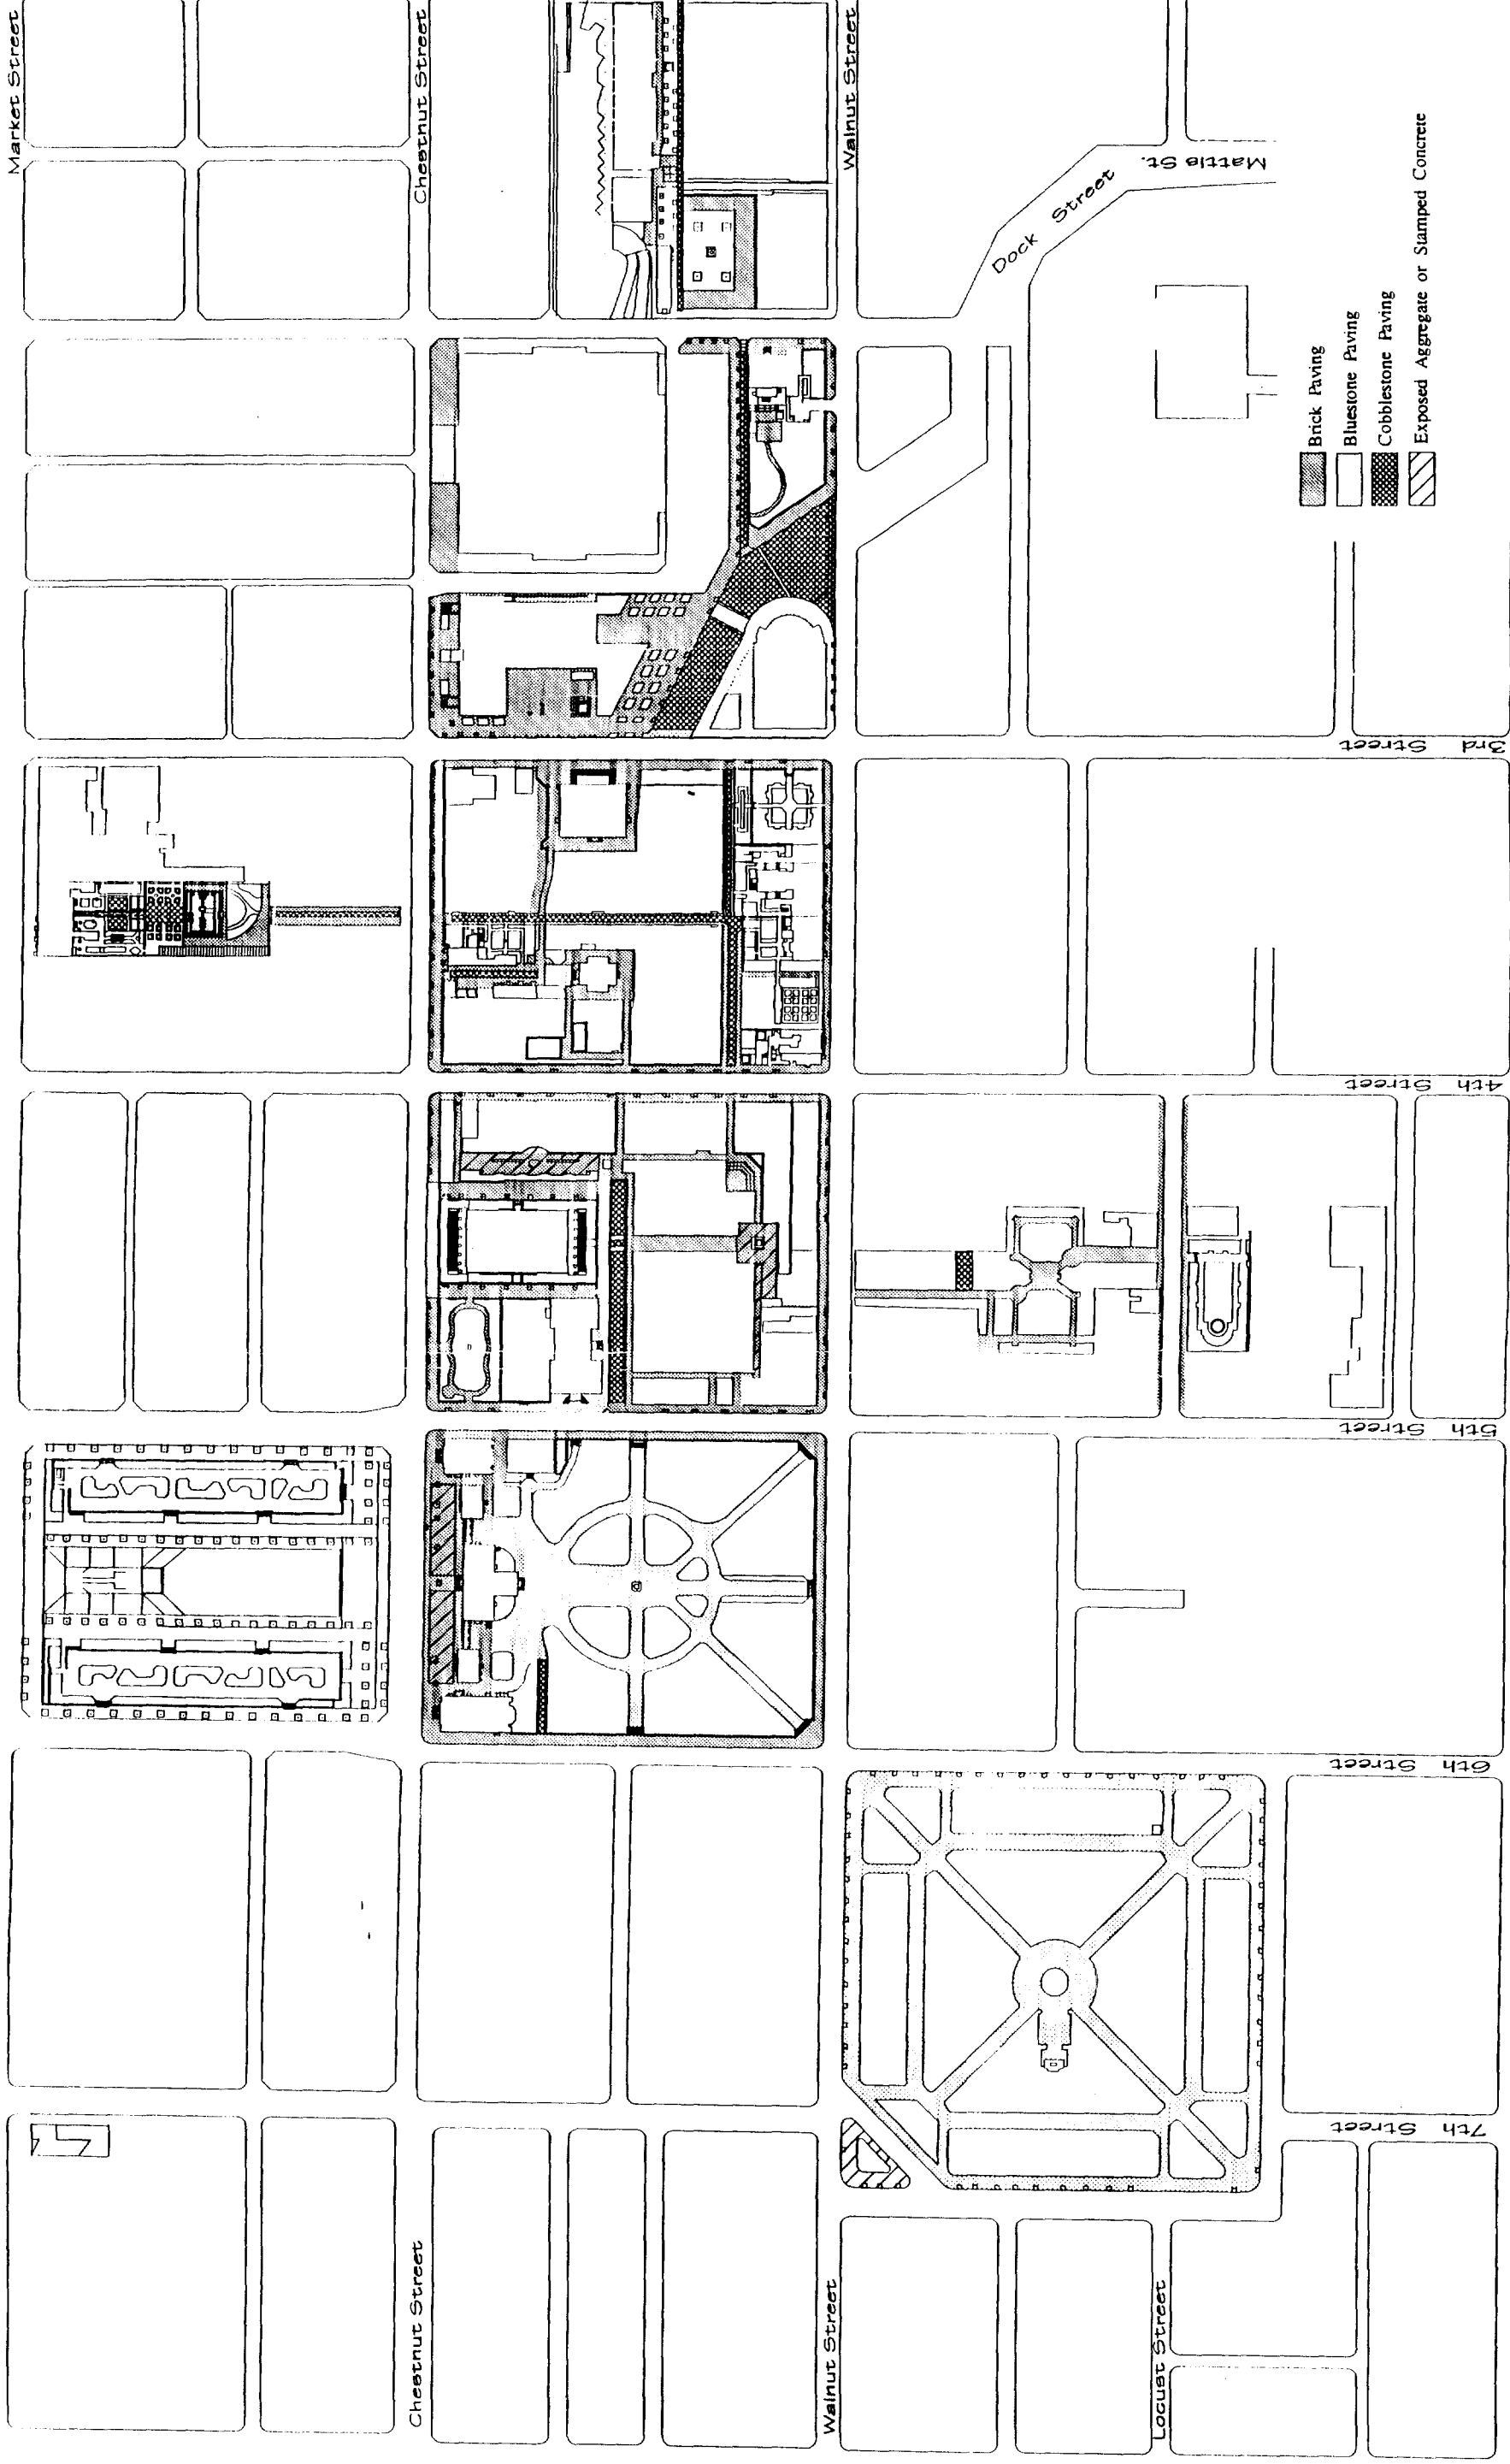
Materials

Notes: Brick and bluestone paving south of the Second Bank has been replaced with stamped concrete in some places (See diagram-"Materials"). In addition, modern stock light standards have been installed along some paths in this area as well.

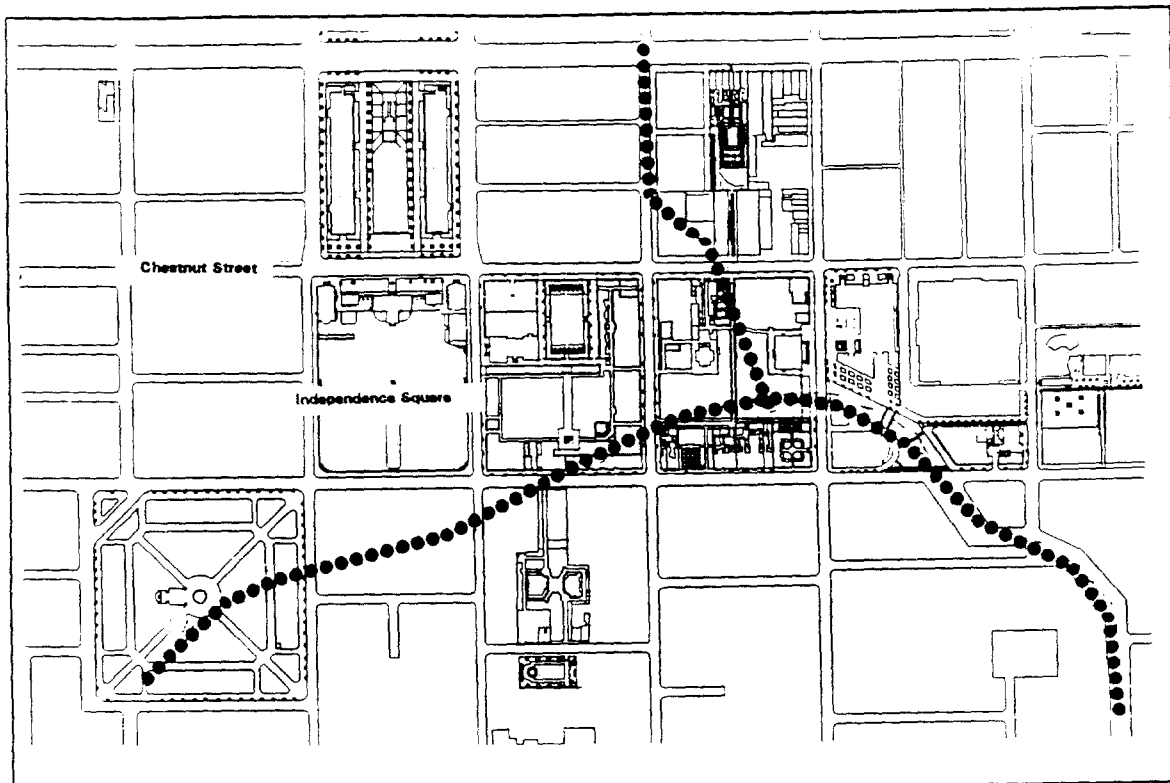
Approximate 18th century alignment: Dock Creek

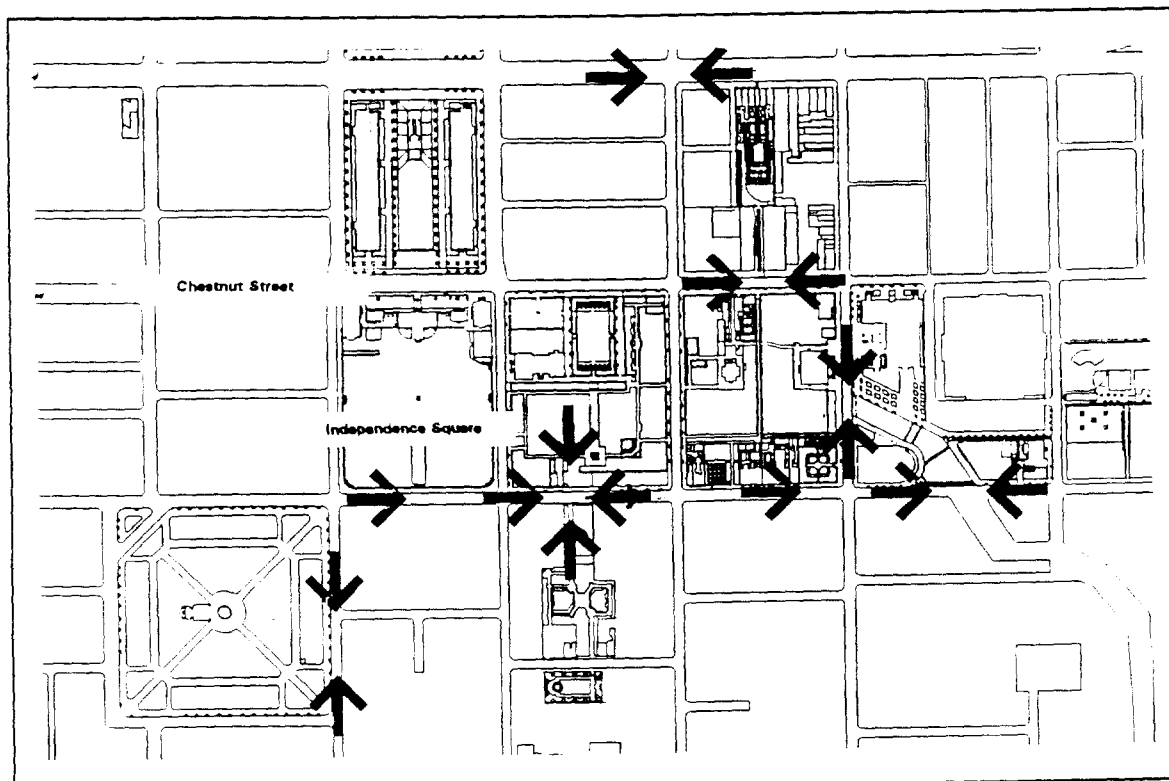
Current sloping conditions visible in city streets

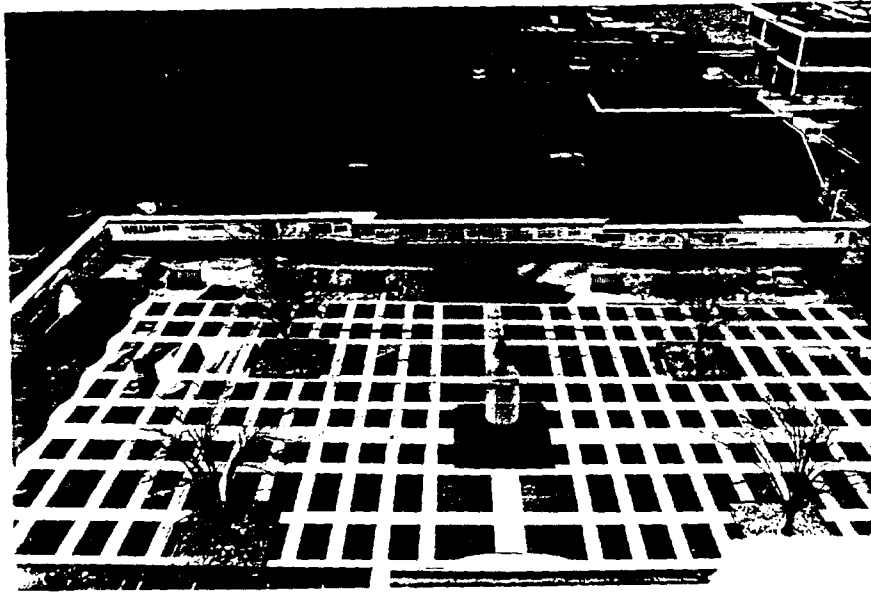
Notes: Overall the square appears to be a stark and poorly articulated entrance point to the park. The trees, a small flowering species that generally self-destructs after 15 to 20 years, will not gain the height or spread to become a presence in the space; the painted mural of the Delaware is an ironic poke at an unattainable view.

Aerial view: Welcome Park

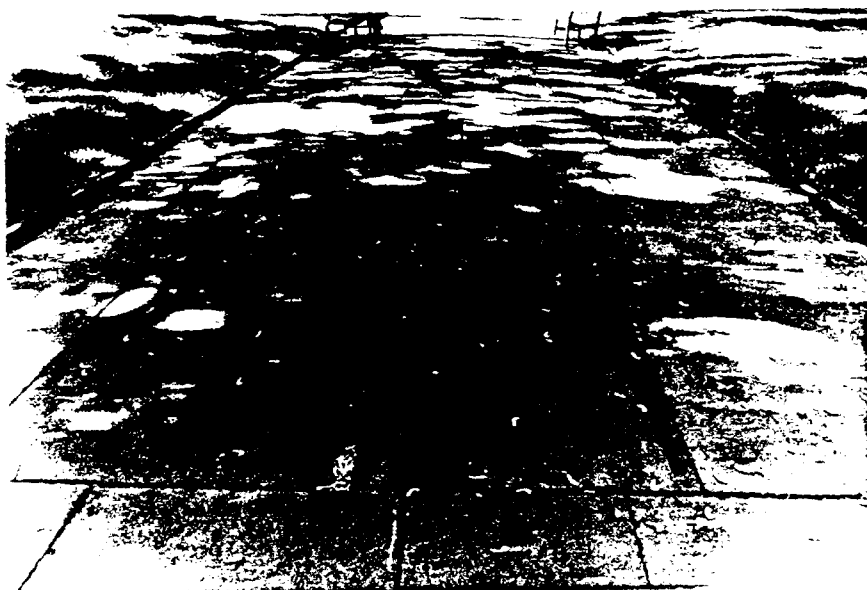
The bluestone paving and curbs are in poor condition. Many stones are heaving and cracked. Some stones have been replaced with concrete. These stones are extremely difficult to replace and and therefore should be considered an irreplaceable historic resource.

Bluestone paving and curbs

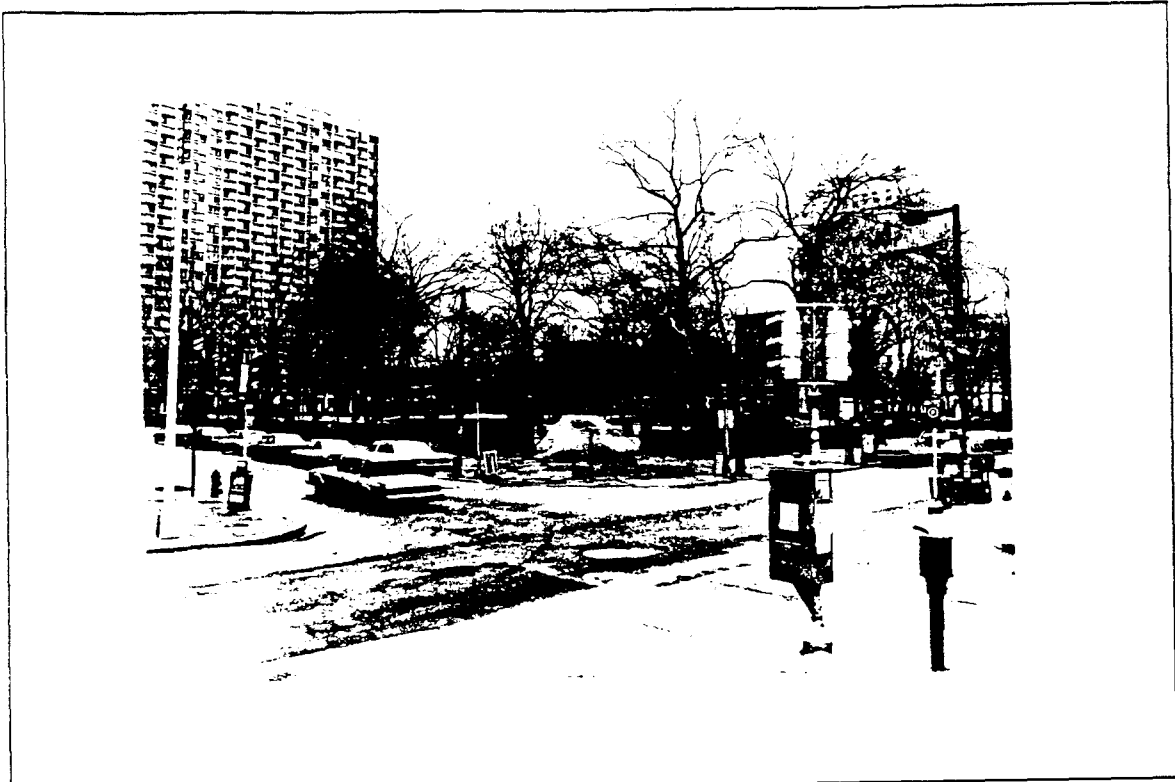
Handicap accessibility is a major site issue, not only because of the grade changes both to the square and the buildings but because of the poor condition of the pavers. This will require a thorough and careful study to ensure that loss of character-defining features are kept to a minimum.

View looking southeast towards Washington Square

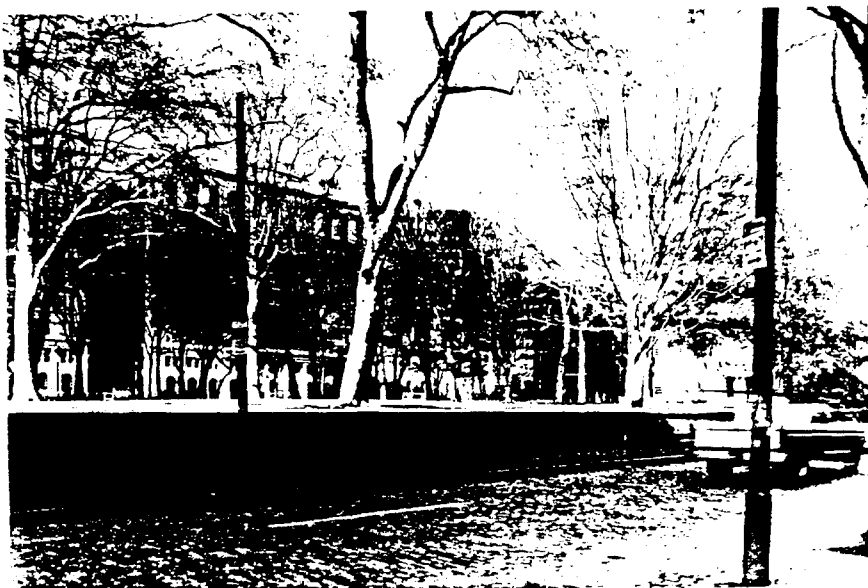
Retaining wall along 5th Street

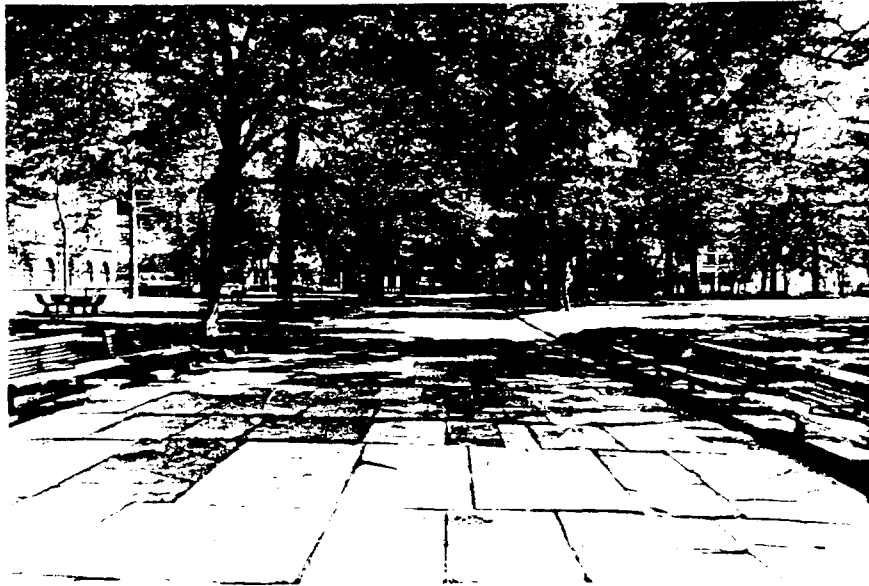
The bluestone paving is in extremely poor condition. Many pieces are cracked; several large areas have settled further exacerbating the cracking and causing large uneven walking surfaces. Care should be taken when considering replacement. The stones may be considered irreplaceable.

Bluestone paving and curbs

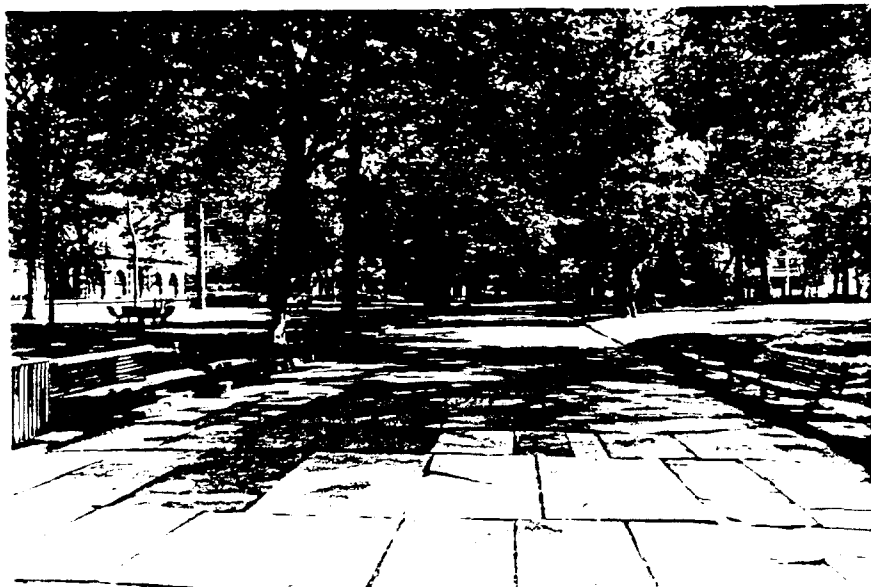
Many of the trees appear quite old and in decline. A good vegetation inventory that includes information about identity, age, size, and condition, if not already accomplished, should be considered to ensure a long-term management strategy and replacement plan.

Canopy trees, lawn
