# Accessibility Self-Evaluation and Transition Plan (SETP)

Badlands National Park  
South Dakota  
August 2024

# **National Park Service Interior Regions 3, 4, and 5**

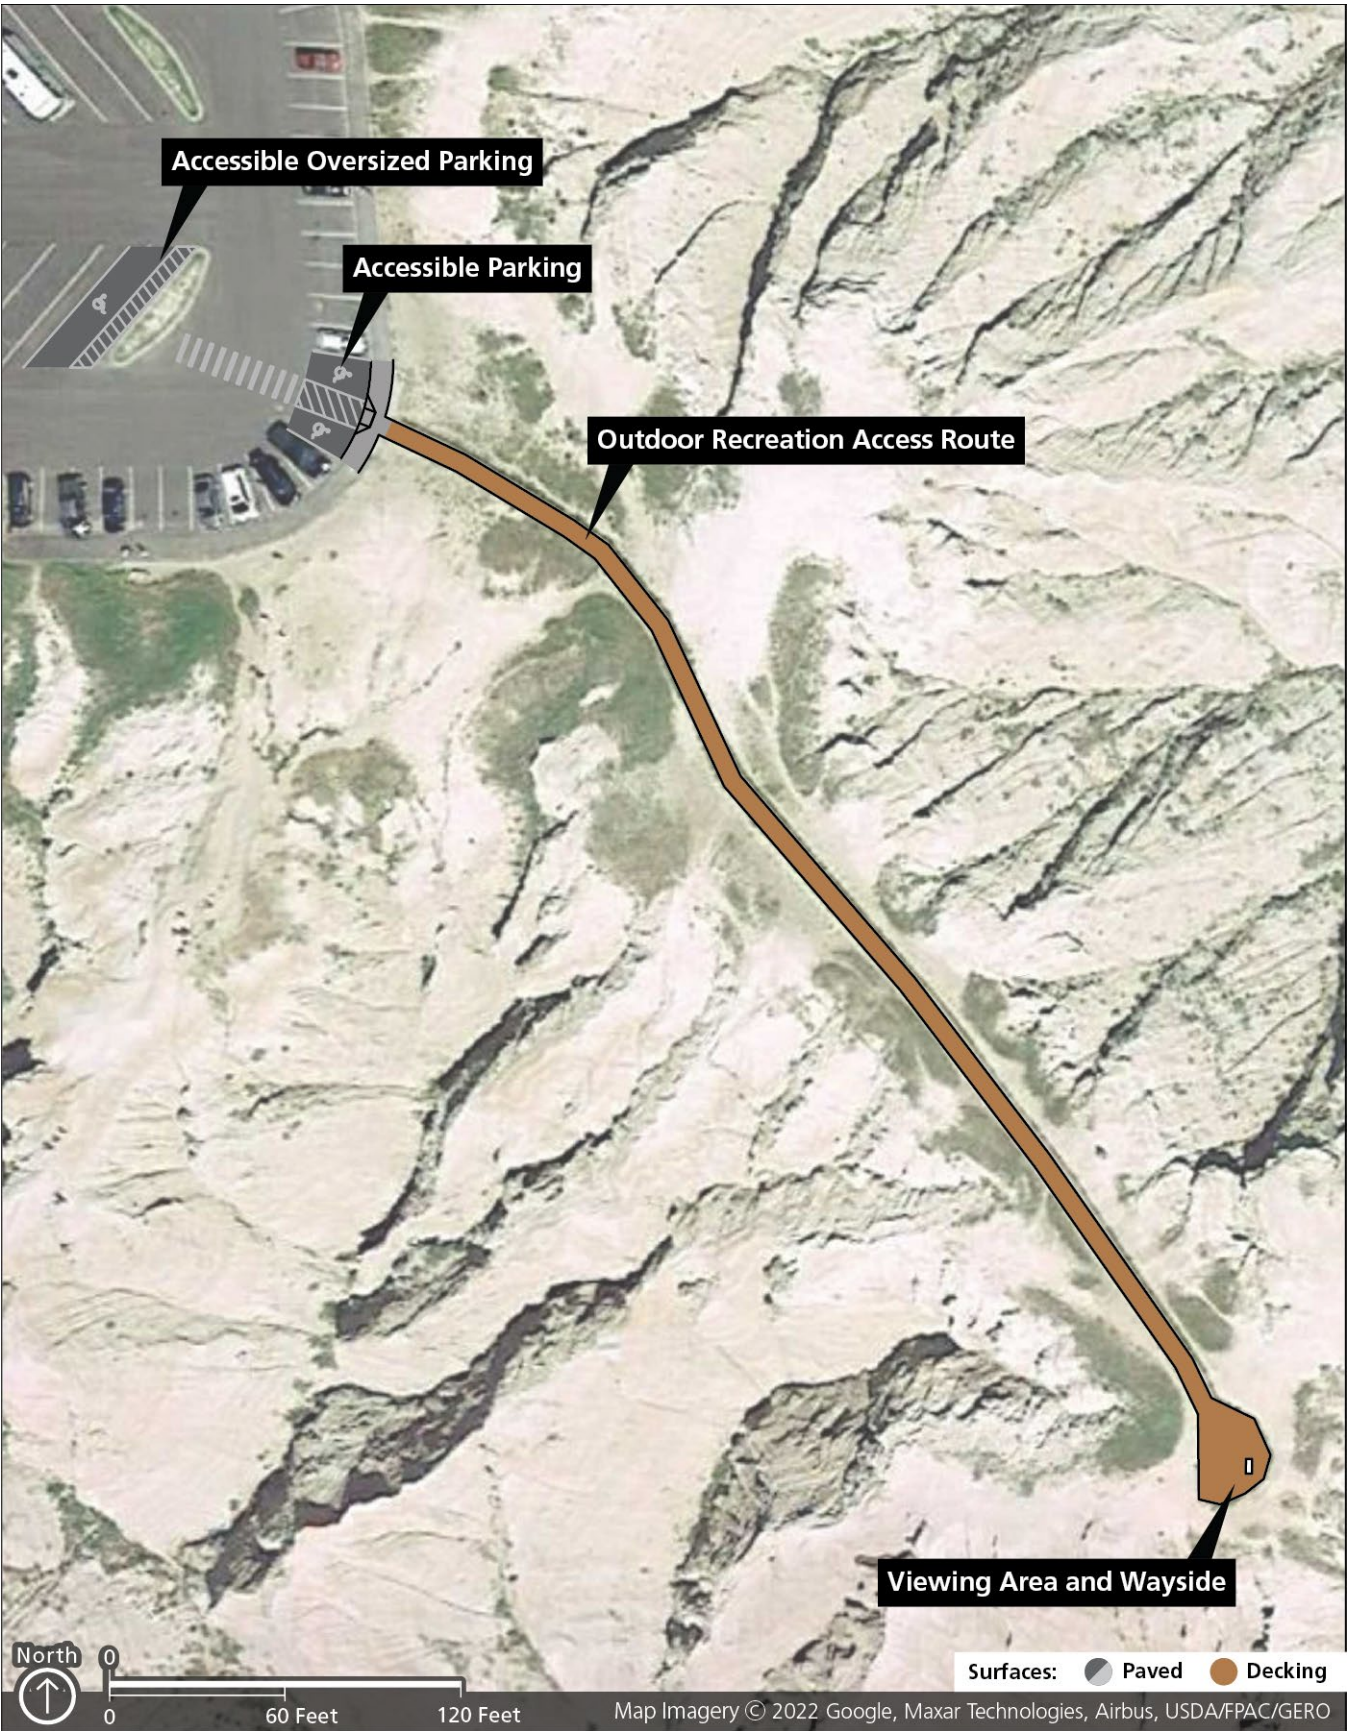
Big Badlands Overlook Site Plan

Big Badlands Overlook is often the first stop for park visitors, and it overlooks the vast Badlands spreading into the horizon. Visitors come to view and photograph the distinctive layers of the formations that represent past environments in geologic time. The 0.2-mile boardwalk is accessible, wide and with low slopes, and an accessible viewing area is located at its terminus. Accessible parking spaces are level but narrow, an accessible oversized parking space is not available, and the curb ramp landing and transition are difficult to maneuver. Accessibility could be improved by widening accessible parking spaces and raising signage, improving route transitions and curb ramp landings, and providing an accessible oversized parking space. Providing audio descriptions of wayside graphics and scenery and exploring other methods of effective communication (e.g., 3D model of the formations) would further improve accessibility at the site.

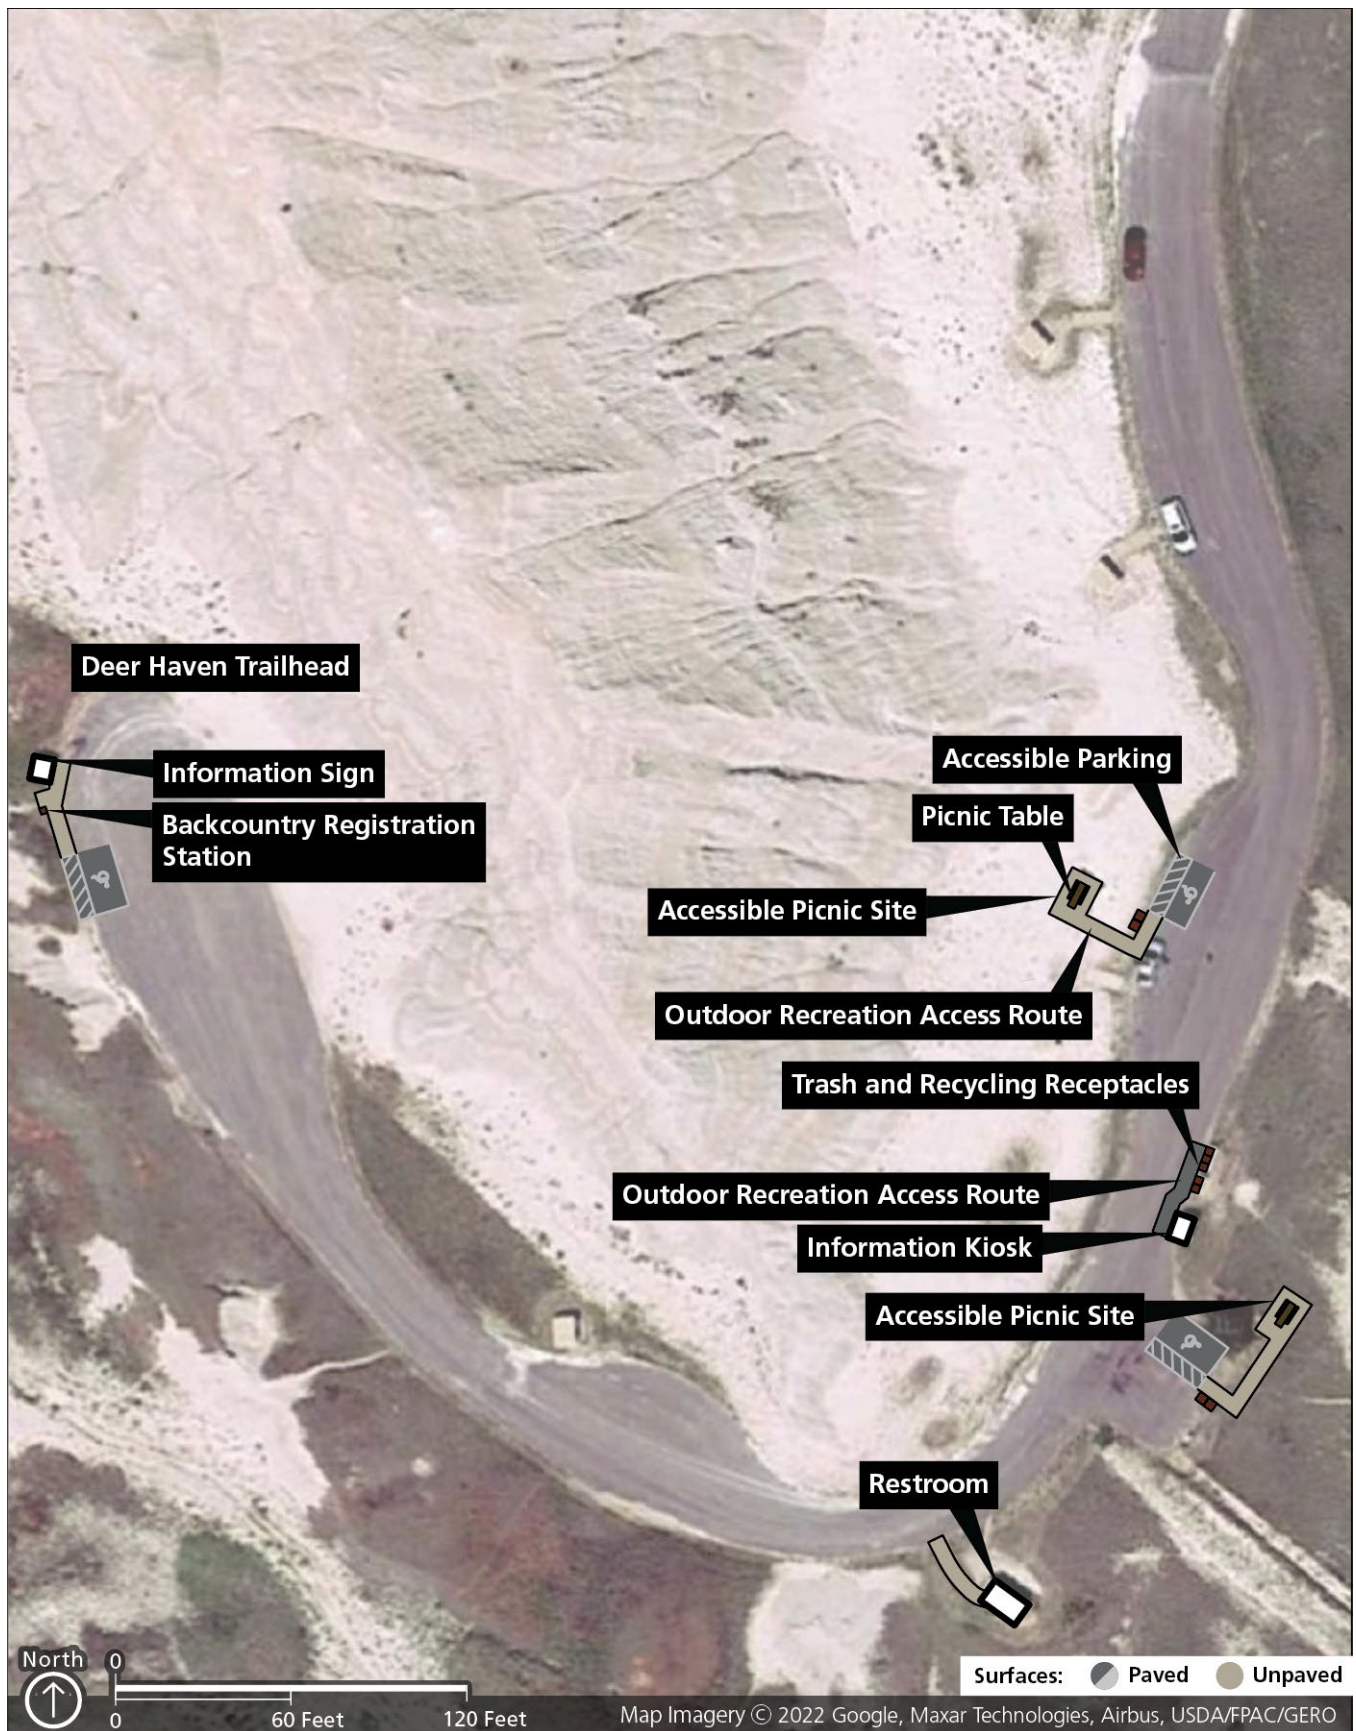
## Conata Picnic Area Site Plan

Conata Picnic Area offers a picnic experience among the Badlands formations for visitors. In addition to picnicking, visitors come to hike to nearby Deer Haven and explore the paleontological excavation called the Big Pig Dig. The site is relatively level and has an accessible restroom, but little else is accessible in the area. Routes between facilities are uneven; the historic picnic shelters lack accessible tables and clear ground spaces; accessible parking spaces are missing; and information panels and trailhead signage use small text, have poor contrast, and do not include adequate approaches. A project is in the works to improve the picnic area and update some of these deficiencies. Accessibility could be improved by adding dispersed accessible parking stalls and picnic sites, improving routes between facilities, and updating information panels and trailhead signage. Providing audio descriptions of the maps and graphics would further improve accessibility at the site.

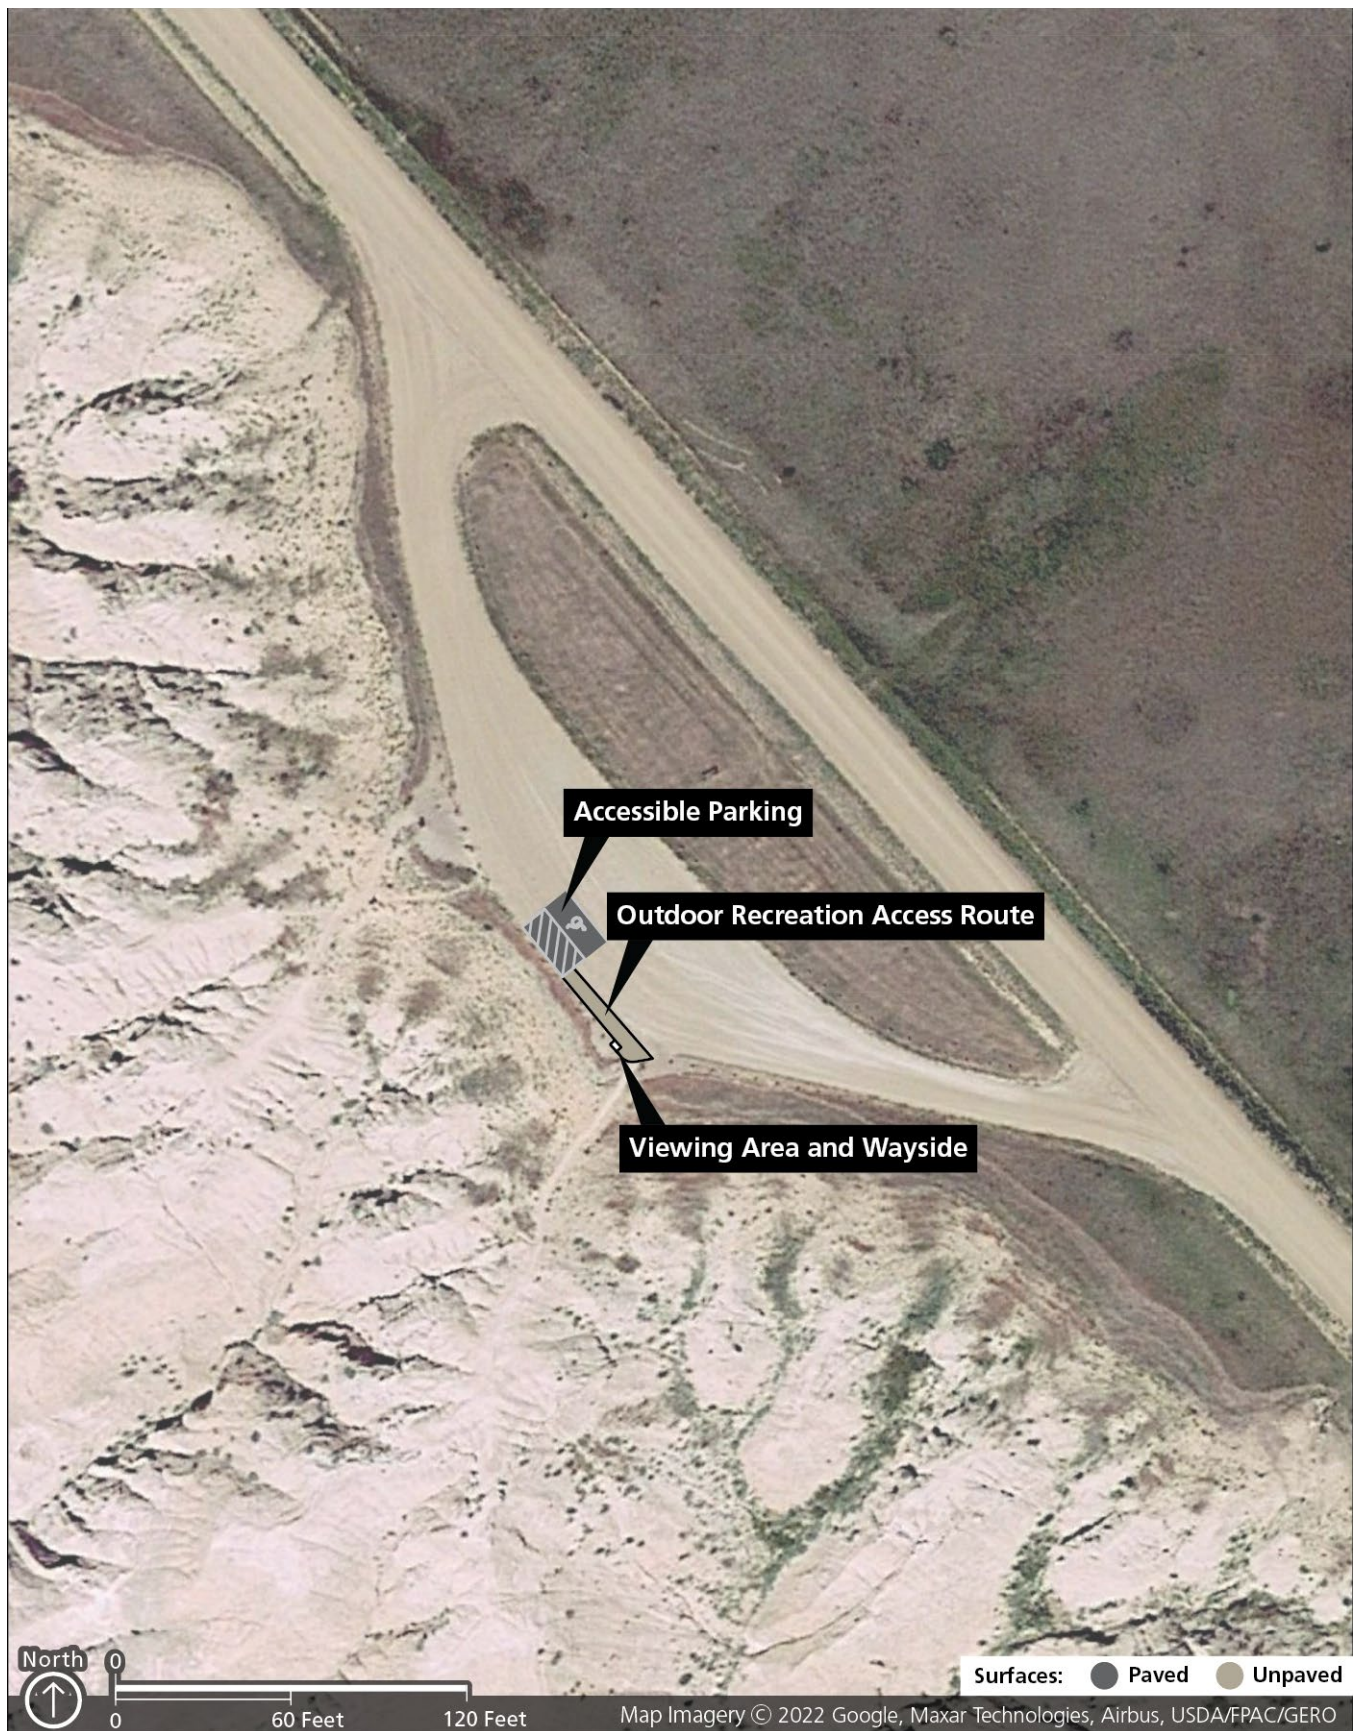
## Hay Butte Overlook Site Plan

Hay Butte Overlook affords scenic views into the Sage Creek Wilderness Area and displays the massive, grass-capped butte known as Hay Butte. Visitors come to view and photograph the scenery, learn about Badlands grassy tabletops, and spot wildlife, such as bison and bighorn sheep that frequent the area. The unpaved pulloff has no designated parking, the route to the wayside and viewing area is loose and has high slopes, and the wayside at the viewing area lacks a level approach. Accessibility could be improved by designating an accessible parking space and establishing/stabilizing a level route to the viewing area. Providing audio descriptions of wayside graphics and scenery and exploring other methods of effective communication (e.g., 3D model of the butte landscape) would further improve accessibility at the site.

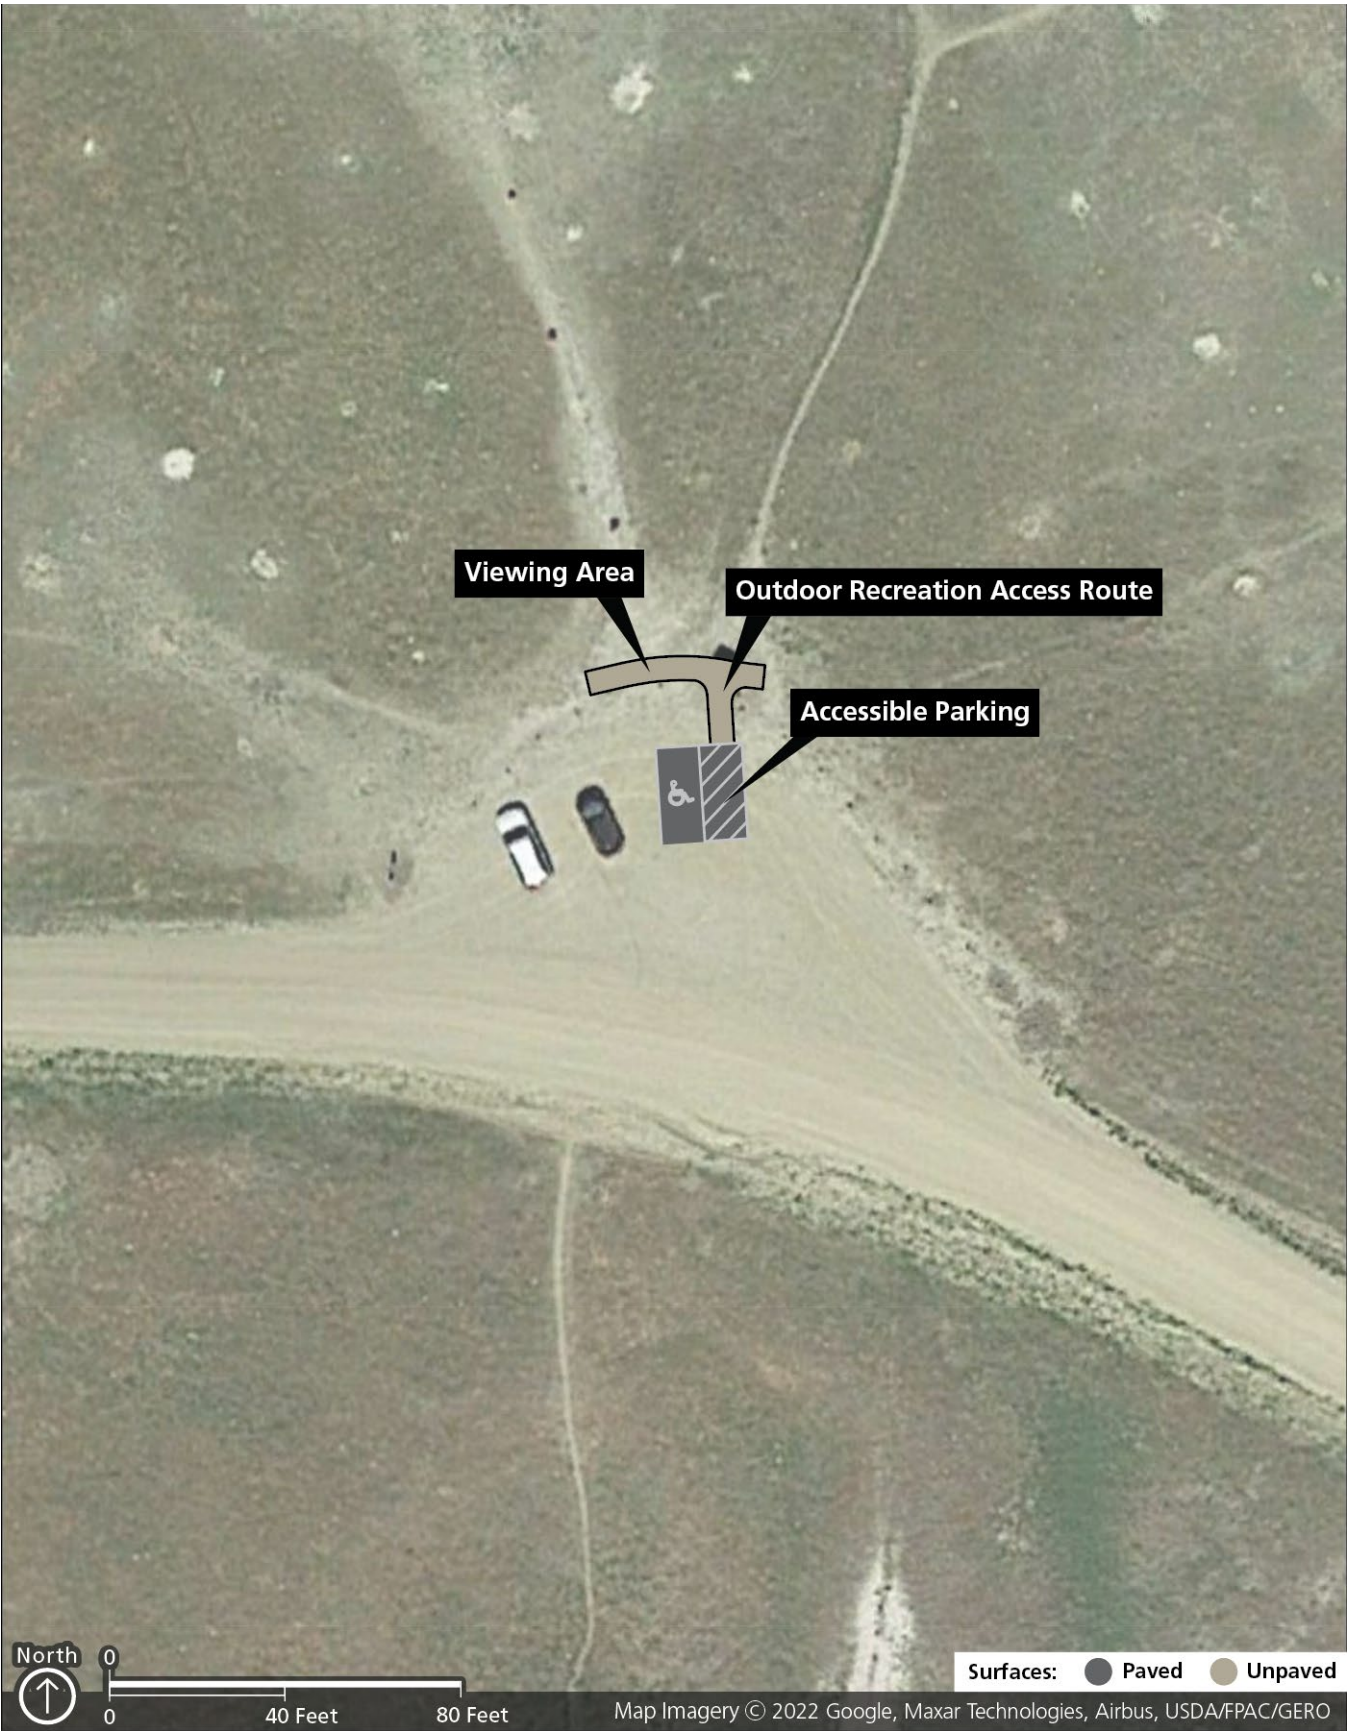
Roberts Prairie Dog Town Site Plan

Roberts Prairie Dog Town is easily accessed via an unpaved pullout and allows for a perfect view of the park's largest prairie dog town. Visitors come to watch and photograph the prairie dogs and other wildlife and listen to their high-pitched squeaks and noises. The unpaved pullout has no designated parking, and the ground around the informal area is uneven, loose, and has high slopes and prairie dog holes. Accessibility could be improved by designating an accessible parking space and establishing/stabilizing a level route to the viewing area. Park staff could also consider adding a wayside and tactile model to convey information.

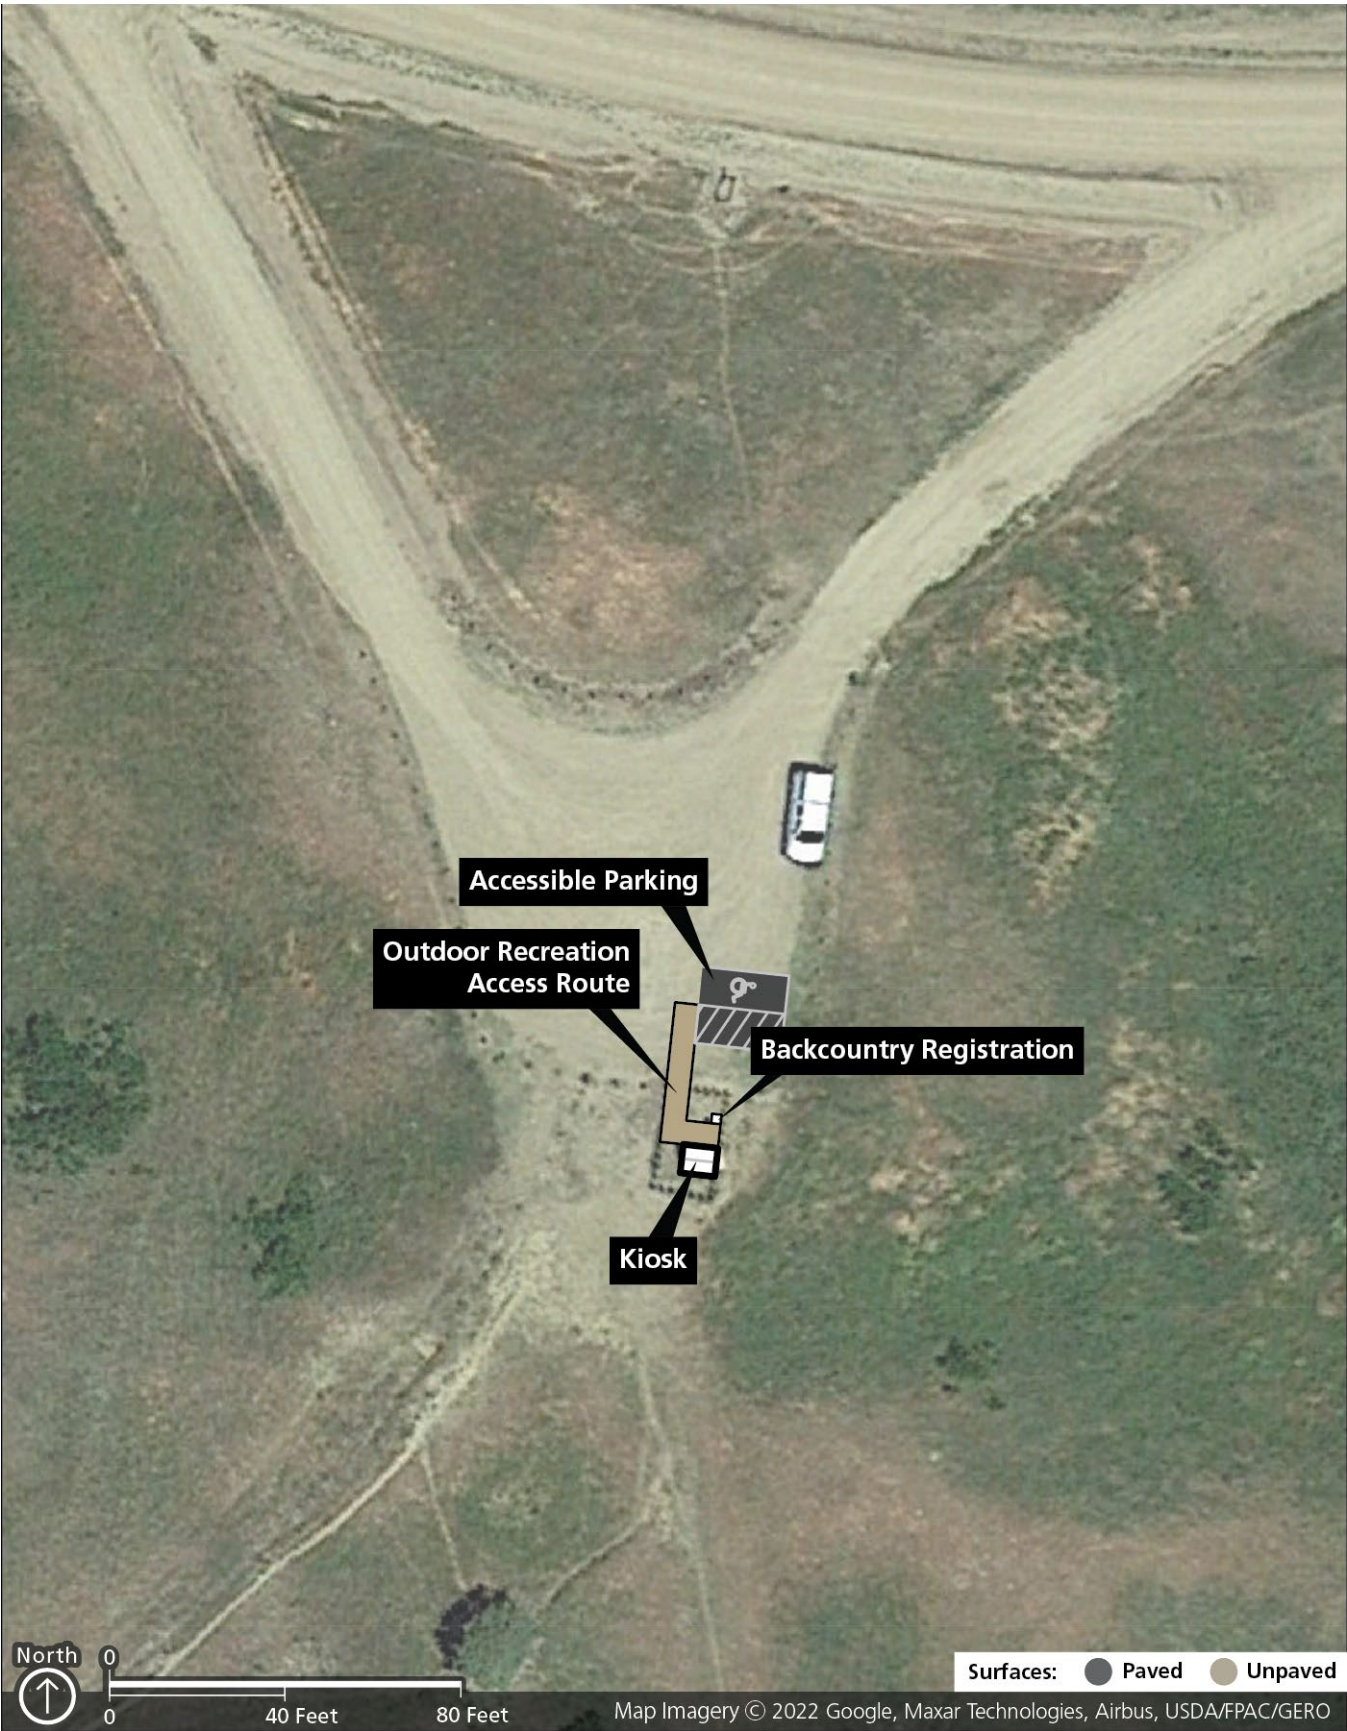
Sage Creek Basin Overlook Site Plan

Sage Creek Basin Overlook provides a view into a pristine mixed-grass prairie where the Badlands formations have almost entirely eroded away. Game trails created by bison are visible across the prairie. Visitors come to view and photograph the prairie that melts into the distant Badlands buttes and to spot wildlife. The parking lot is unpaved, and the route to the kiosk with an interpretive panel and backcountry registration box has high slopes and is uneven. The interpretive panel has small text, and registration box is too high. Accessibility could be improved by establishing an accessible parking space near the kiosk, improving the route to the kiosk, updating signage, and lowering/replacing the backcountry registration box. Providing audio descriptions of the interpretive panel graphics and scenery and exploring other methods of effective communication would further improve accessibility at the site.

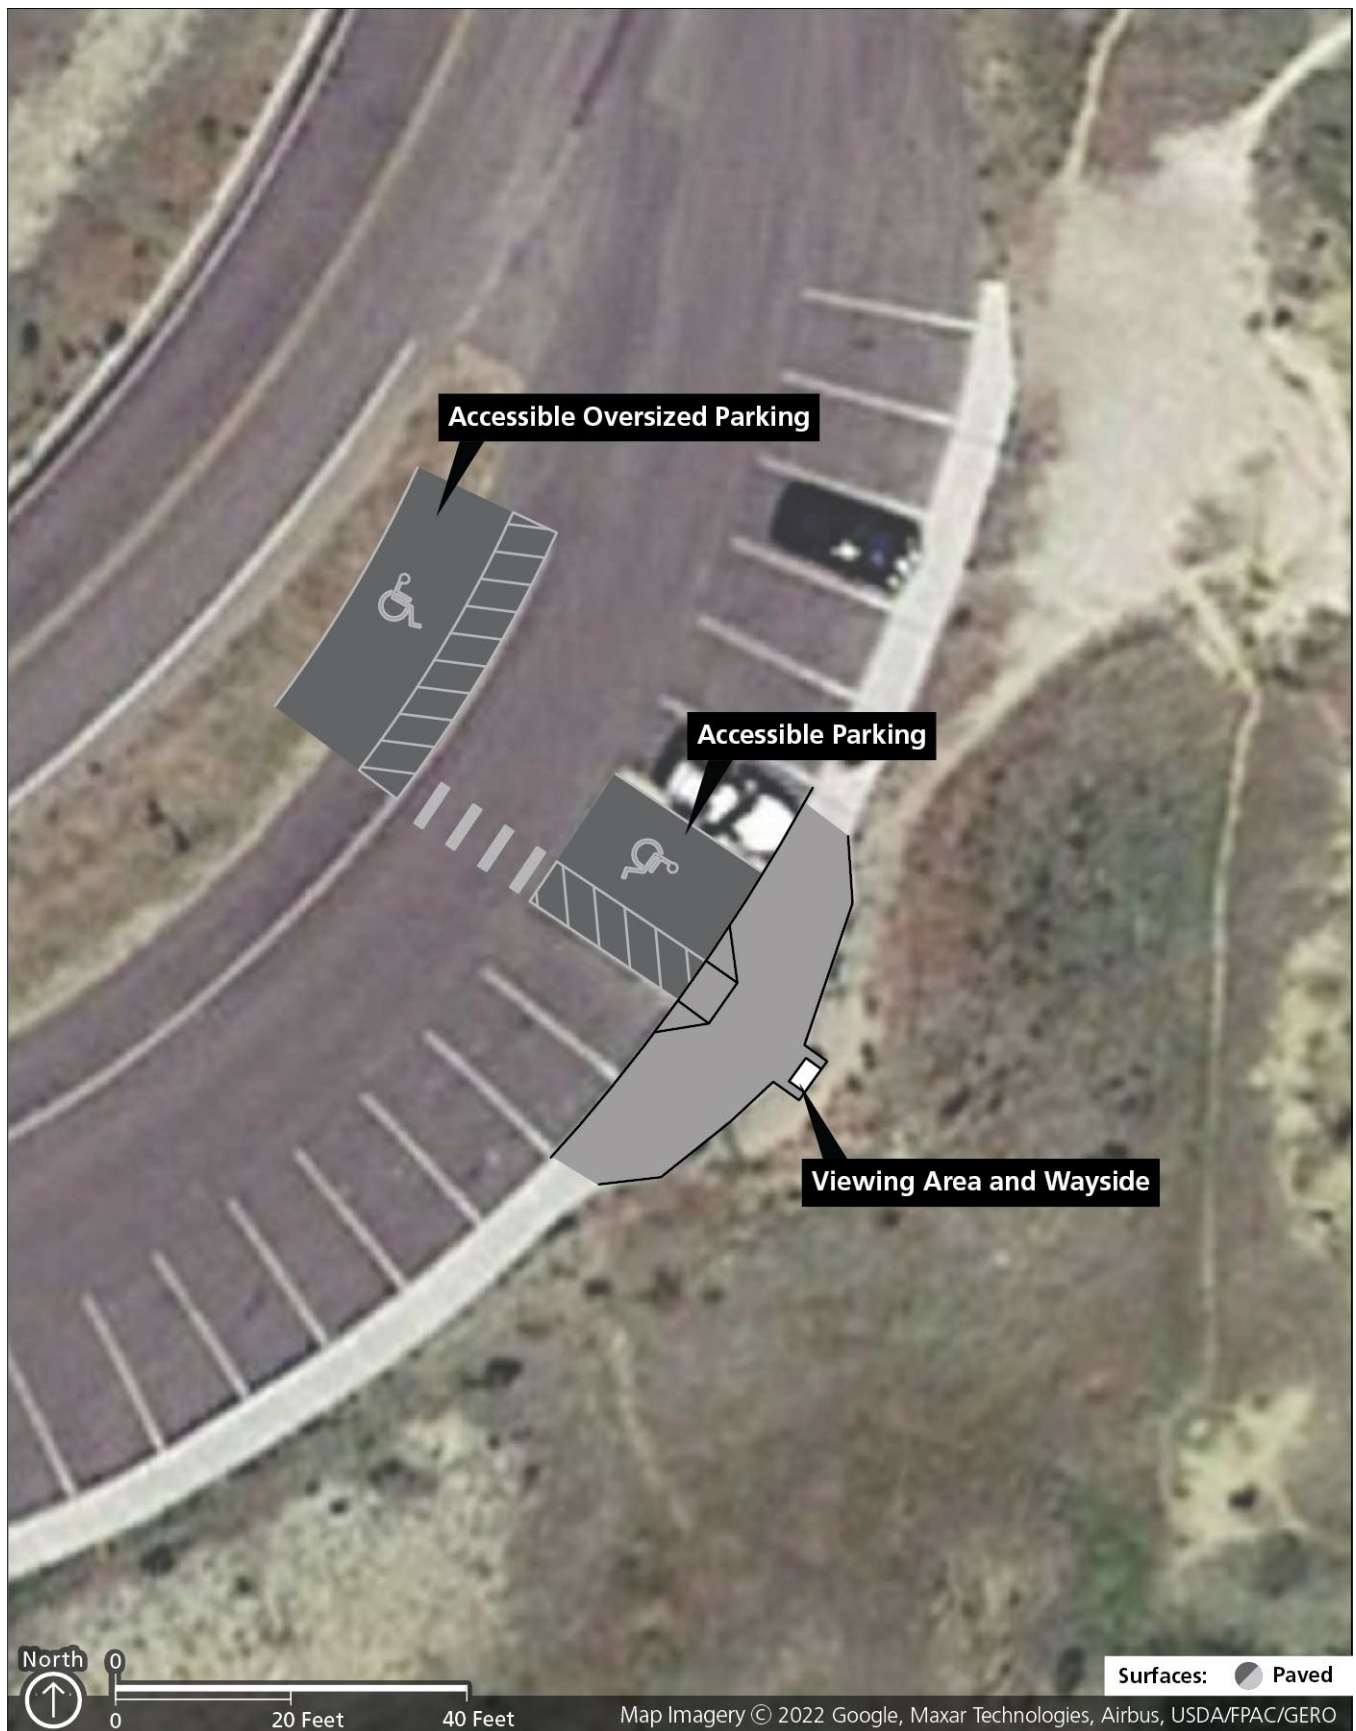
## Yellow Mounds Overlook Site Plan

Yellow Mounds Overlook is a popular area affording views of the older and most colorful strata of Badlands geology. Visitors come to view and photograph the colorful formations at different times of day when the light hits the hills. The area is mostly accessible, with an accessible parking space and viewing area. The wayside is cracked and faded and could be improved, along with improving parking signage and adding an accessible oversized parking space. Providing audio descriptions of wayside graphics and scenery and exploring other methods of effective communication (e.g., 3D model of the large formations) would further improve accessibility at the site.
