Chapter 1: Purpose and Need

The National Park Service (NPS) is considering the rehabilitation of the Badger Pass Ski Lodge, located at the Badger Pass Ski Area, on Glacier Point Road within Yosemite National Park, California (Figure 1-1). The ski lodge is in need of rehabilitation and repair in order to assure visitor safety, maintain ski-area visitor services, and to continue to contribute to the significance of the Badger Pass Ski Area historic site within the Glacier Point Road Historic District.

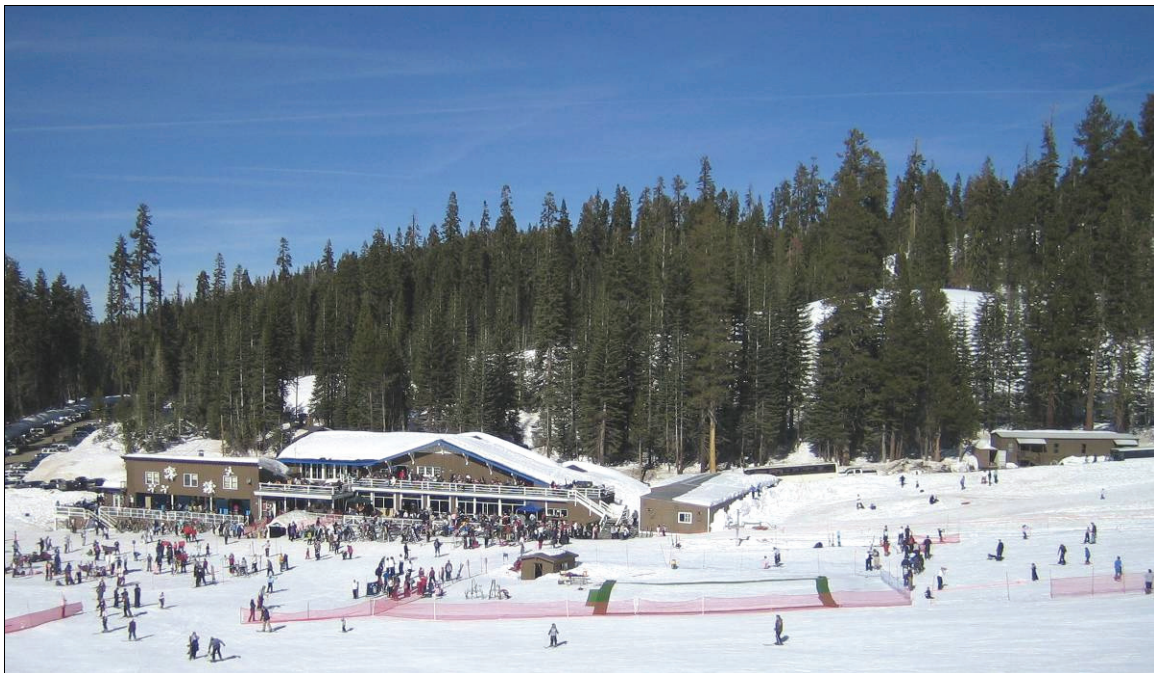
Figure 1-2 Badger Pass Ski Lodge, view to north from slopes, 2008.

With vertical half-log siding, wood frame multi-light windows, a front gable, and an asymmetrical roof with wide overhanging eaves, the original ski lodge building is characteristic of NPS Rustic architecture with Swiss chalet influences. From 1936 through the 1990s, the original building underwent multiple expansions and modifications to meet the changing needs of the ski industry. Some of the changes implemented after 1953 were not compatible with the original NPS Rustic architecture of the 1935 building. For example, more modern clerestory construction with vertical wood siding was added in 1954. As visitor demand increased, further additions were constructed at the ski area to provide expanded services, including ski rentals and merchandise sales.

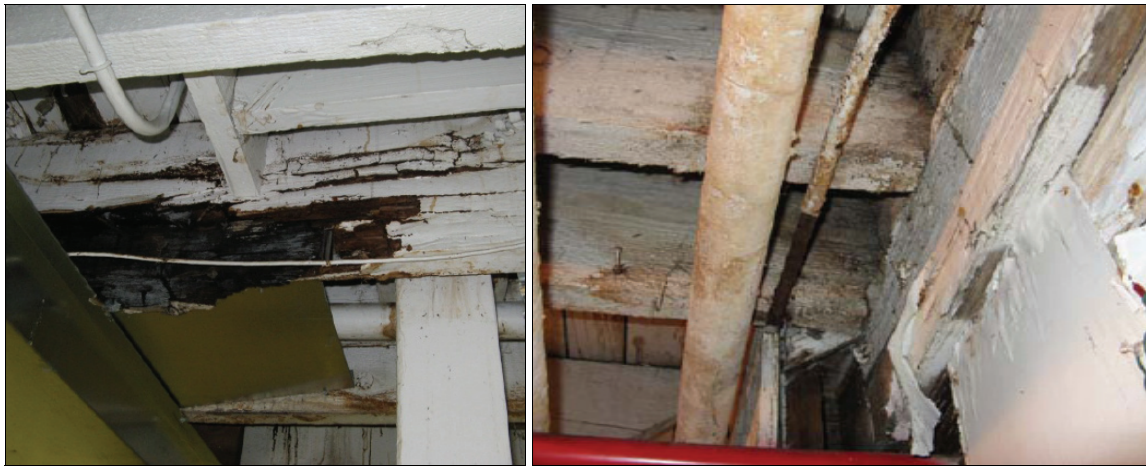
Figure 1-3 Examples of deteriorated floor beam and wood decay at structural members of the north wall and ceiling, basement level.

Structural degradation in parts of the building envelope, due to water damage and dry rot, also has occurred and must be corrected. Most of the ski lodge windows and doors need repair, and in some cases, entire window walls need replacement.
