North Entrance / Park Street

Existing Condition- Problem Statement

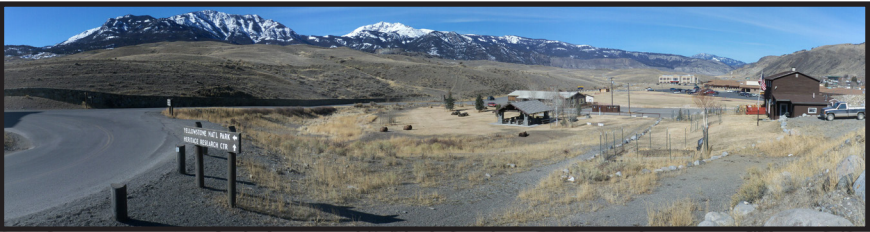
Arch Park

No pedestrian connection to 'Park Street'
No accessible walkway leading from 'Park Street'
Property ownership (private, YA, school, etc)
Under utilized and poor connection to the Arch and Park Street
Limited restroom facilities
Parking

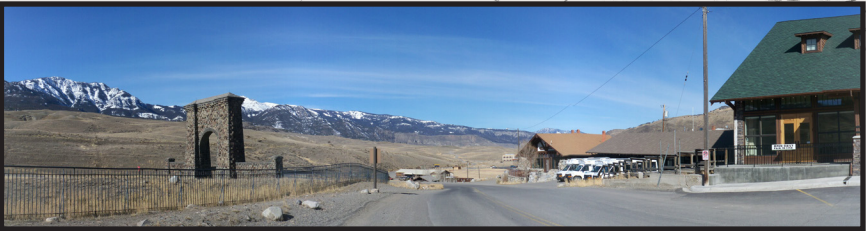
Roosevelt Arch

Iconic Arch draws visitors and photographers
Major concerns with pedestrian and vehicle interactions
No formal / safe viewing platform out of traffic
Informal road shoulder and No 'safety' zone
3 way intersection, roadway prism does not accommodate traffic
Arch geometry does not allow 2 way traffic (14')
Traffic backs up from the North Entrance station adding to congestion
Hair pin curve does not accommodate oversize vehicles and buses, (drift)
Visitors stopping / parking on the shoulder / road way impact traffic flow
Yellowstone Association parking and RV site give visitors the impression parking is okay

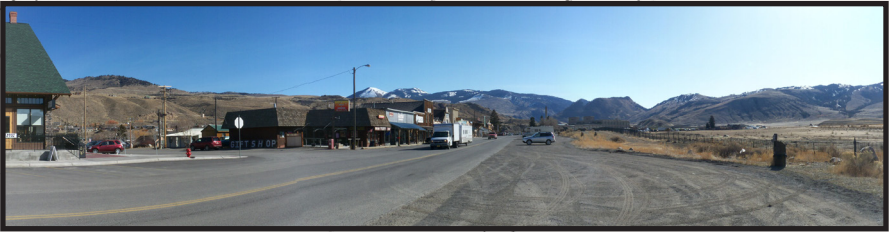
North Entrance Station

Peak vs. Off Peak, operational needs
Peak time of operation (June 1 thru Sept 30) (8am - 5 pm)
3 way stop requires a roving employee within traffic (identified) safety concern
Poor ergonomics of existing entrance kiosk
Queuing/staging capacity (92) of the road between the gate and arch (during peak hours of operation)

1) kiosk is unable to keep up with inbound traffic which backs up into town
Traffic entering thru the Employee / Delivery lane (Xanterra road)= conflict
Exiting traffic thru Xanterra= conflicts
Length of wait to enter the park thru the entrance gate (peak hours of operation)
During Peak hours staff switches to a 'Survival' traffic flow
Inbound traffic one way (from Arch)
Outbound traffics exits thru Xanterra
'Pinch' point entering the park, archeological resources prevent expansion into the hill
Traffic entering the Grand Loop Road from the 'Old' Gardiner Road
Administrative needs are 'shoehorned' into existing kiosk

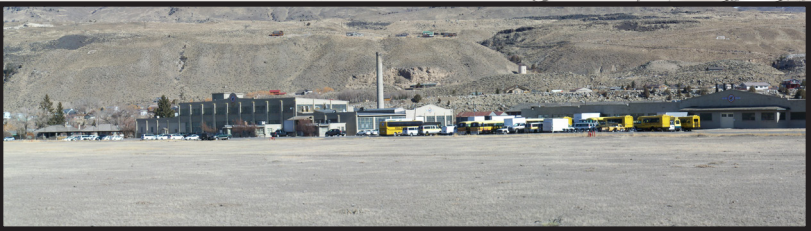
Park Street

Circulation, multiple traffic maneuvers into the main roadway
Main road travels thru a parking lot
Parking is informal and unorganized
No designated oversize and bus parking
No turn around and turning radii for oversize vehicles
Pedestrian and vehicular conflicts,
No designated pedestrian walking / crossing areas
Improve pedestrian experience and provide opportunities
Parking capacity is exceeded during peak times
Approximately 110 informal Auto parking spaces
