NPS Engineering Evaluation/ Cost Analysis Field Activities Report

Virgin Islands National Park

**Caneel Bay Resort Site
St. John, USVI
EDL Number 5SER3346**

March 12, 2021

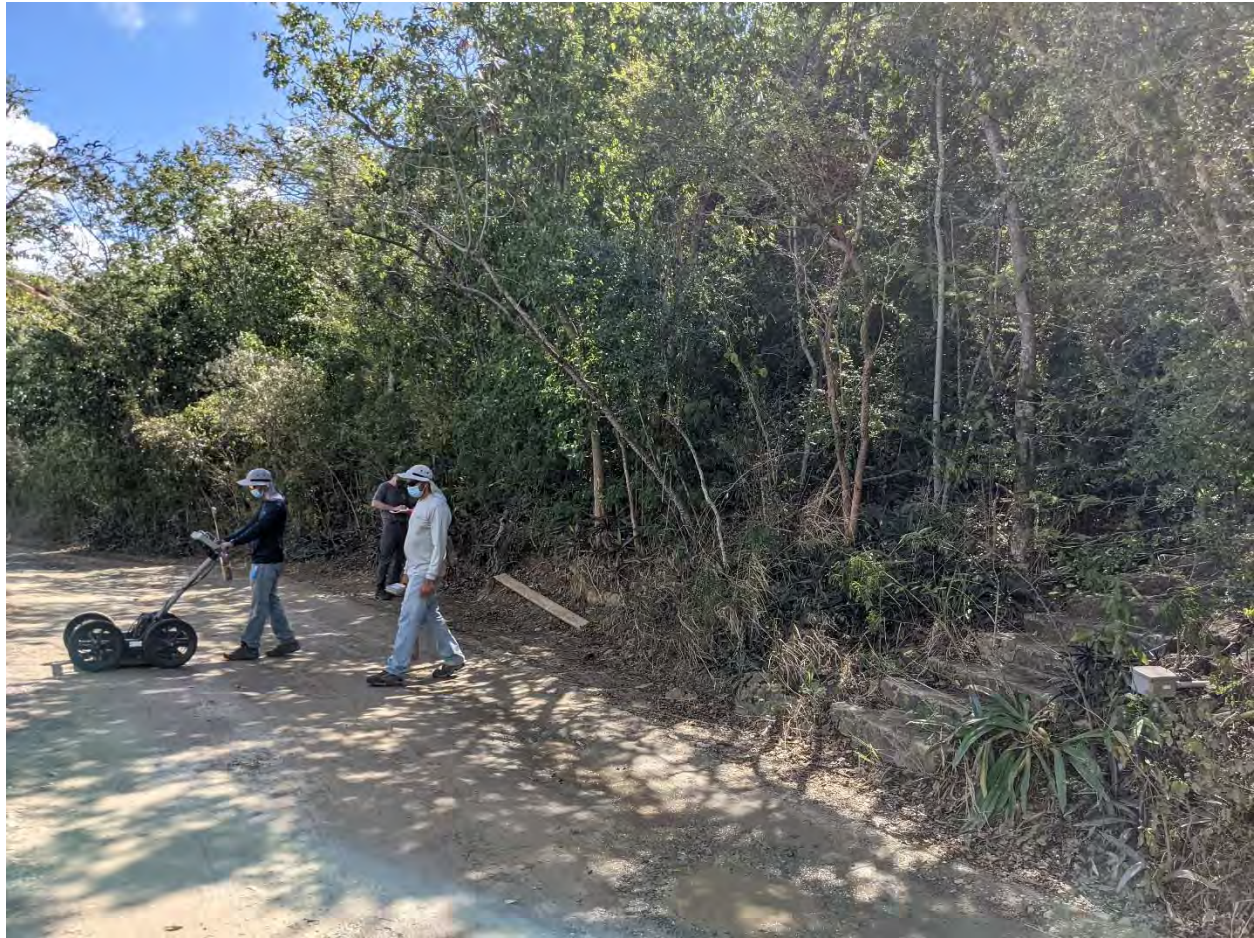
Photograph 3. View of subsurface utility clearance using GPR and EMI of proposed drilling location along access road to Honeymoon Beach.

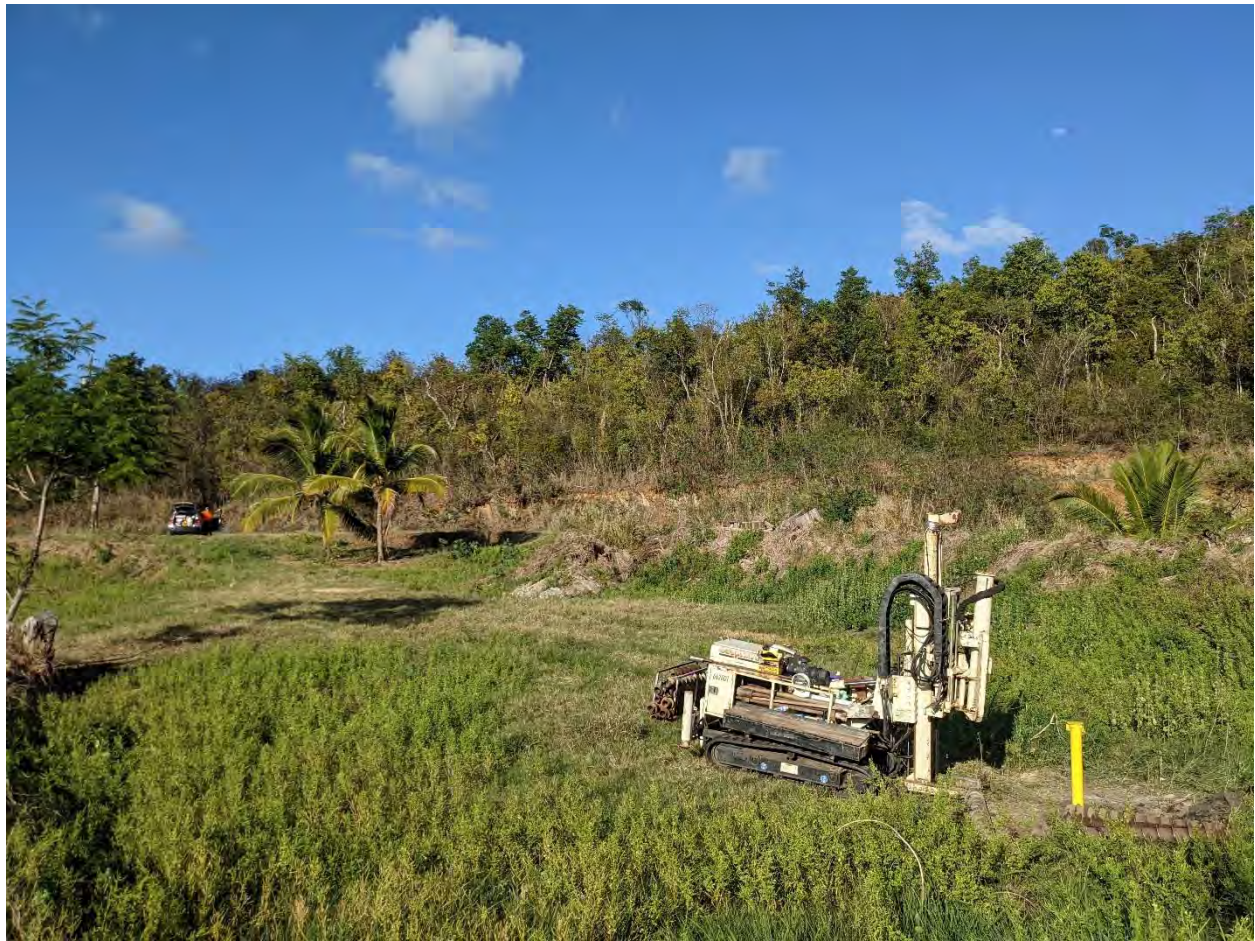
Photograph 10. View to north of monitoring well MW-3-01 installed at the southeastern edge of the debris landfill. VHB selected the well location to coincide with the locations of the apparent seeps observed along the southern edge of the landfill.

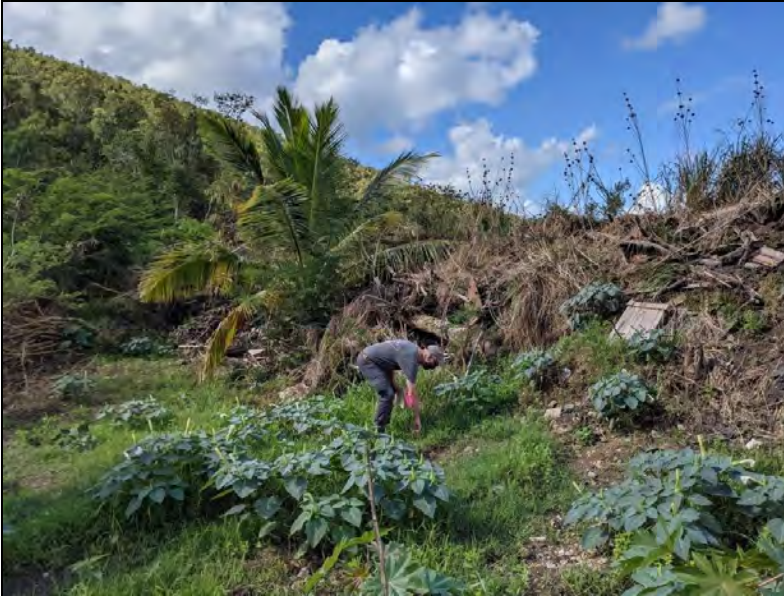
View of Area 3 behind/to east of landfill berm that appears to be comprised of fill. Cleared for possible additional boring.

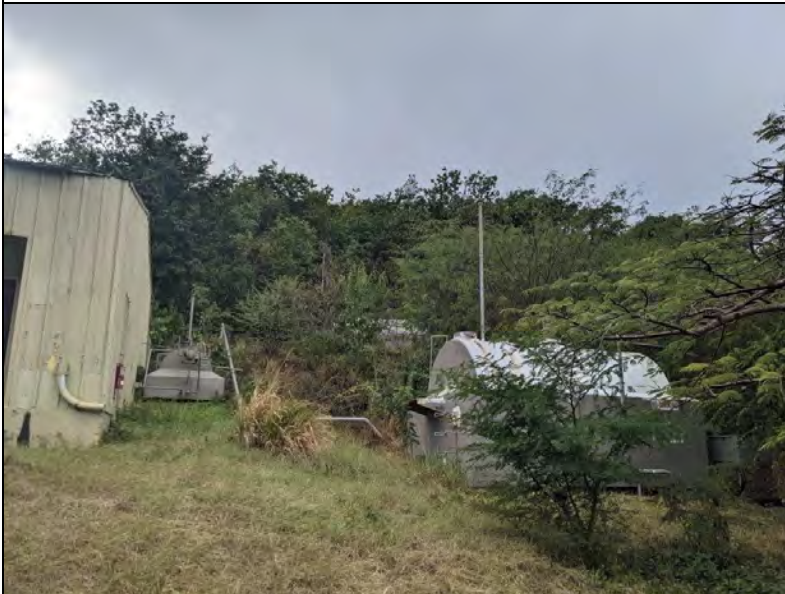
View of Area 2 AST area, looking SW upslope to 3 ASTs. Note growth relative to previous site visits.

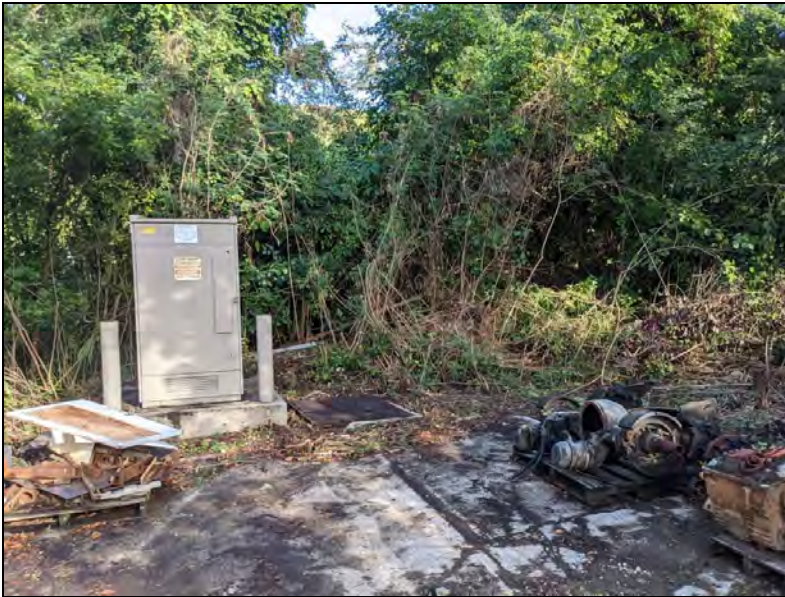
View into IA-2-01 looking east. Note thick vegetation.

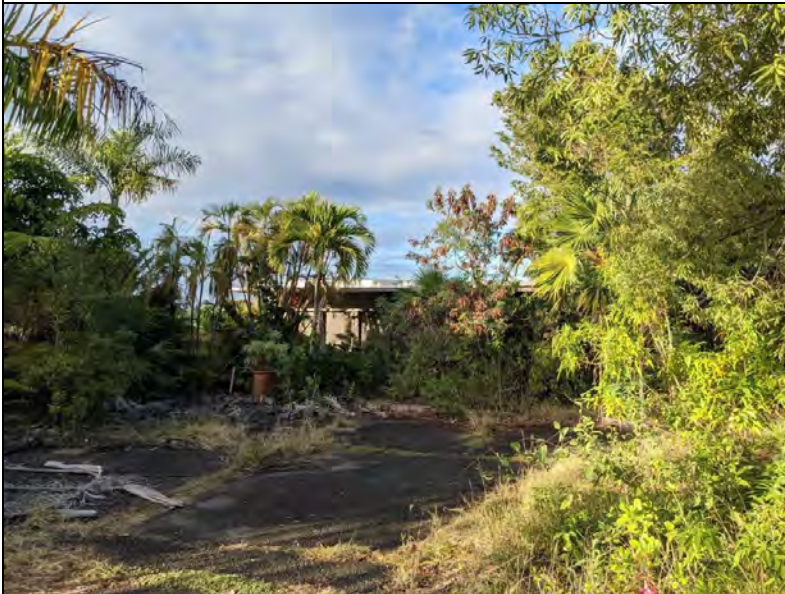
View of Cottage 7, note dense vegetation.

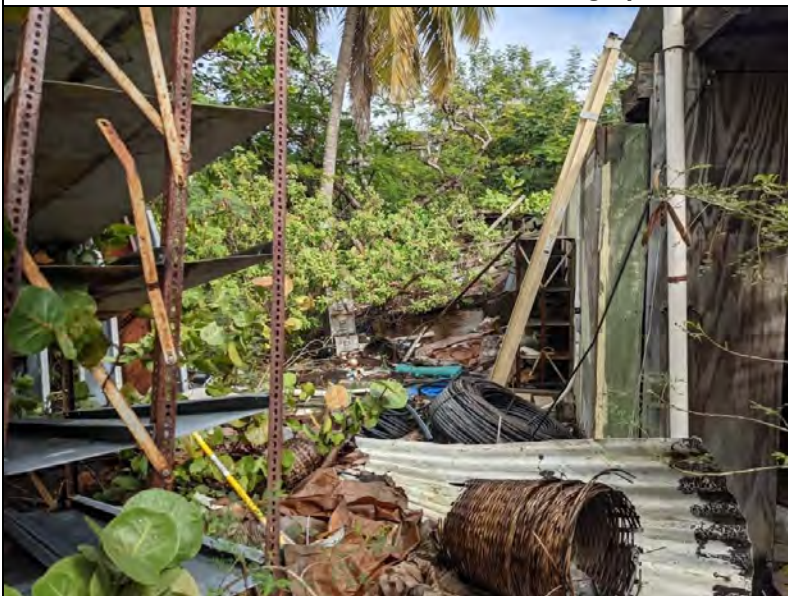
Debris and vegetation at the southern end of the Grounds & Landscaping building. This area was intended for GPR survey but the equipment could not access the ground surface.

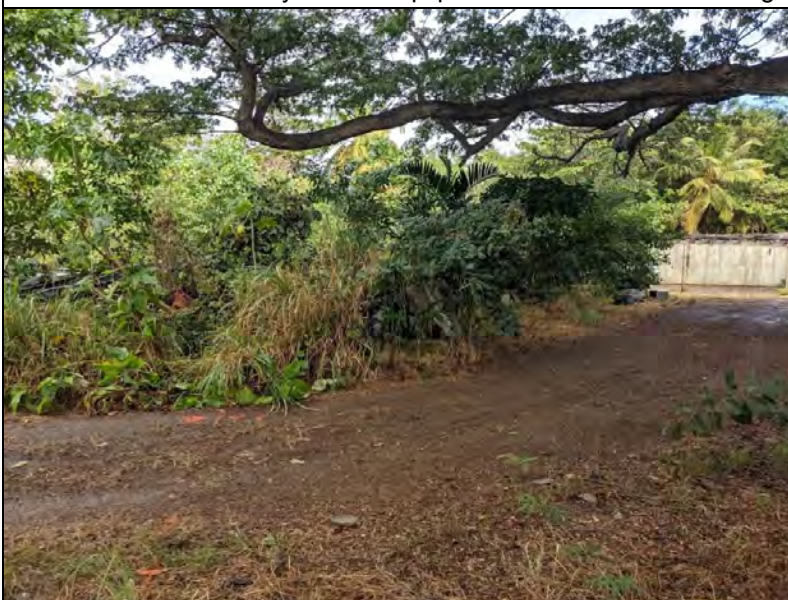
- Decision Question 11: Is there evidence that known asbestos pipes are connected to an existing buried network?
 - VHB and Javier J. Bidot Associates conducted a GPR survey for buried piping in the vicinity of the broken asbestos pipe identified during the Level 2 investigation in Area 2. Due to debris and dense vegetation, the asbestos pipe could not be located at the surface at the time of the GPR survey. Two unknown buried pipes were identified in the vicinity during the GPR survey. The broken asbestos pipe identified during the Level 2 investigation was later located during ISM sampling. Approximately 14 feet of pipe was exposed and determined to be running to the west, towards the former greenhouses.

View to west of unknown pipe (location matches some prior descriptions) markout (~2' bgs) crossing road in grounds & landscaping area, leading under former greenhouse (now overgrown). G&L equipment maintenance building visible behind to right. Broken pipe fragment (possibly asbestos) visible in foreground. Pipe was not observed at ground surface and could not be traced further.

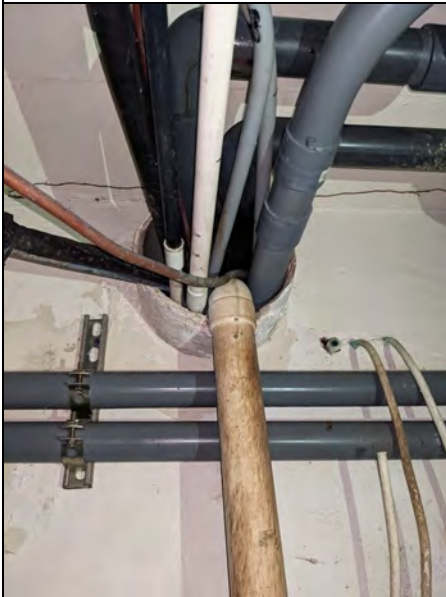
View of pipes leaving northern wall of Cottage 7 bomb shelter electrical room through possible asbestos carrier pipe. Note level gauge and possible fuel lines to right.

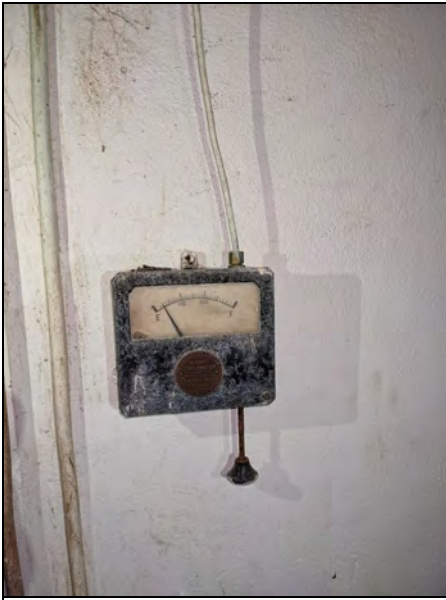
- Decision Question 9: Is there evidence of an underground storage tank (UST) at Cottage 7?
 - VHB inspected the Cottage 7 grounds and basement, which was identified as the former bomb shelter by Brad Dow. A tank level gauge with suspected metallic fuel lines leading through an exterior wall were observed in the basement. Using electromagnetic induction (EMI), Javier J. Bidot Associates traced the metallic lines outside the structure; the signal was lost under several air conditioning units. Open areas around the metallic lines and Cottage 7 were scanned using GPR; however, access was limited due to dense vegetation, debris, and the air conditioning units.

View of level gauge mounted on northern wall of Cottage 7 basement/bomb shelter. Medallion reads "The Liquidometer Corporation, Midget Levelometer. Serial 11." Based on the gauge graduations, the tank may have been ~ 300 gallons.

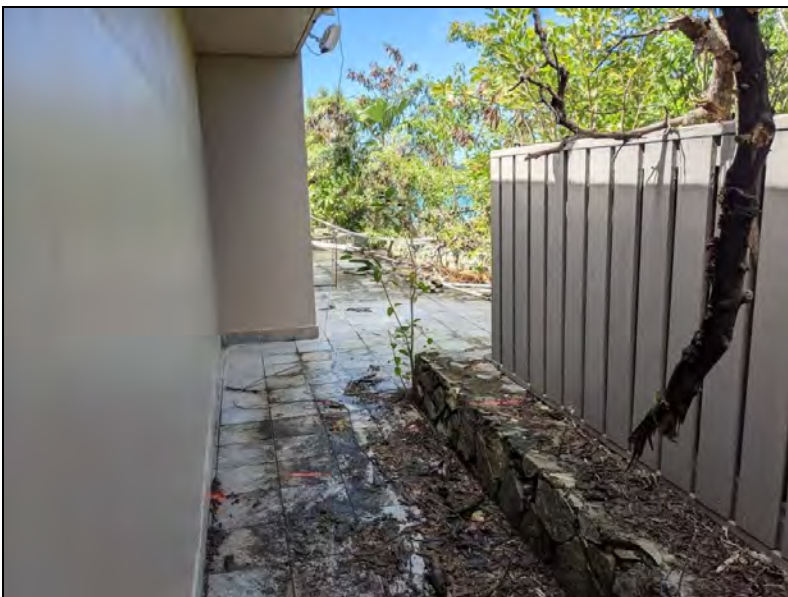
View to west of traced possible fuel line from northern side of Cottage 7 basement/bomb shelter (marked with orange paint near center of floor).

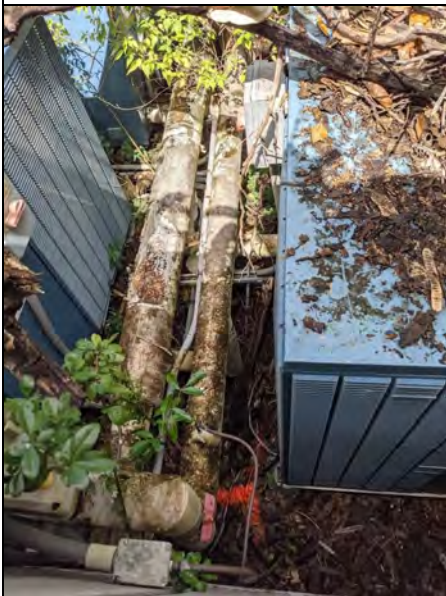
View of traced possible fuel line to area AC units and probable sanitary sewer manhole. Signal was lost beneath the AC units. GPR tracing of surrounding cleared areas did not locate any anomalies. GPR search was limited by debris, AC units, and dense vegetation.

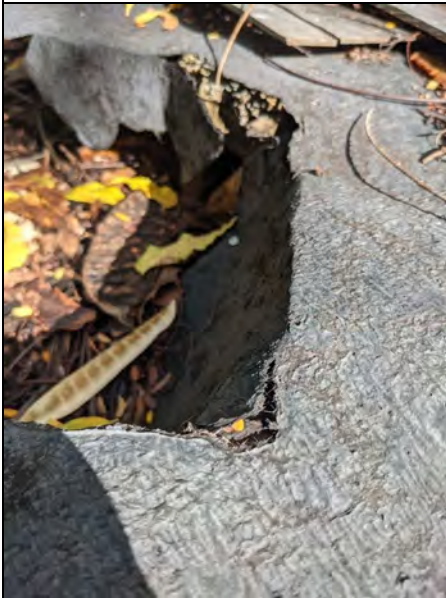
4. Roofing debris, including roll tar paper with visible fibers in Turtle Bay Estate courtyard.

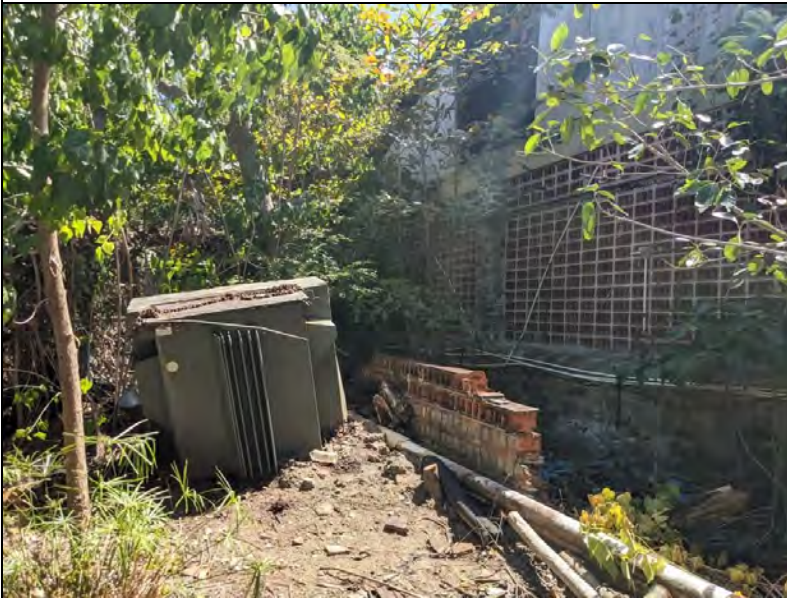
2. View of apparently relocated transformer 13 near warehouse.

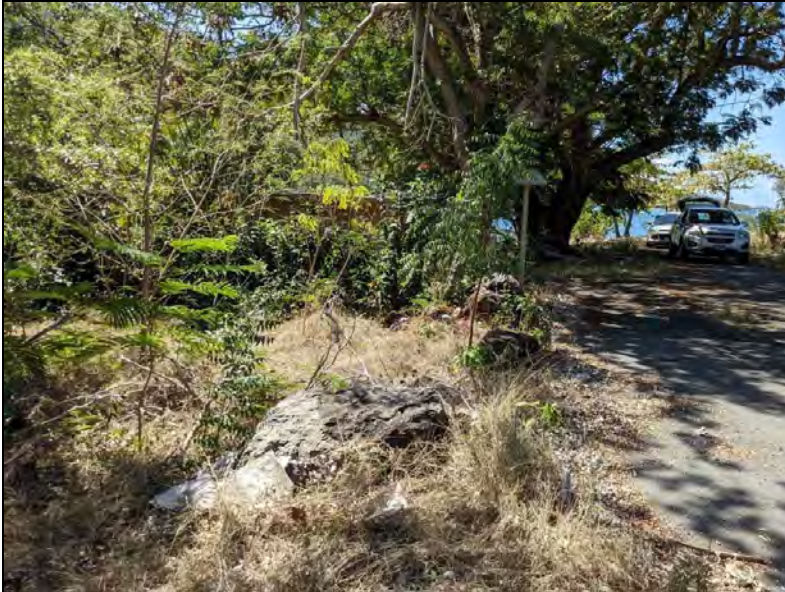
6. View to west of drywall debris with visible fibers in foreground. Caneel Beach rooms behind.

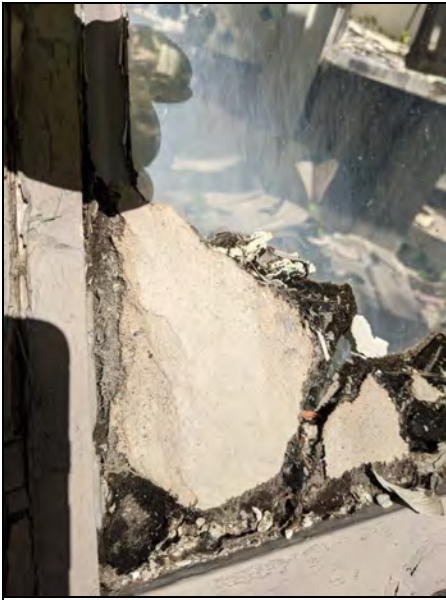
9. View of drywall debris with visible fibers in southern Caneel Beach room.

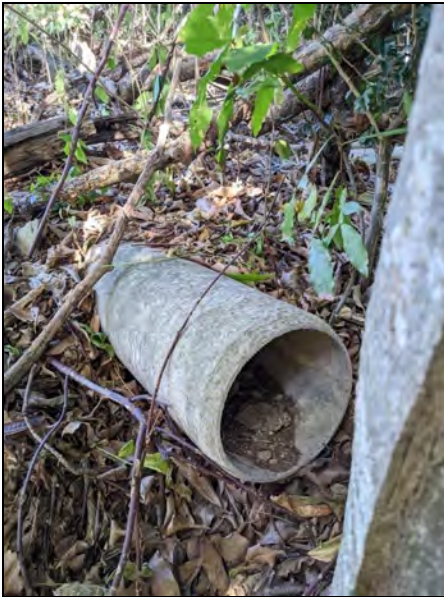
7. Possible asbestos pipe at the southern end of the gravel staging area

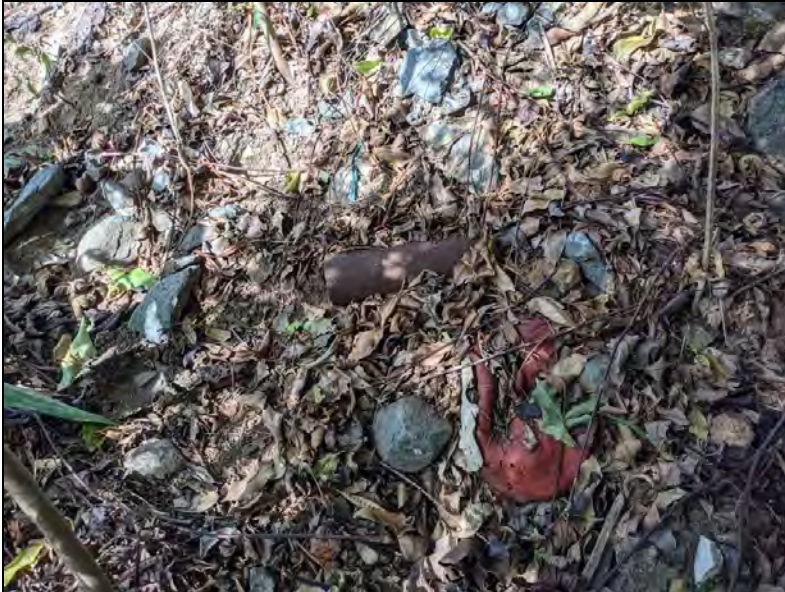
8. Possible asbestos-cement pipe at the southern end of the gravel staging area. Note apparently dumped paint.

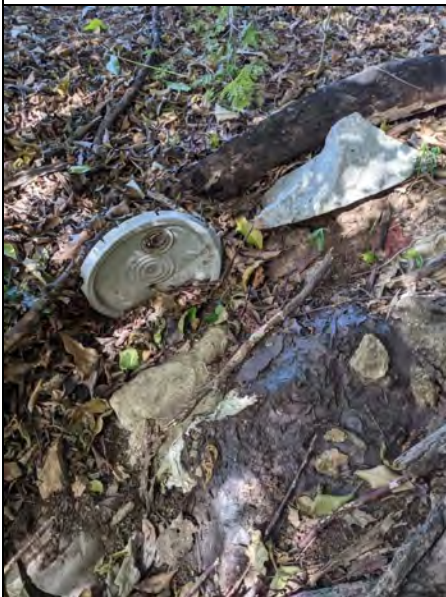
9. Area of apparently dumped paint at the southern end of the gravel staging area.

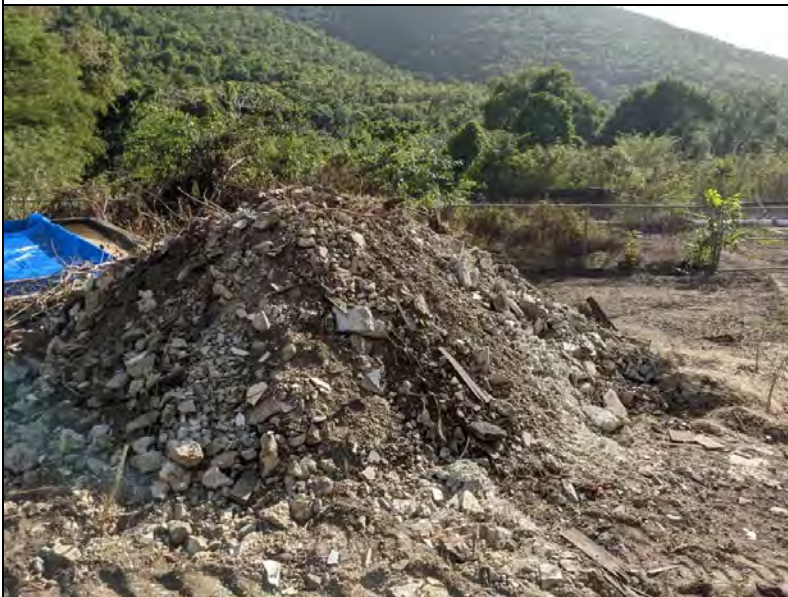
10. View looking south of demolition debris pile adjacent to former WWTP pump house. WWTP behind.

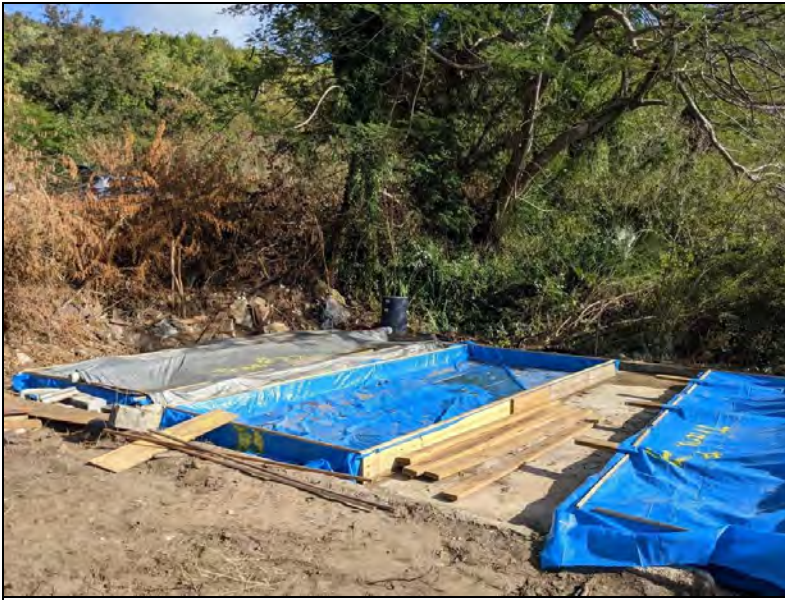
11. View looking south of apparent containment pads built on former WWTP pump house concrete pad. Tarps are labeled with "Tran. #22" and "Tran. #23".

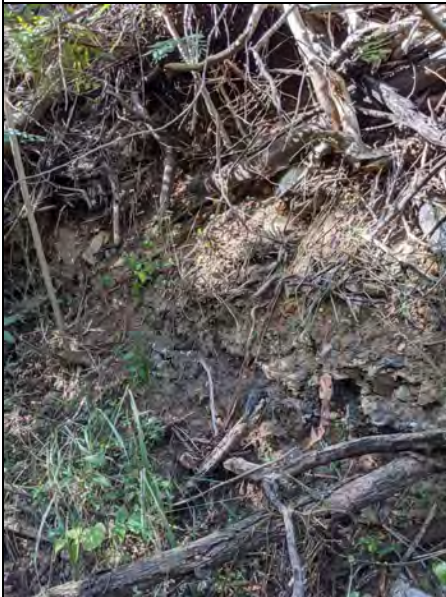
4. View of exposed landfill face from apparent wash to south of landfill. Note steel, plastic, aluminum in fill.

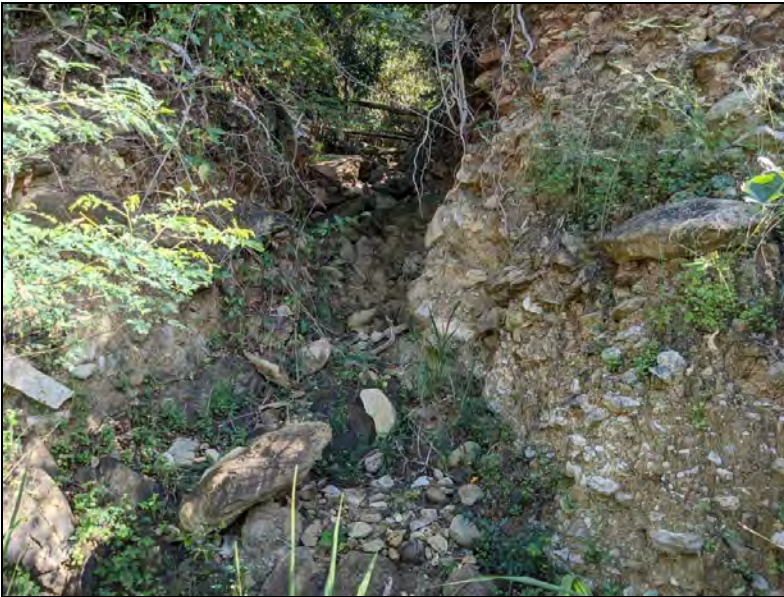
- NPS and VHB observed an apparent wash (i.e., a channel created by erosion) along the eastern and southern sides of the debris landfill, outside the brush berm. The wash extended from a former quarry area and drained downhill towards Honeymoon Beach. Exposed waste was observed in the debris landfill face along the wash. Additionally, based on the presence of salt deposits, three possible seeps that would drain to the wash were observed along the debris landfill face in the areas of exposed waste. The seeps were not wet during the field work. To assess the nature and extent of contamination that may have been discharged from the debris landfill, NPS added one ISM surface soil DU to the area that encompassed the three seeps, and another ISM surface soil DU to the bottom of the wash channel downhill from the seeps.

5. View of tributary wash to apparent wash along eastern and southern sides of the landfill.

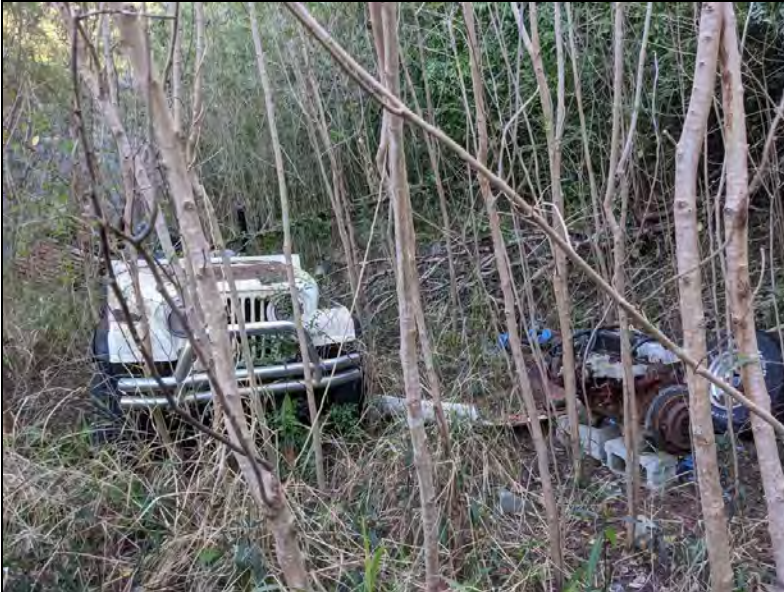
6. View of jeep, car engine, transmissions, and other car parts in southern end of the staging area below the catchment.

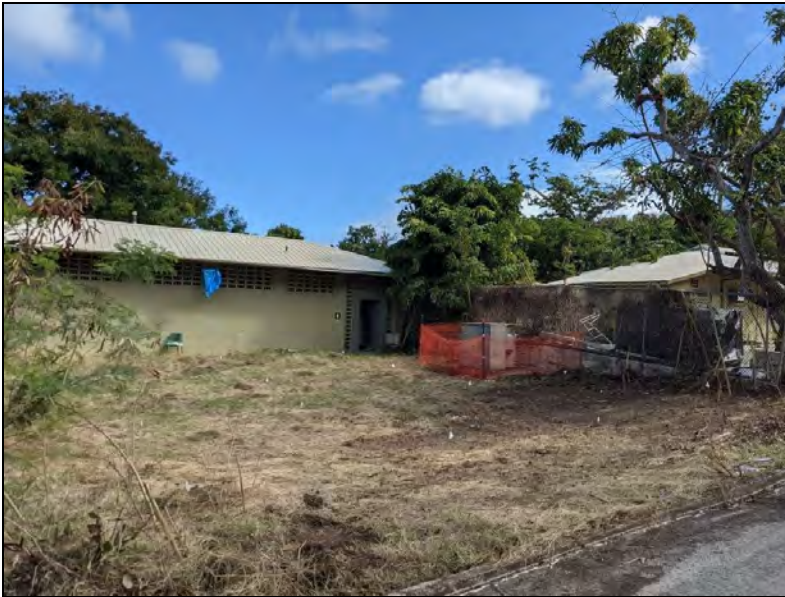
3. View looking north through IA-2-02, note increment in immediate vicinity of leaking transformer 22 was adjusted to avoid oil.

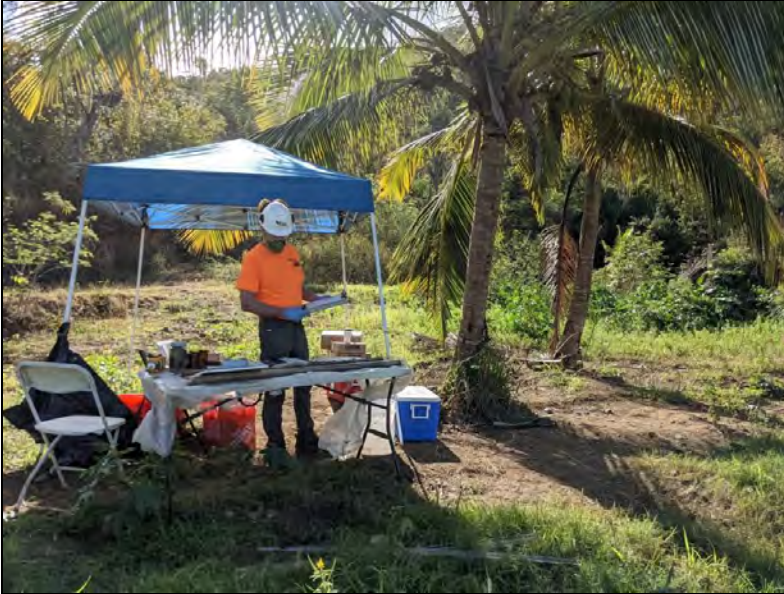
1. Logging soil cores at the landfill.

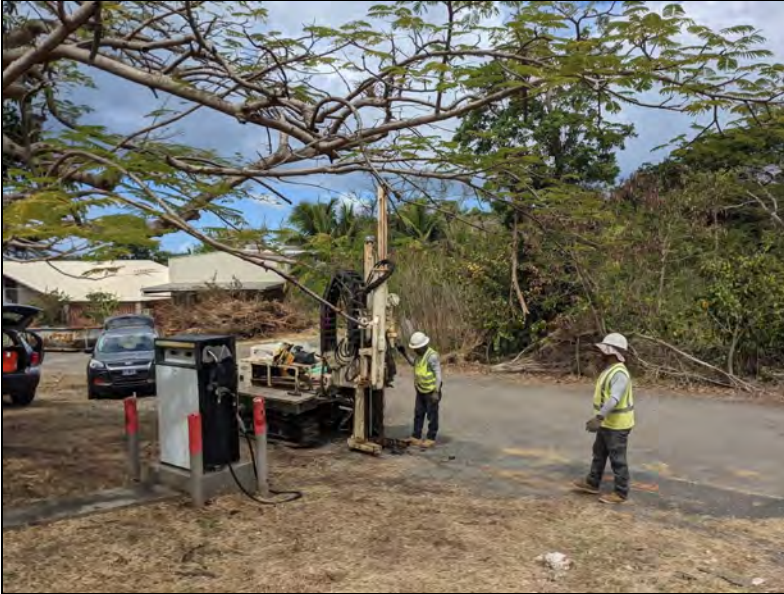
1. Drill rig set up at boring location SC-2-05, to the north of the ASTs and fuel dispenser.

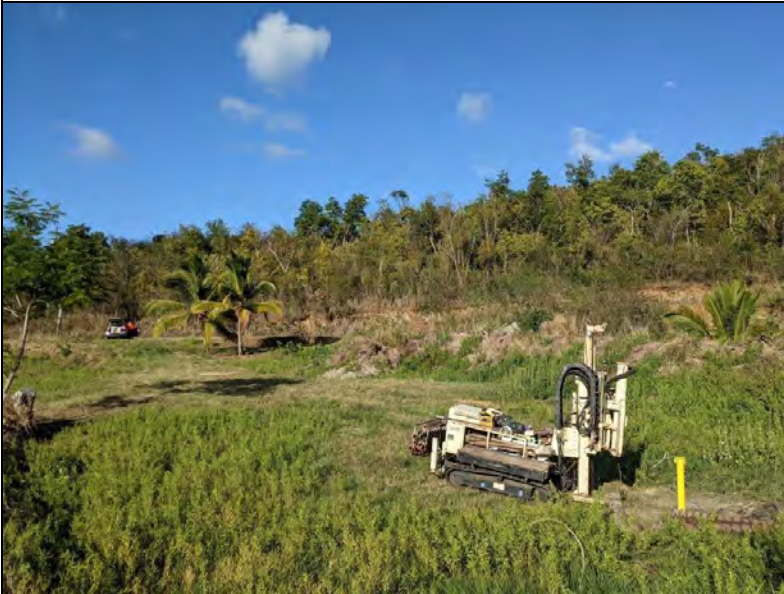
1. View looking north of MW-3-01 installed in the southeastern portion of the landfill, at boring location SC-3-09.

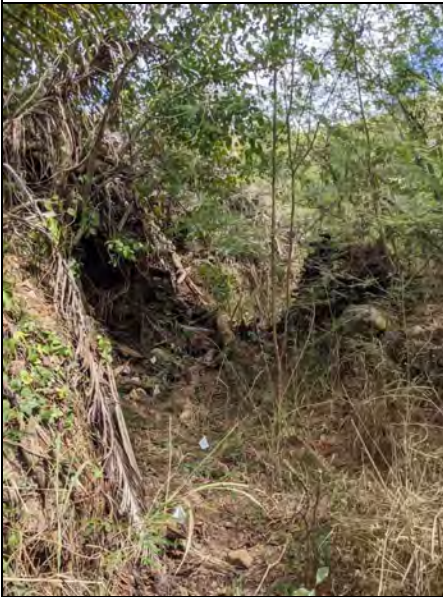
2. View of IA-3-03 ISM sampling layout along wash to south and east of landfill.

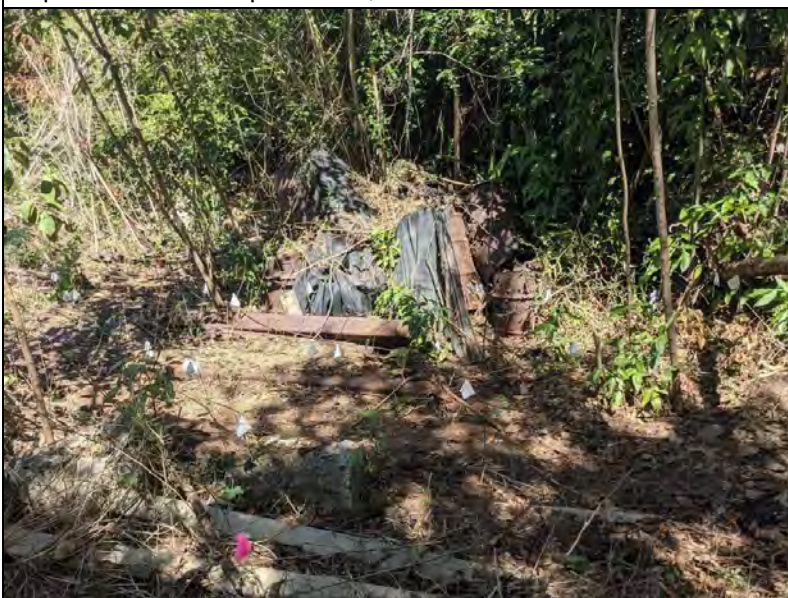
2. View of IA-1-04 staked out for ISM sampling, around partially buried drums at the eastern edge of Area 1.

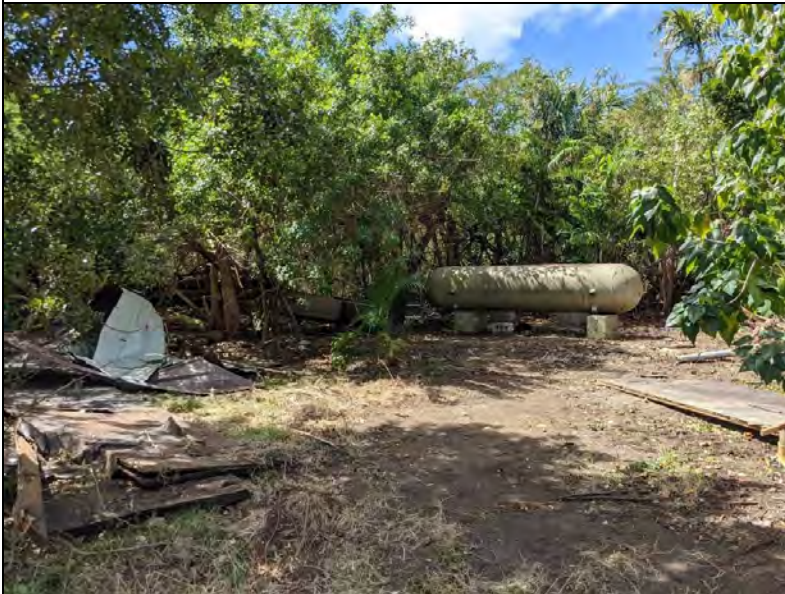
4. View to west of propane tank near Hawksnest Beach where debris has been cleared to provide access.

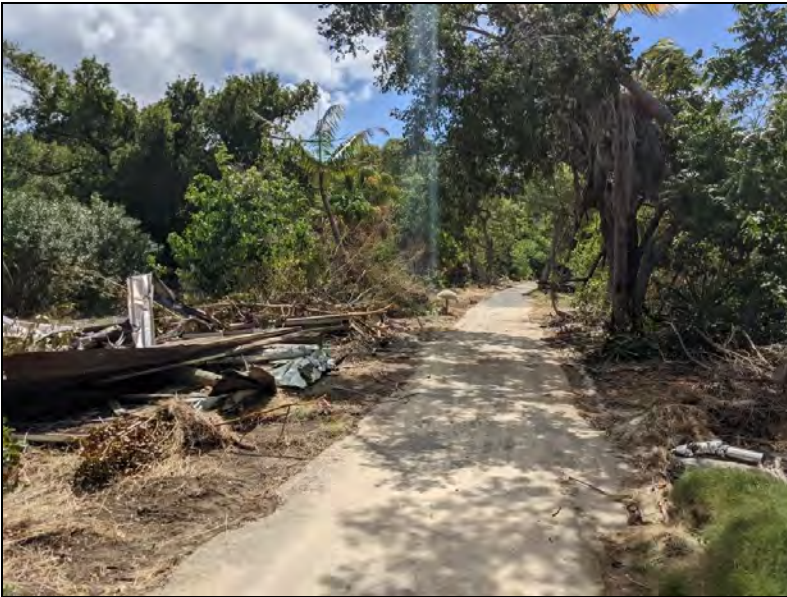
5. View to south of walkway near Scott Beach; debris has been cleared since last seen.
