# PHOTOGRAPHIC RECORD

## National Capital Region Wetland Restoration Action Plan Catoctin Mountain Park Spring 2016

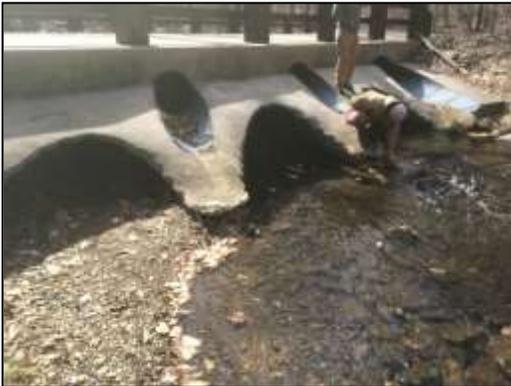
Bridge crossing and culverts located downstream of CATO-3.

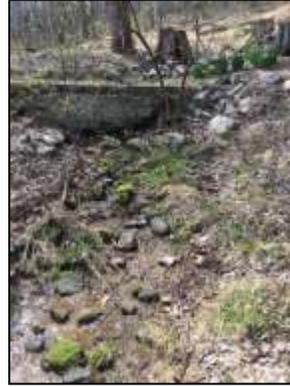
Wetland seep below spring house at Stream channel at CATO-7.

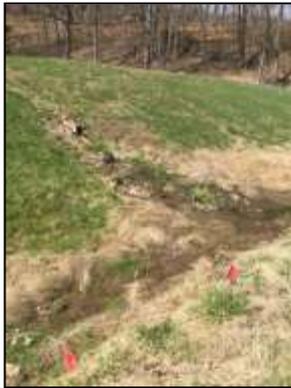
Pond outfall and berm of large open water pond at CATO-7.

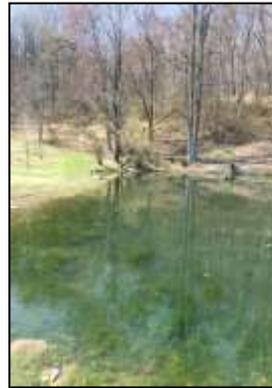
Open water pond located at CATO-7.

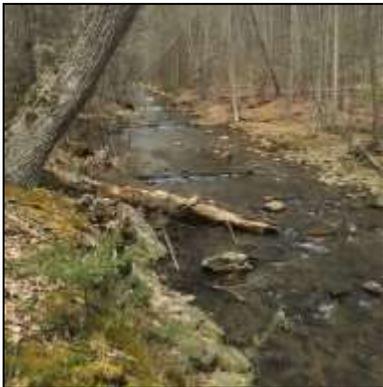
Stream channel located at CATO-8.

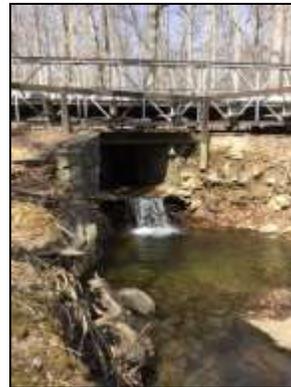
Historic culvert with fish passage concerns at CATO-9.

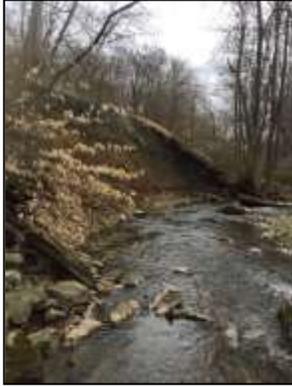
Severely eroded stream bank located along the railroad tracks at CATO-13.

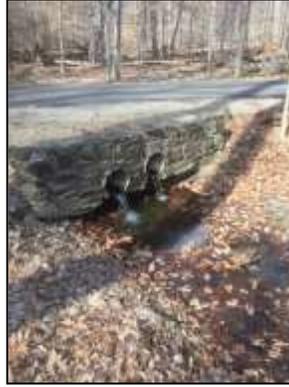
Road crossing and culvert at CATO-14.

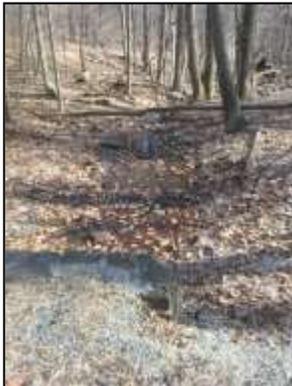
Area upstream of existing culvert at CATO-14.

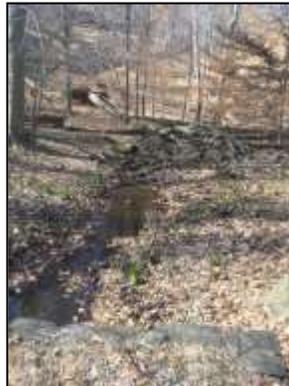
Stream channel downstream of existing culvert at CATO-14.

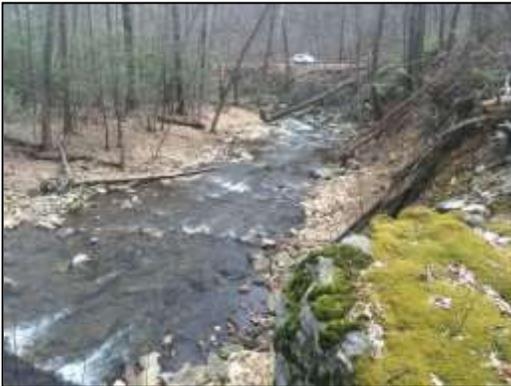
Erosion on the right bank of CATO-16.

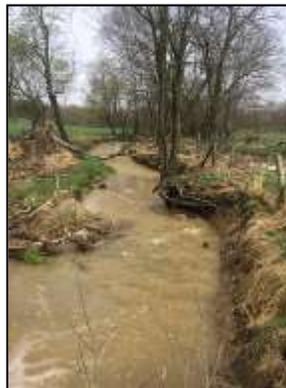
Lack of riparian stream buffer along the stream channels at MONO-1

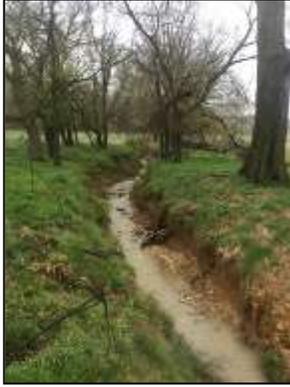
Lack of riparian buffer along WUS-2 at MONO-1.

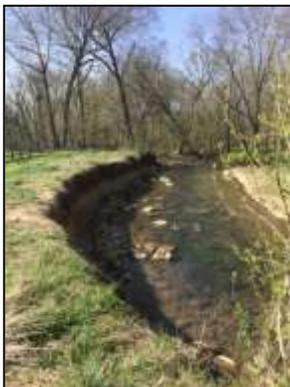
Eroded streambank located at MONO-4.

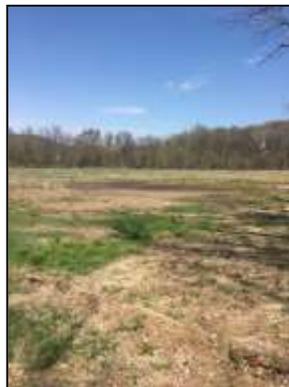
Emergent wetland located at MONO-4.

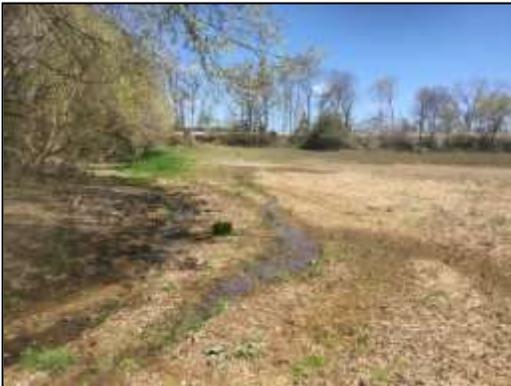
Edge of prior converted wetland along the tree-line at MONO-5.

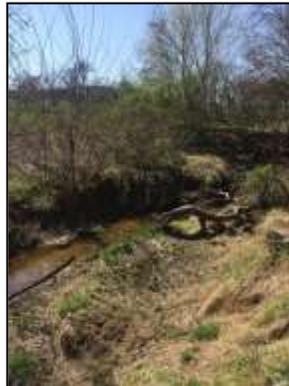
Erosion along the stream bank at MONO-6.

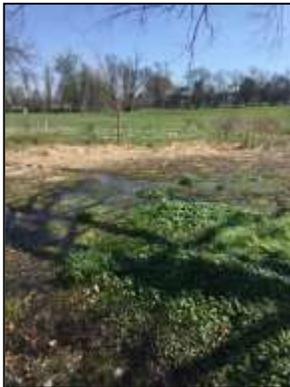
Emergent wetland located at MONO-6.

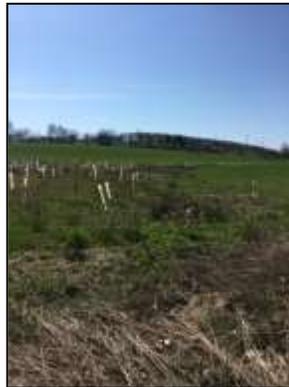
Native tree planting located at MONO-6.

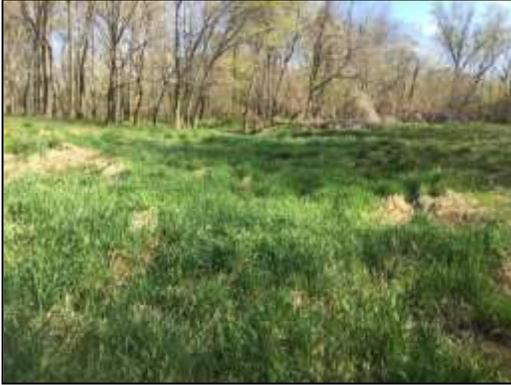
Reed canary grass dominating the emergent wetland at MONO-7.

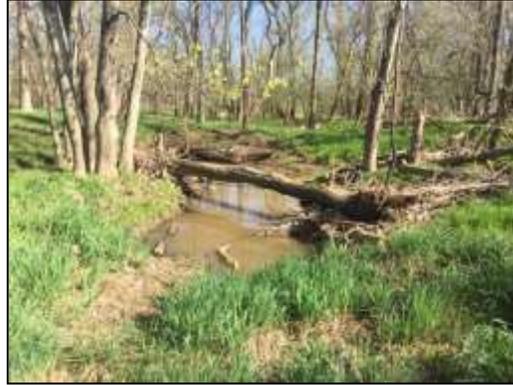
Stream channel located downstream of Wetland 1 at MONO-7.

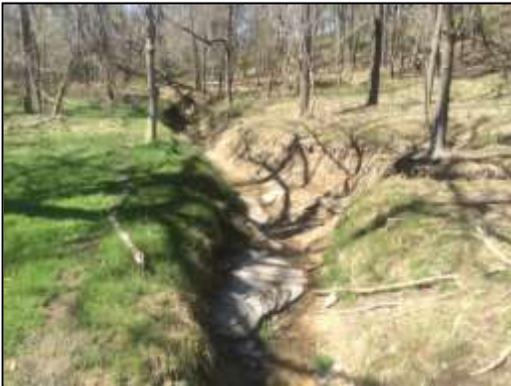
Channel erosion and incision at MONO-10.

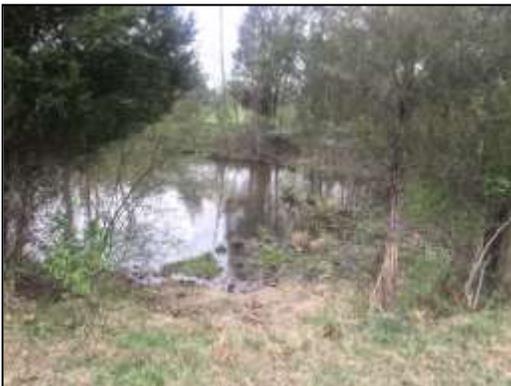
Open water pond identified at HAFE-4.

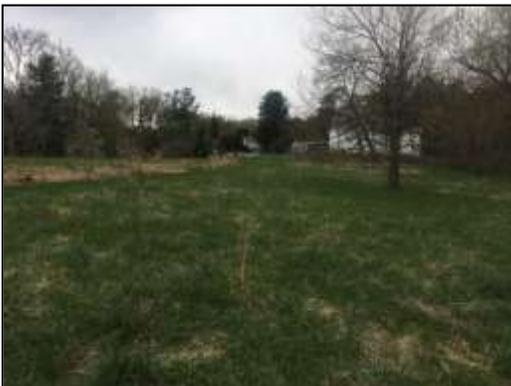
Grassland surrounding wetland at HAFE-6.

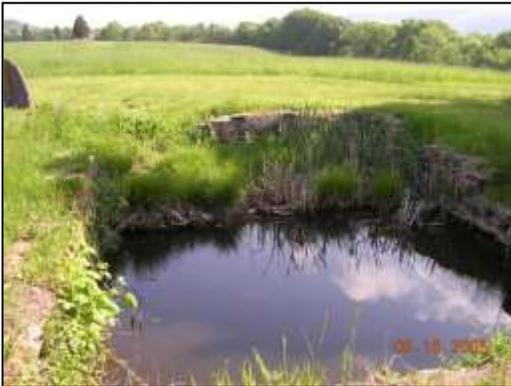
Wetland area at HAFE-8 prior to being filled in with gravel.

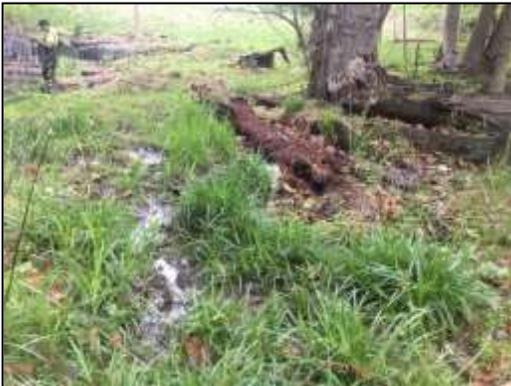
Existing wetland located adjacent to WUS-1 at CHOH-1.

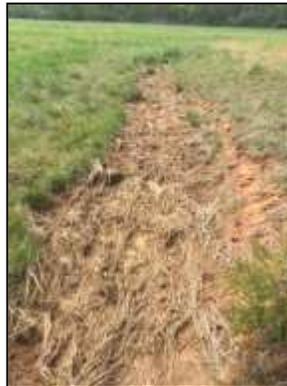
Drainage ditch located within the agricultural field at CHOH-5.

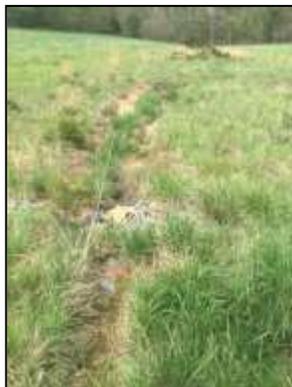
Channelized drainage located at CHOH-5 with rock check dams.

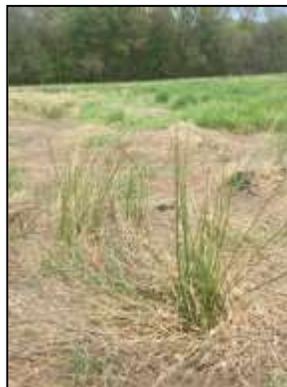
Wetland vegetation within the agricultural field at CHOH-5.

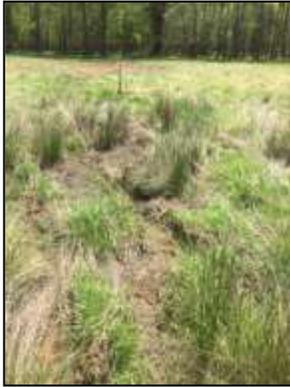
Wetland vegetation located at CHOH-6.

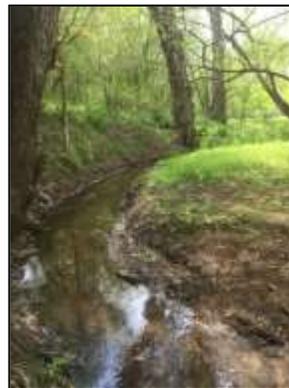
Stream channel located at CHOH-17.

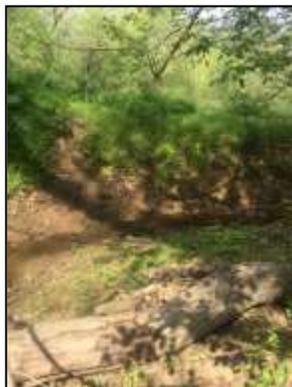
Eroded stream bank located at CHOH-17.

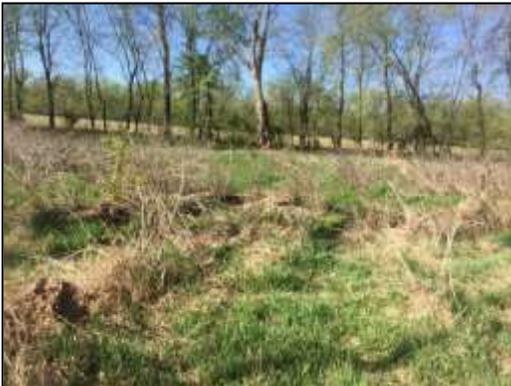
Overview of the wetland located at CHOH-19.

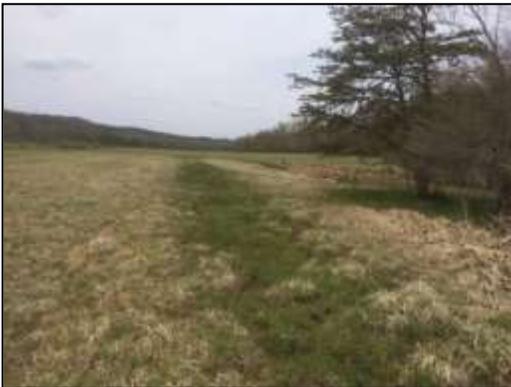
Emergent wetland swale located within the agricultural field at CHOH-23.

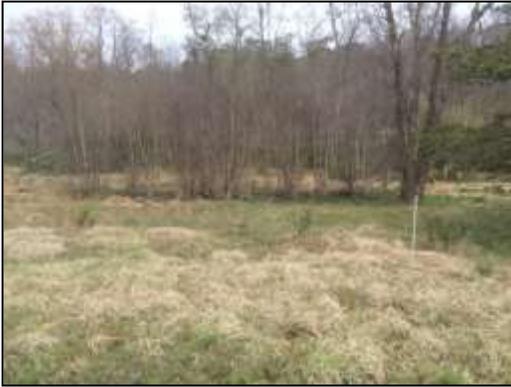
Emergent wetland located at CHOH-23.

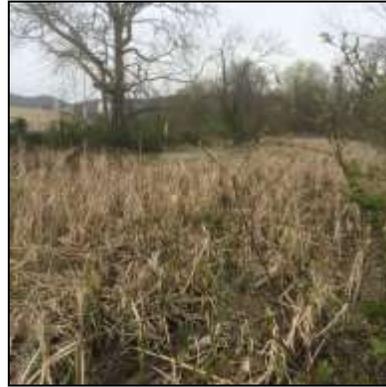
Wetland located at CHOH-24.

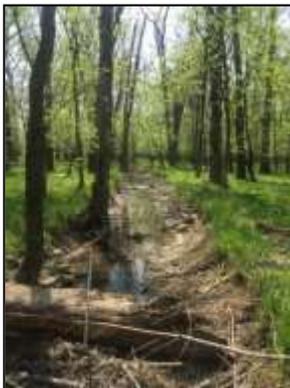
Straightened stream channel at CHOH-25.

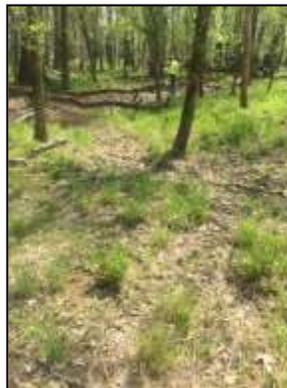
Drainage patterns within the forested wetland at CHOH-25.

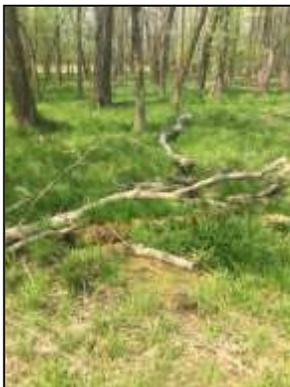
Reed canary grass identified within the forested wetland at CHOH-25.

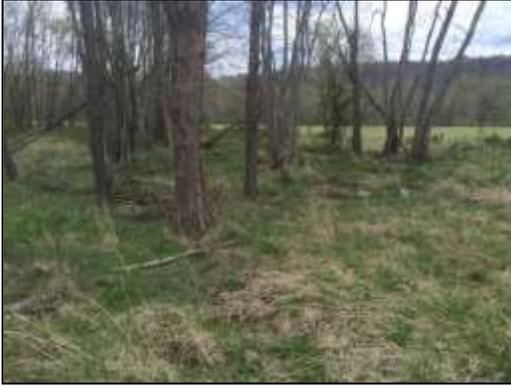
Forested wetland located at CHOH-27.

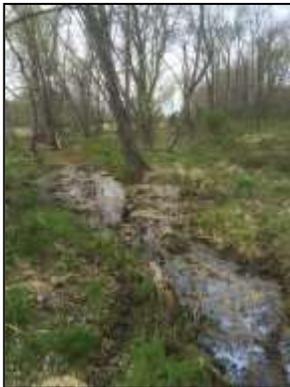
Drainage patters within the forested wetland at CHOH-27.

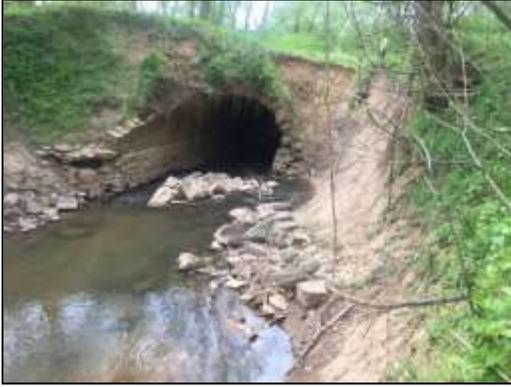
Unstable culvert and highly eroded stream banks located at CHOH-29.

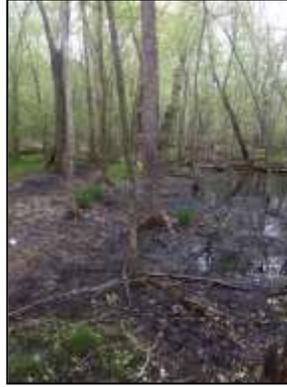
Forested wetland located at CHOH-30.

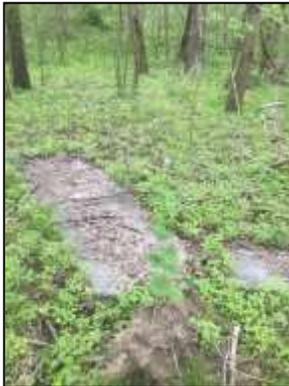
Concrete slabs identified within the forested wetland at CHOH-30.

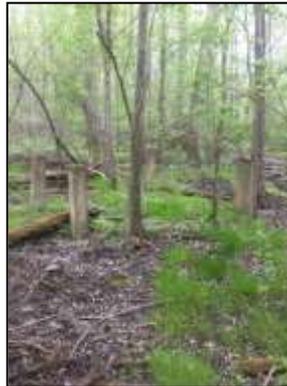
Concrete pillars located within the forested wetland at CHOH-30.

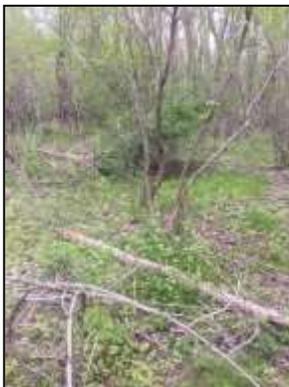
Multiflora rose within the forested wetland at CHOH-30.

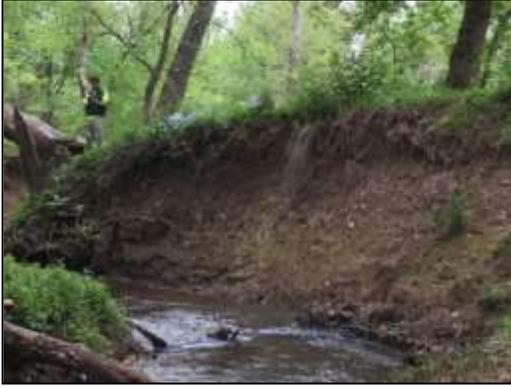
Severe stream bank erosion identified at CHOH-31.
