Clara Barton National Historic Site Conditions Assessment

Final Submittal

November 27, 2018

Contract No. P14PC00202
Order No: 140P3018F0013
AECOM Project No.60562621

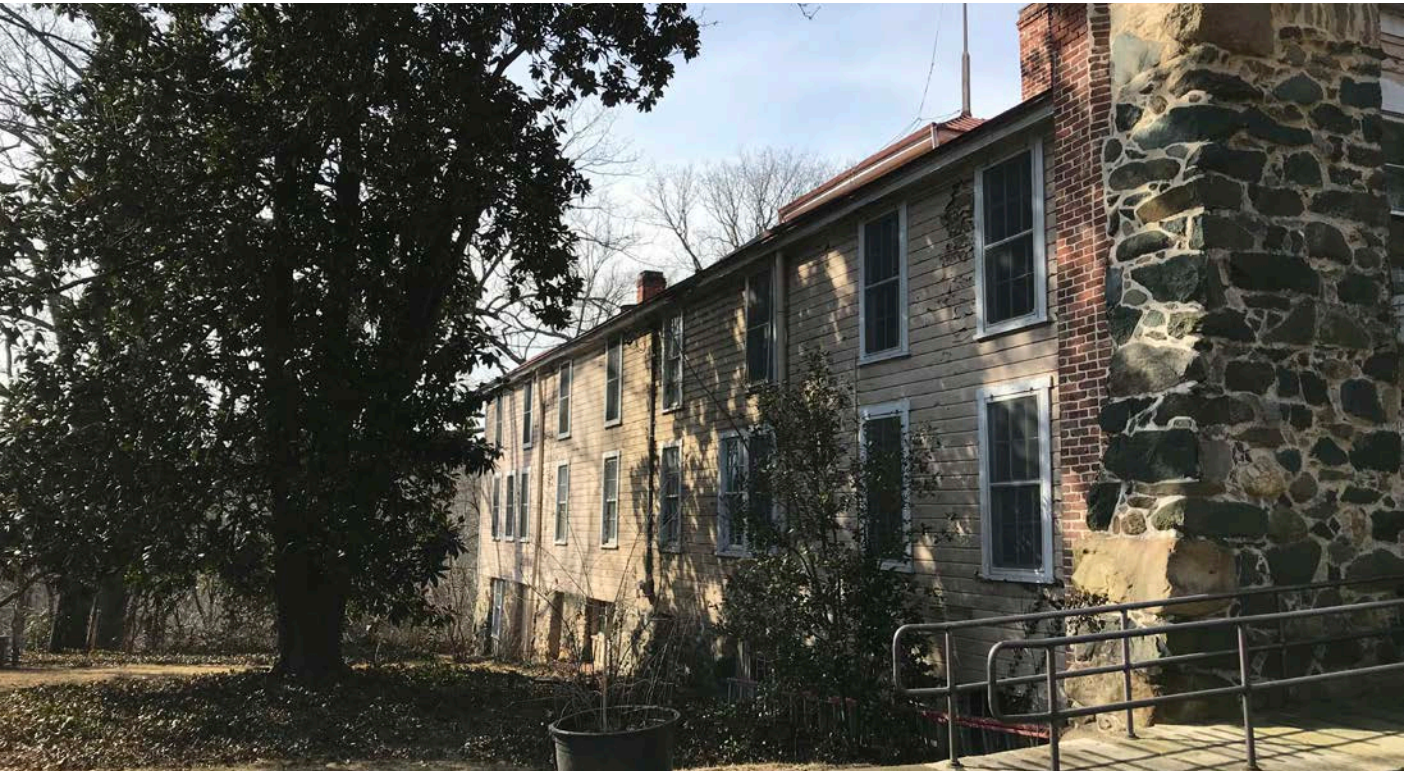
Figure 3.3 South Façade

There is significant paint failure across the entire façade.

Generally, the rubble stone construction is in fair condition but spot re-pointing is recommended.

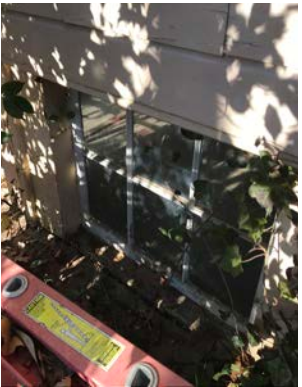
W0.1 Water Infiltration and Rot at Ground Plane

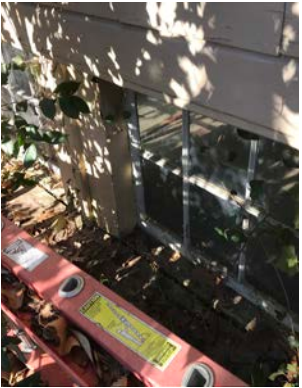
W0.2 Peeling Paint and Water Ingress

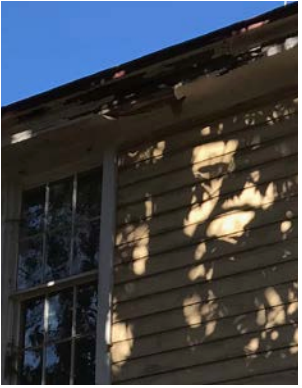
Eave Fascia is Damaged

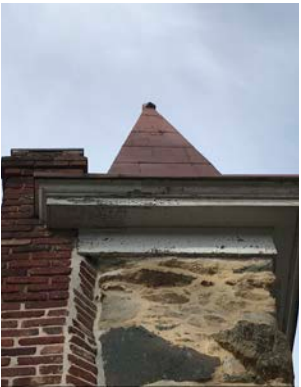
Tower Fascia has Peeling Paint

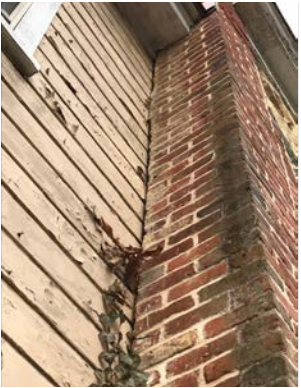
Chimney is Weathered and is Missing Sealant

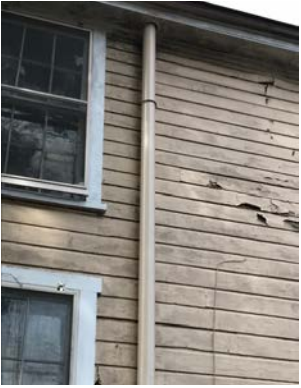
Siding has Peeling Paint

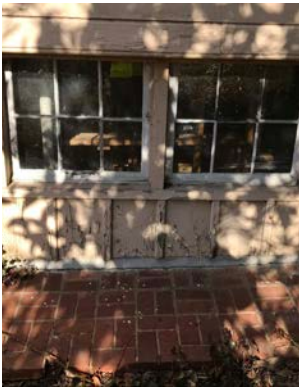
W0.5 Peeling Paint

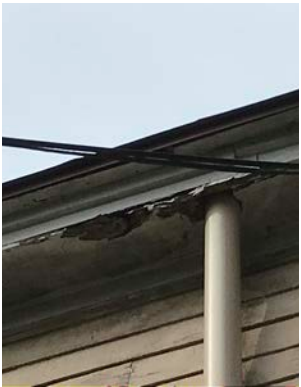
Eave Fascia is Damaged

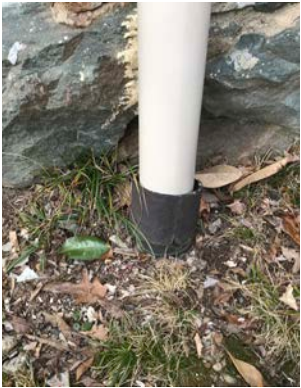
Drain Sleeve is Damaged

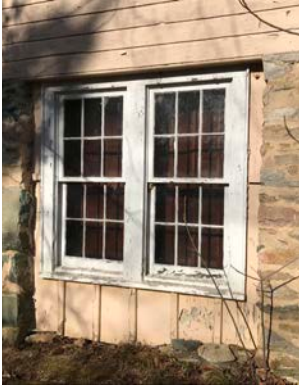
W0.6 Water Infiltration and Rot at Ground Plane

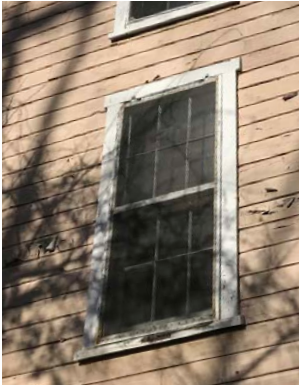
W1.9 Peeling Paint

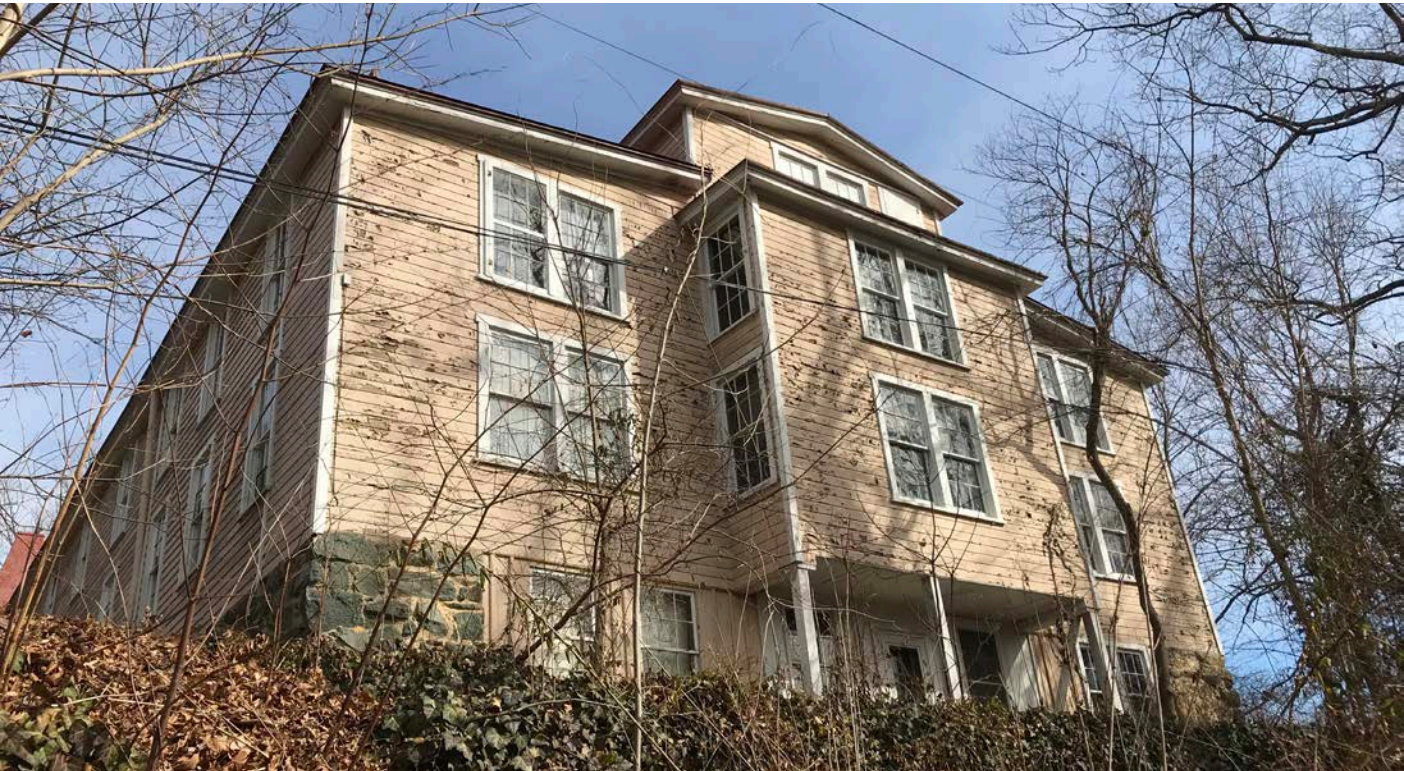
Figure 3.5 West Facade

There is significant paint failure across the entire façade.

Generally, the rubble stone construction is in fair condition but spot repointing is recommended.

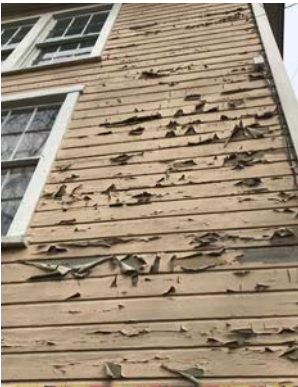
Siding has Peeling Paint

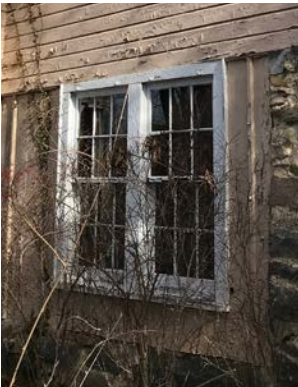
W0.7 Vegetation is Interfering with Window Function

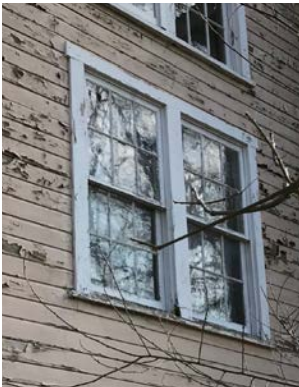
W1.14 Peeling Paint and Damaged Sill

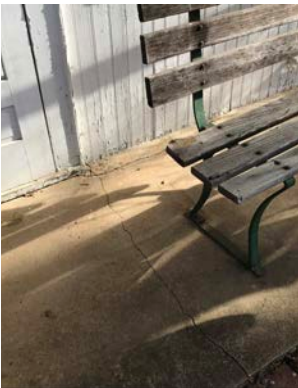
Concrete Patio is Cracked

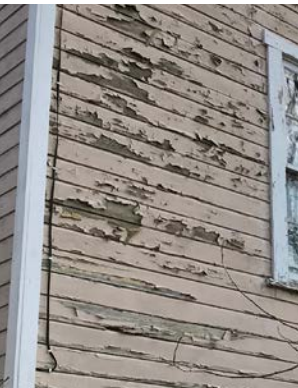
Siding has Peeling Paint

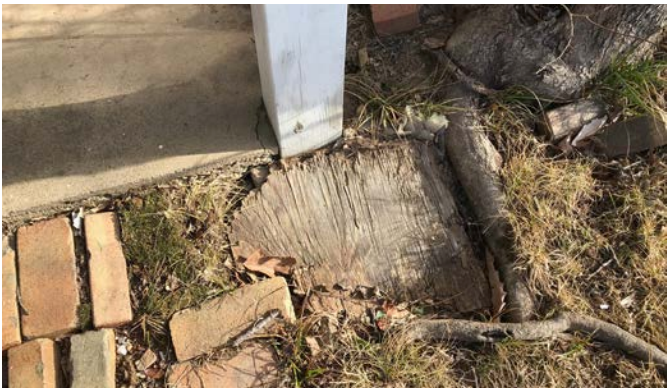
Hole in the Ground at the Column Base

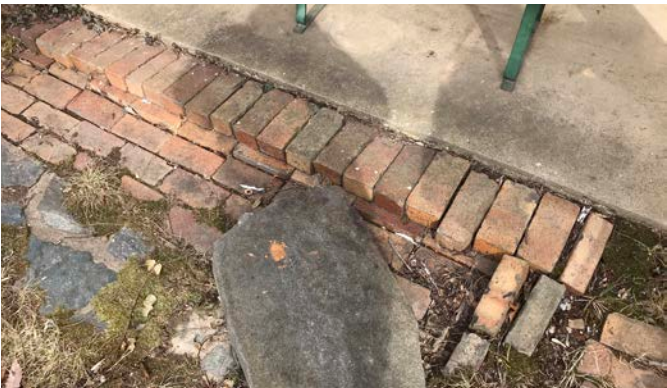
Brick Step has Missing Mortar and is Uneven

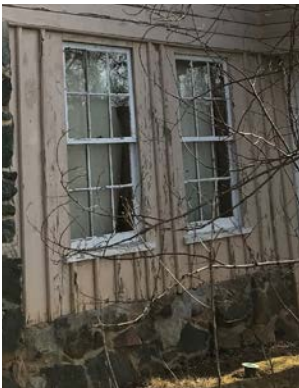
W0.10, W0.11 Peeling Paint

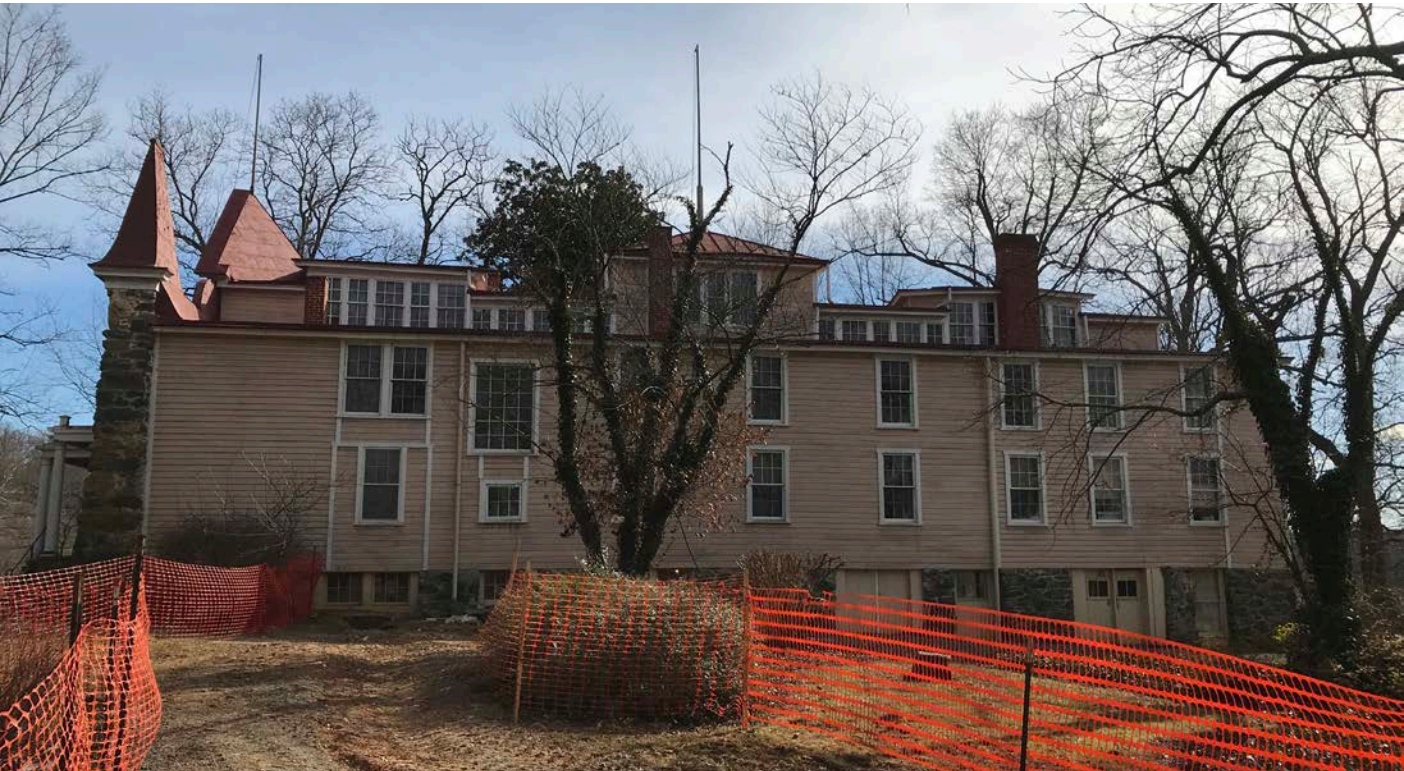
Figure 3.7 North Facade

There is evidence of water damage at the door thresholds and at the base of masonry openings at the basement punched windows. Recently added weatherstripping interferes with closing of the door, resulting in maintenance staff’s consistent removal of the weatherstripping.

Generally, the rubble stone construction is in fair condition but spot repointing is recommended.

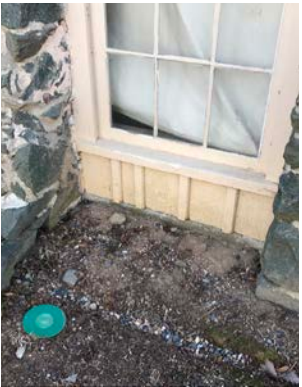
W0.12 Rotting at Ground Plane

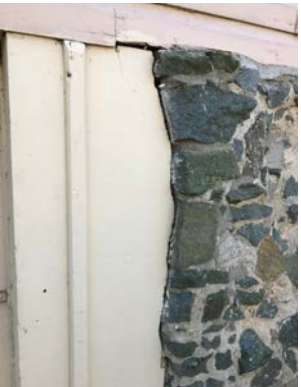
Masonry / Siding Joint Lacks Sealant

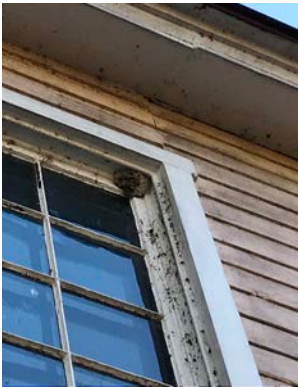
W0.20 Insect Infestation

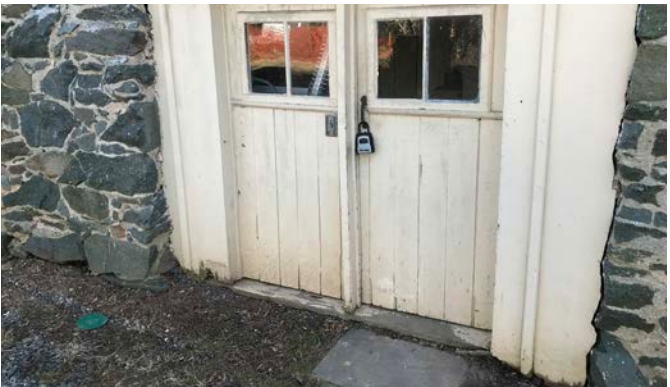
D0.4 Rotting at Ground Plane. Recently installed weather stripping interfering with function of the door. This door requires a comprehensive rebuild. This can be done using modern standards while retaining the historic look of the existing doors.

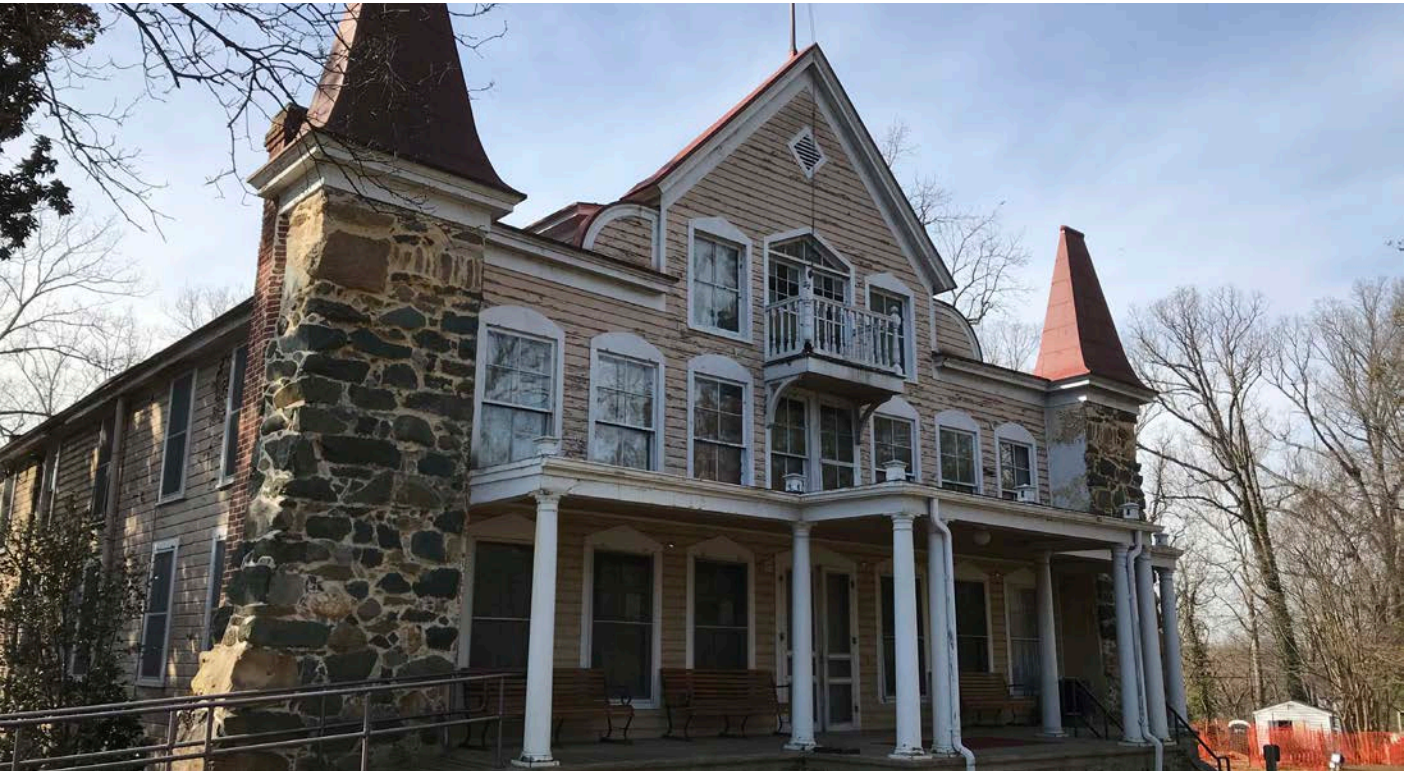
Figure 3.9 East Façade

The roof of the porch once had a full-height balustrade, allowing for its use as a second floor porch. Between 2008-2012, posts were removed and capped due to rot. Post stumps can be seen projecting up through the roofing material. In addition, the existing drawings received from the NPS indicate a railing at the perimeter of the porch roof. This railing is no longer present. This porch roof is currently not suitable for traffic and pending structural review, should not be accessed.

There is a small balcony on at the center of the third floor, supported by wood brackets. This balcony is currently not suitable for traffic and pending structural review, should not be accessed.

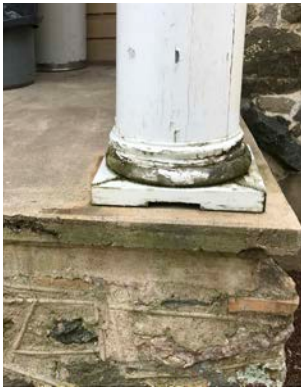
Weathering at Column Base

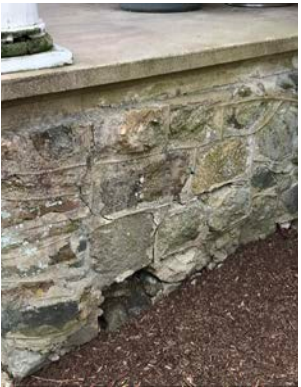
Damaged Masonry

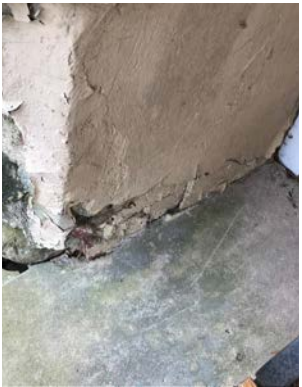
Damaged Exterior Stucco

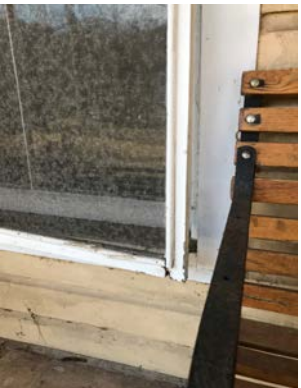
W1.25 Insect Screen Damaged

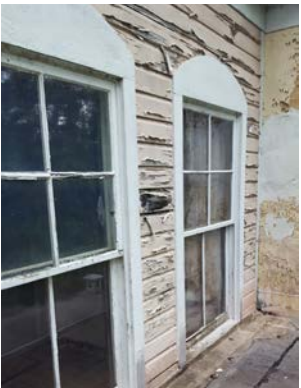
Damaged German Siding

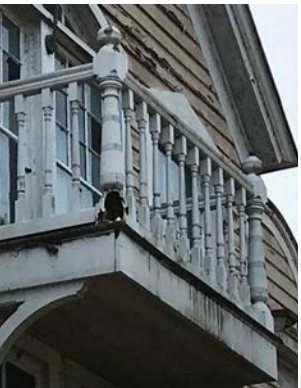
Damaged Balustrade at 3rd Floor Balcony

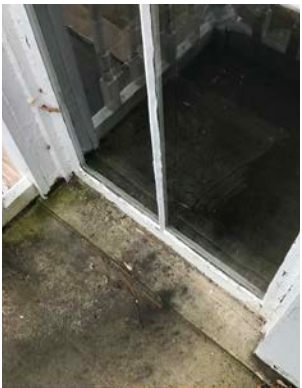
W3.13 Sill Damage Due to Low Slope of 2nd Floor Balcony

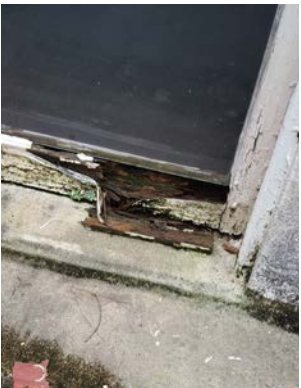
Damaged Window at 2nd Floor Balcony due to False Gable Roof Runoff

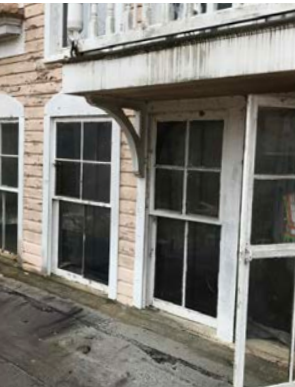
Porch Roof - Low Slope A1

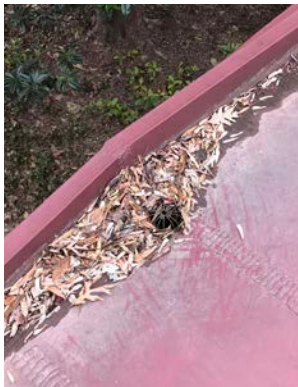
Obstructed Roof Downspout A8

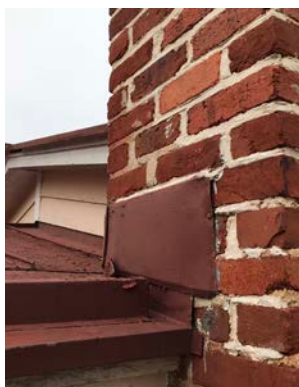
Cracked Flashing - Chimney C3 A11

- Repoint the tops of chimneys C1, C3, C4, C5 and C6. Refer to figure 3.11 for chimney assessment. ②
- Re-flash all upper roof chimneys. ②
- The chimney caps currently have slots allowing air movement. This is adequate but it is recommended to supplement this with stainless steel flashing to reduce water ingress from driven rain. ③

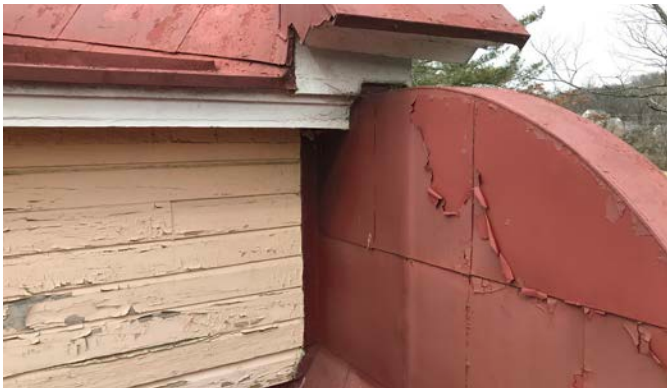
Peeling Paint A6

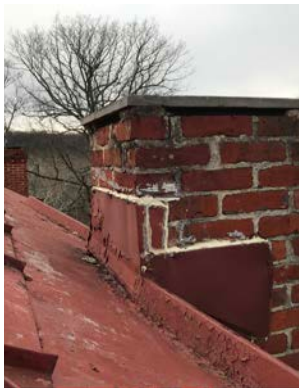
Flashing Cracked - Chimney C2 A12

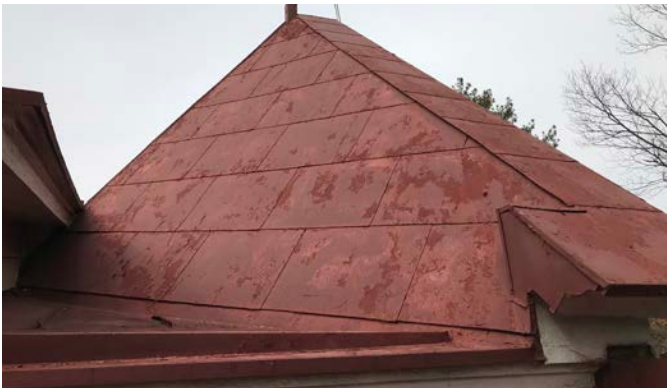
Peeling Paint at Rear of Front Gable A21

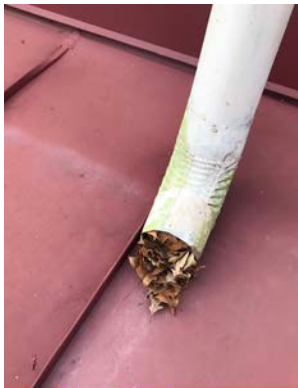
Obstructed Down Spouts A7

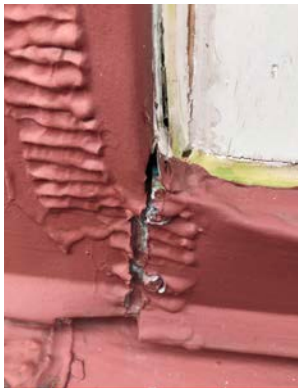
Cracked Flashing A9

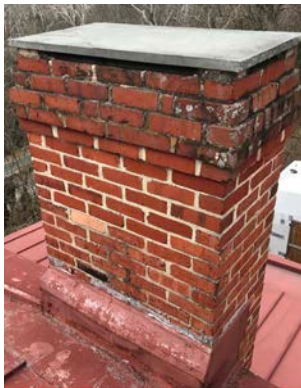
Weathered Masonry and Mortar - Chimney C1 A16

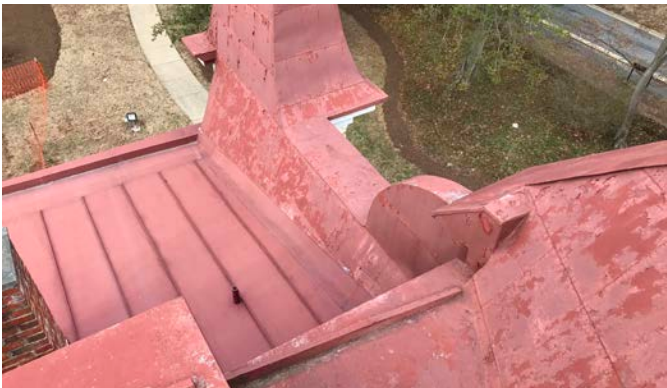
Peeling Paint at North Tower Roof A22

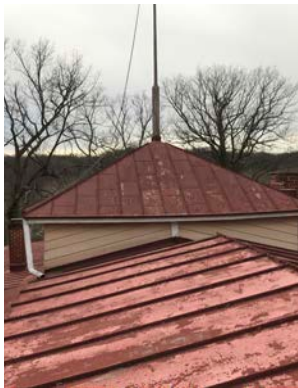
Peeling Paint at Upper Roof A10

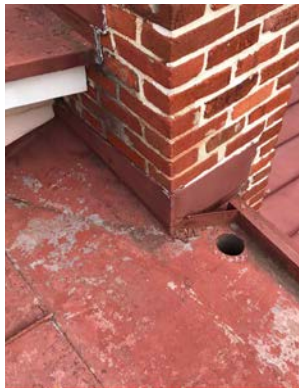
Peeling Paint at Upper Roof - Chimney C3 A14

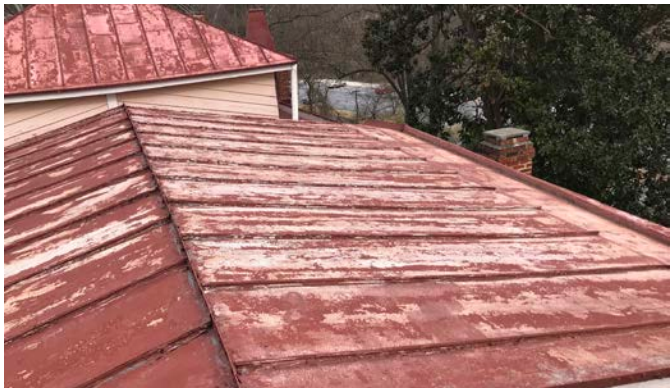
Peeling Paint at Upper Roof A18

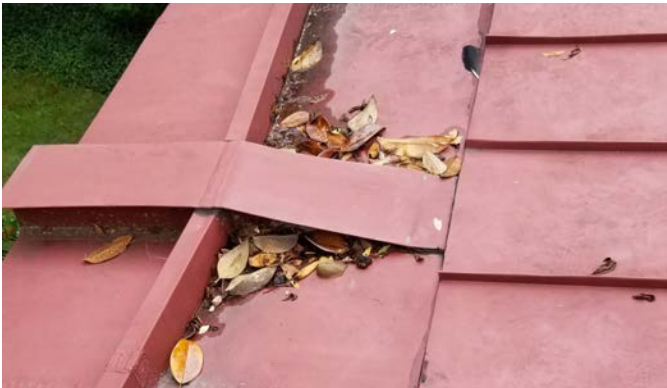
Pooling Water at Roof Expansion Joint

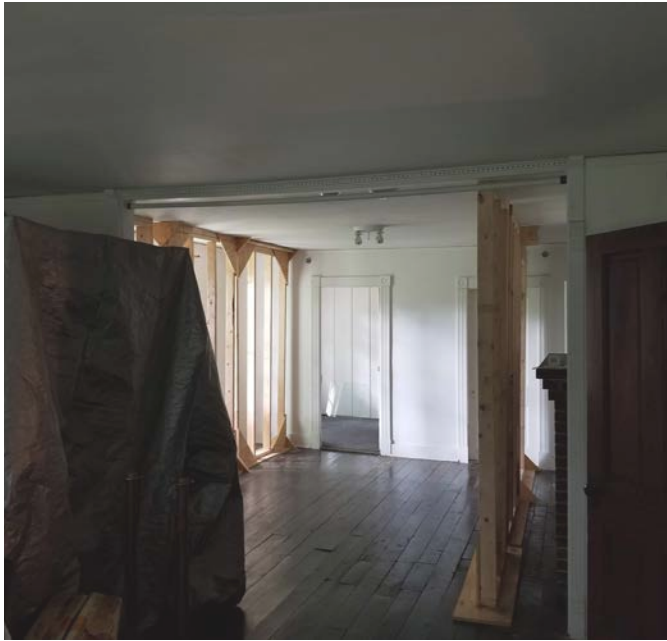
Although, no deterioration was visually observed, multiple sections of shoring were observed under the roof framing on the Second Floor (Figure 3.14, 3.15 and 3.16) that extended down through the First Floor and into the Basement where it was supported on temporary wood block foundations (refer to Figure 3.13). Based on discussion with NPS staff, the shoring was installed during the recent roof replacement project and located in the following spaces:

Figure 3.13 Structural Shoring in Unfinished Basement [001]

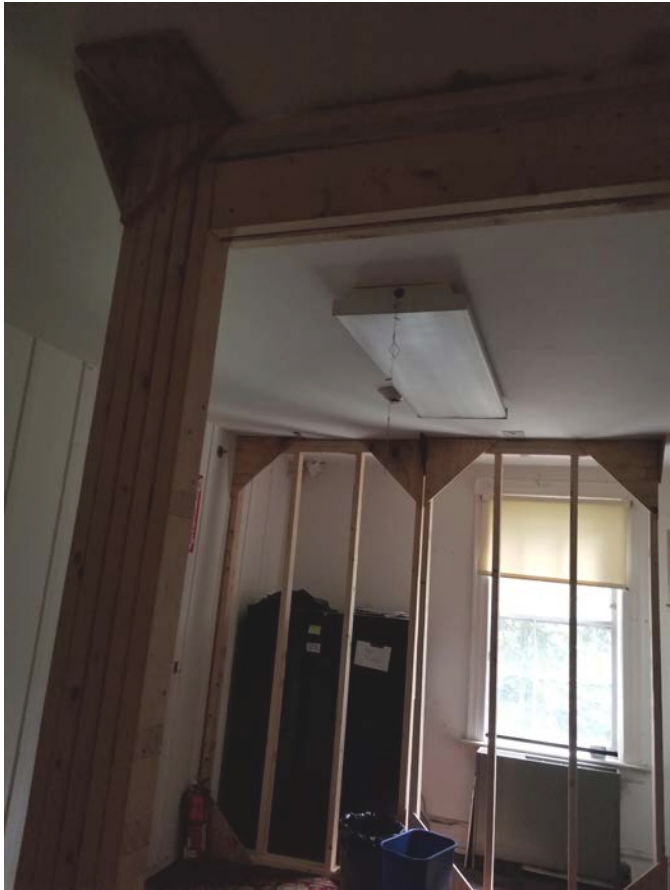
Figure 3.14 Structural Shoring in Rear Parlor [104]

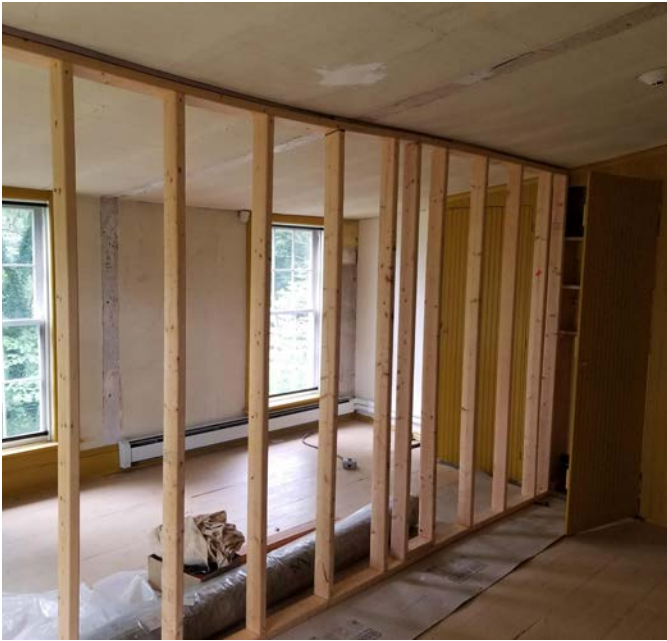
Figure 3.15 Structural Shoring in Office [106]

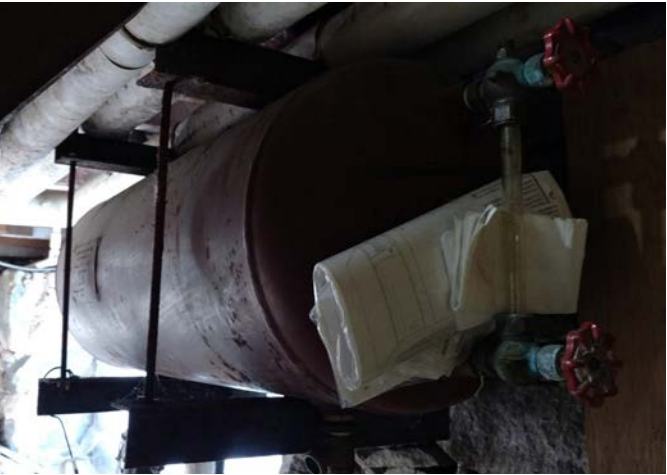
Figure 3.28 Chilled Water Expansion Tank Nameplate Data M5

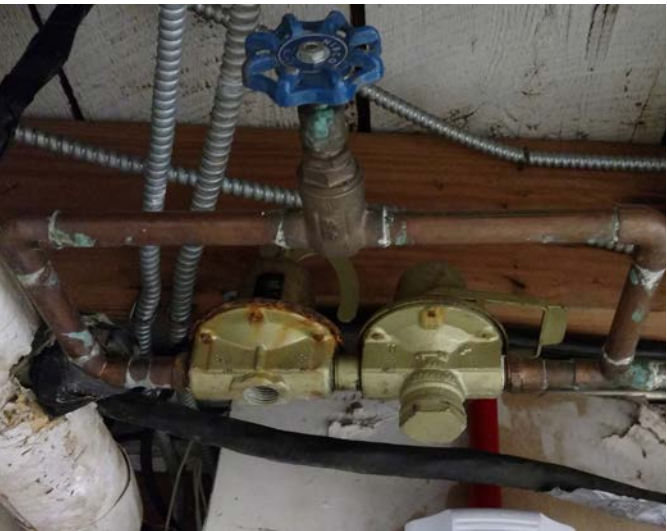
The backflow preventer assembly at the make-up water connection to the chilled water loop is in visibly poor condition. The valve assembly is missing a plug/cap at one of the valves. Additionally, the valve assembly and associated piping are exhibiting rust.

Figure 3.62 Chilled Water Make-up Backflow Preventer P4

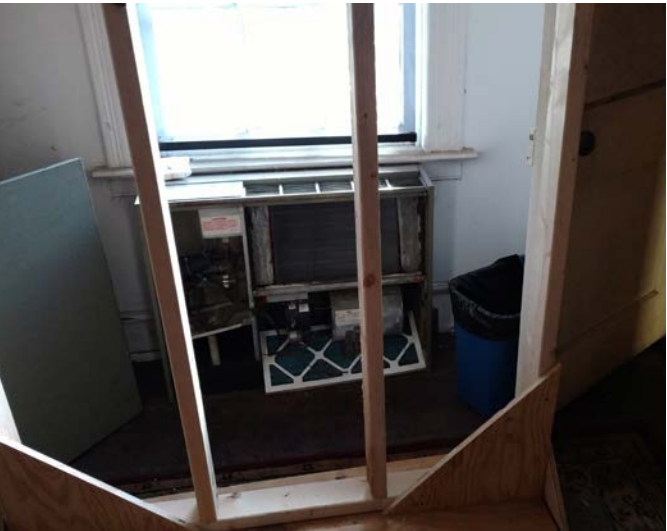
Figure 3.64 Four-pipe Fan Coil Unit serving Office 106 M18

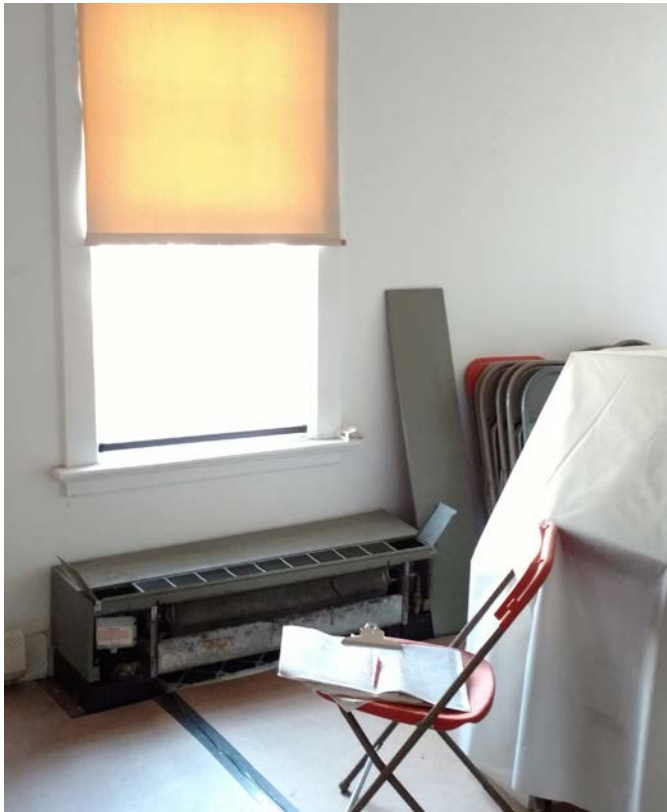
Figure 3.66 Four-pipe Fan Coil Unit serving Visitor Orientation 113 M19

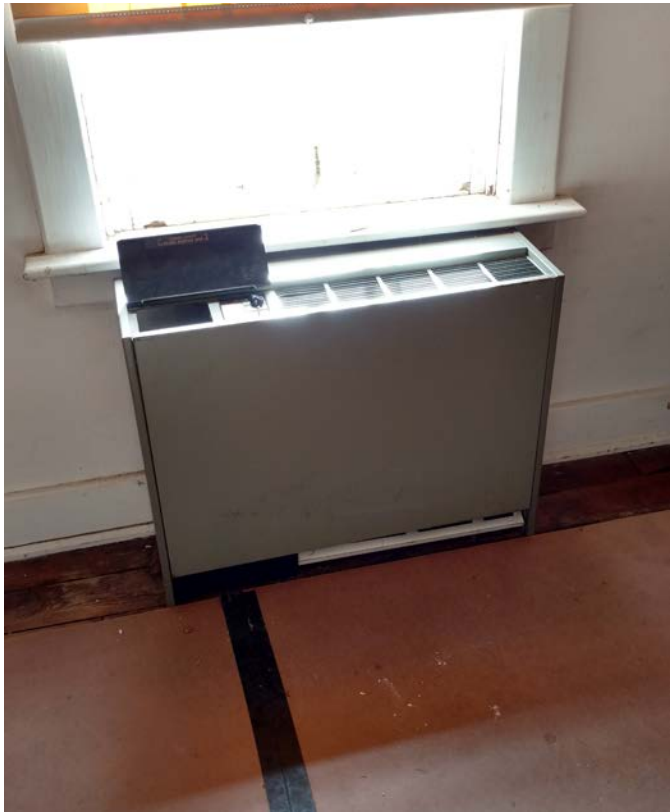
Figure 3.68 Four-pipe Fan Coil Unit serving Office 107 M20

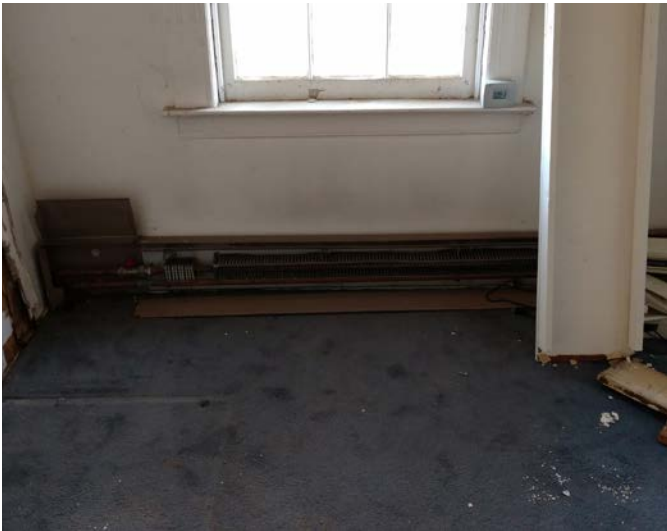
Figure 3.70 Hot Water Finned Tube Radiator serving Collection Storage 105 M21

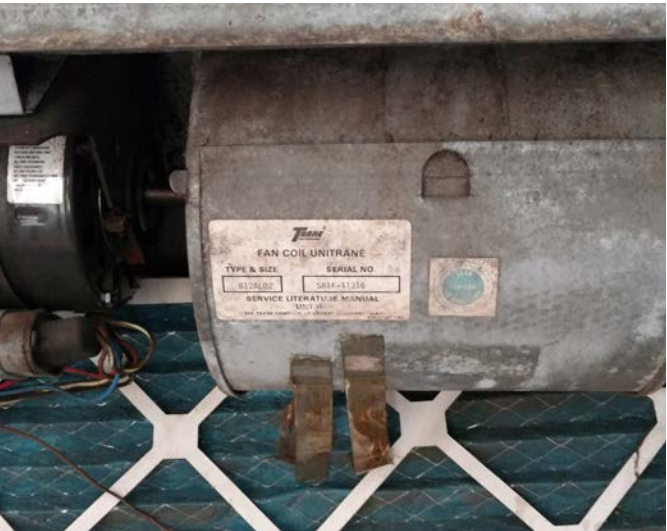
Figure 3.65 Fan Coil Unit Motor and Nameplate Data (Office 106) M18

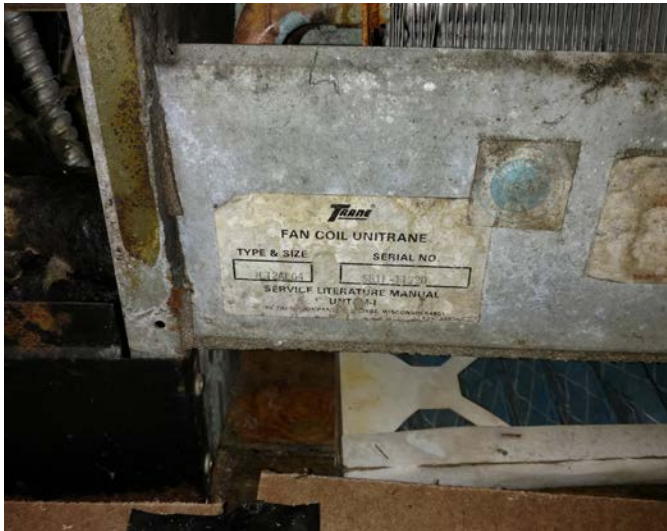
Figure 3.67 Fan Coil Unit Nameplate Data (Visitor Orientation 113) M19

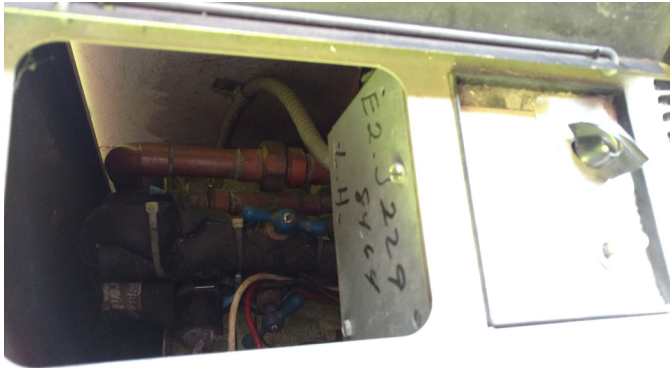
Figure 3.69 Fan Coil Unit Controls and Valving (Office 107) M20

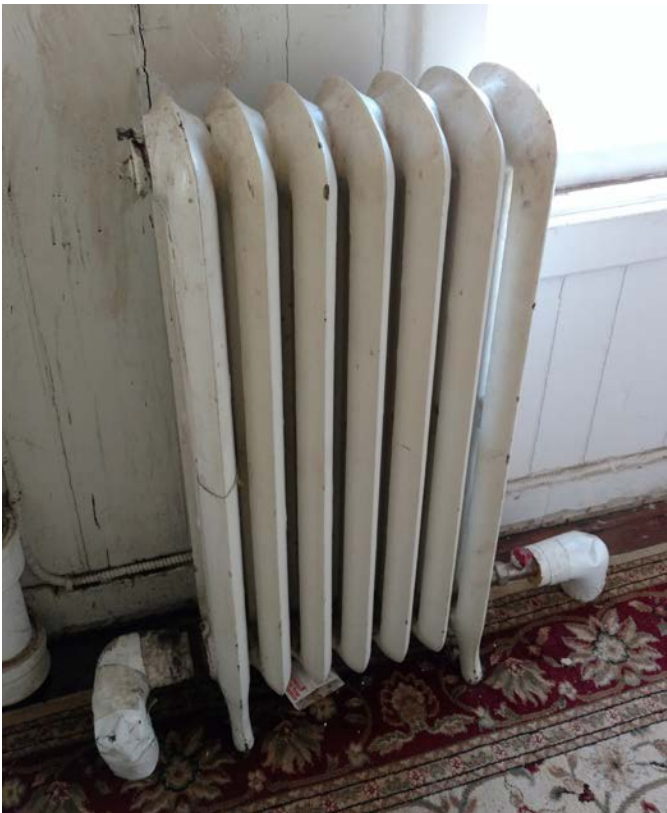
Figure 3.71 Hot Water Radiator serving Clara Barton's Kitchen 111 M22

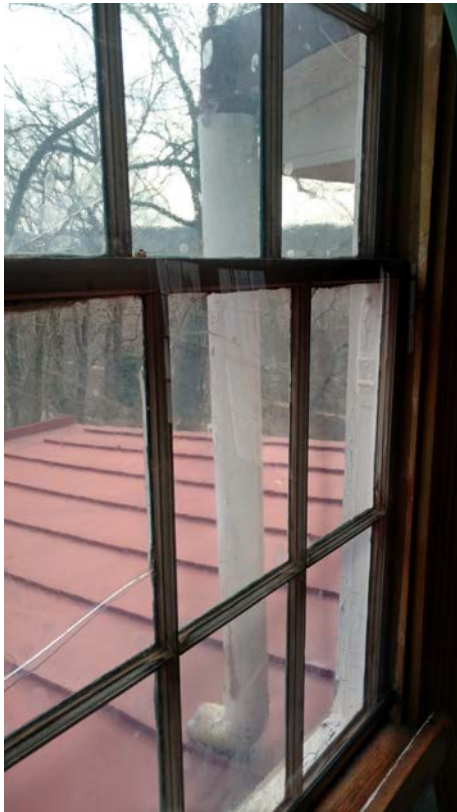
P7

Figure 3.100 Metal Downspouts on Lower Roof (View from 3rd Level Windows)

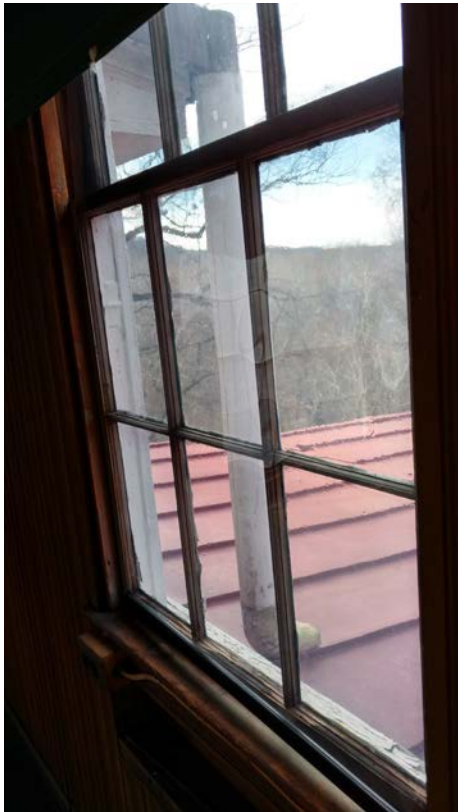
P7

Figure 3.102 Metal Downspouts on Lower Roof (View from 3rd Level Windows)

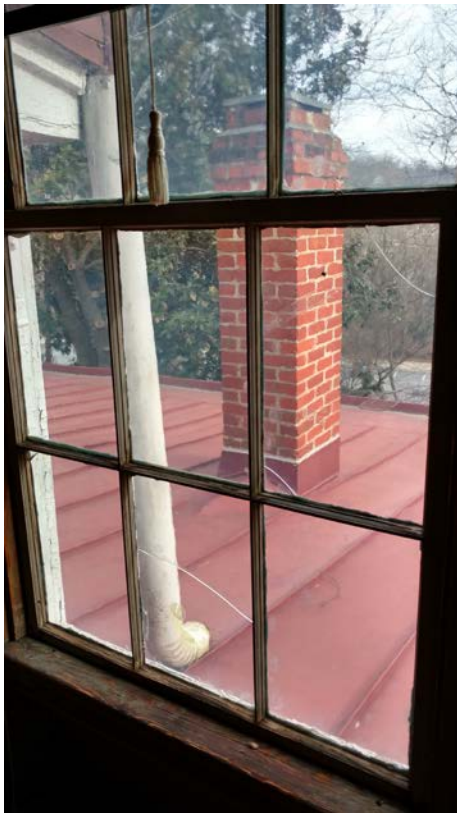
P7

Figure 3.101 Metal Downspouts on Lower Roof (View from 3rd Level Windows)

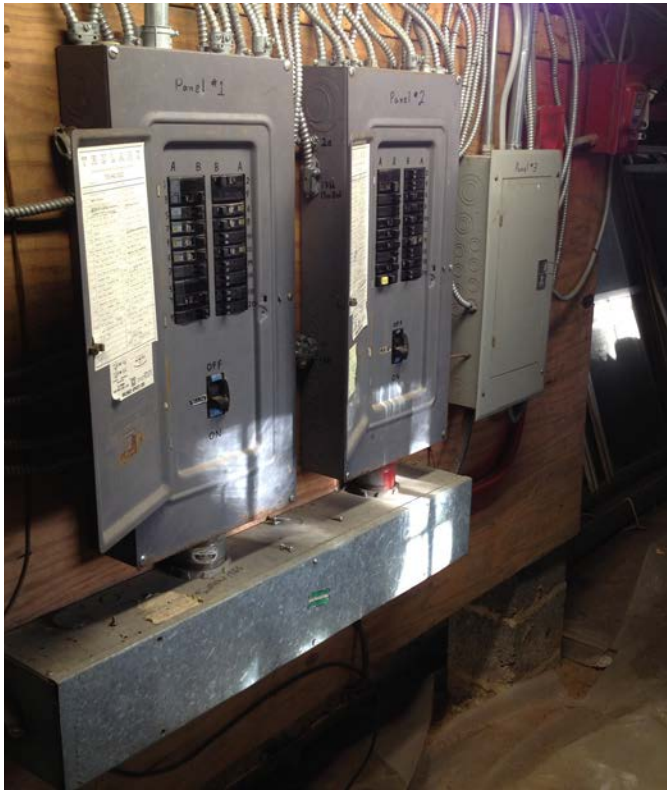
3. The service entrance arrangement violates NFPA 70 Art 230.42 (B) because the main protective devices downstream of the service entrance conductors exceed the capacity of the incoming service entrance feeder. The unprotected service entrance feeder has a 180 A capacity, but the sum of the service entrance protective device ratings exceeds 500A. Therefore, the protective devices will allow loads to exceed 180A which could cause the service entrance cable to exceed its temperature rating and cause a fire. This is a very serious code violation.

4. The building has no surge protection. While not a code violation, the increase in the use of electronic LED fixtures and computers makes these essential for any facility.

Figure 3.107 Service entrance conductors capacity is lower than the overcurrent devices at the service equipment; no surge protection devices E4

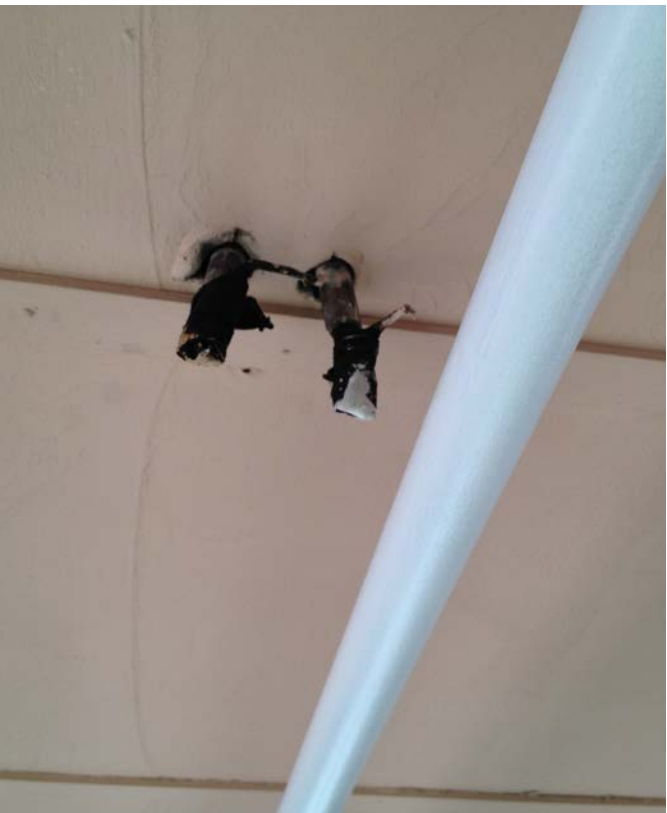
Figure 3.122 Obsolete knob-and-tube wiring E14

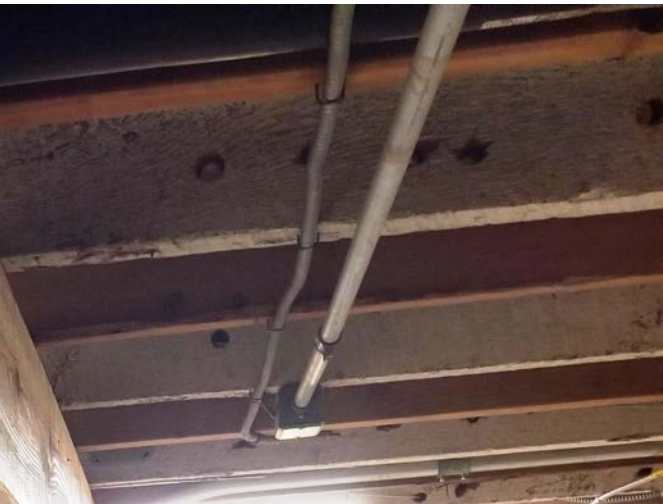
Figure 4.1 First Floor Joists (Painted White - Original; Unpainted - 1981 Strengthening)

Although a number of the existing First Floor joists (those painted white) have areas with a significant number of drill holes, the newer wood joists (unpainted), installed per the 1981 Sheladia drawings, have very few. Based on the drawings and our survey, we can reason that the Sheladia design accounted for these holes when determining the size and spacing of the supplemental wood joists. Therefore, although noticeable, we would conclude that the First Floor would retain the 60 psf live load capacity as designed in 1981. Refer to Figure 4.2.
